Study of vulnerability and damage: the case study of Castelnuovo after L'Aquila earthquake (Italy)

B. Ortolani, A. Borghini, S. Boschi, E. Del Monte & A. Vignoli Department of Civil and Environmental Engineering, University of Florence, Italy

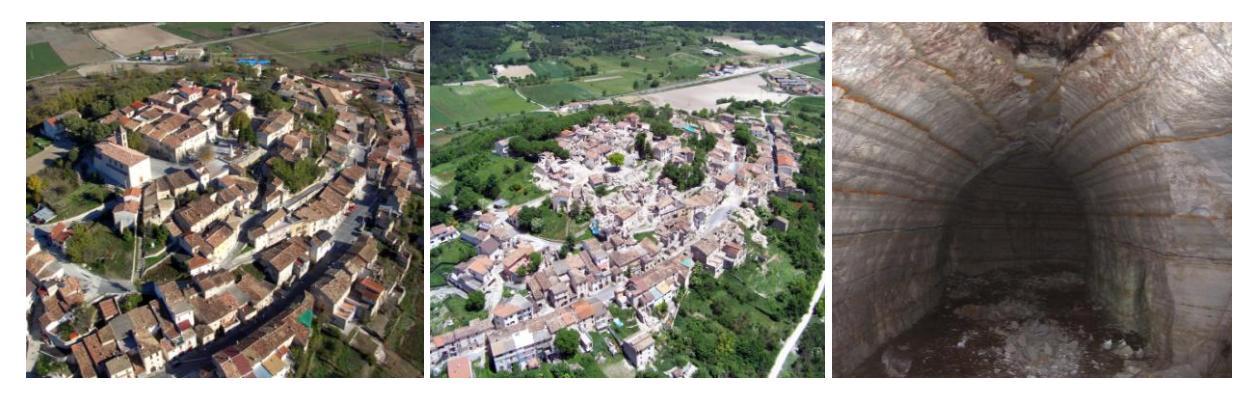
The macroseismic effects reached intensity 9.5 (MCS scale) at Castelnuovo and, in fact, the shake caused collapse of the 50% of the buildings (Fig.1.2.b.), serious damage into most buildings and even the death of 5 people.

The village is insert within the complex defense and sighting medieval system, located in the L'Aquila's valley. The whole subsoil of Castelnuovo is characterized by the presence of subterranean tunnels dug into silt (Fig.1.2.c.). Access to tunnels generally corresponds to the ground floor of the buildings directly from the street level. Originally, in fact, ground levels of the building were stables for animals or agricultural storages.

Figure 1.2. (a) Aerial photo of Castelnuovo before L'Aquila earthquake. (b) Aerial photo of Castelnuovo after L'Aquila earthquake. (c) Example of subterranean tunnel

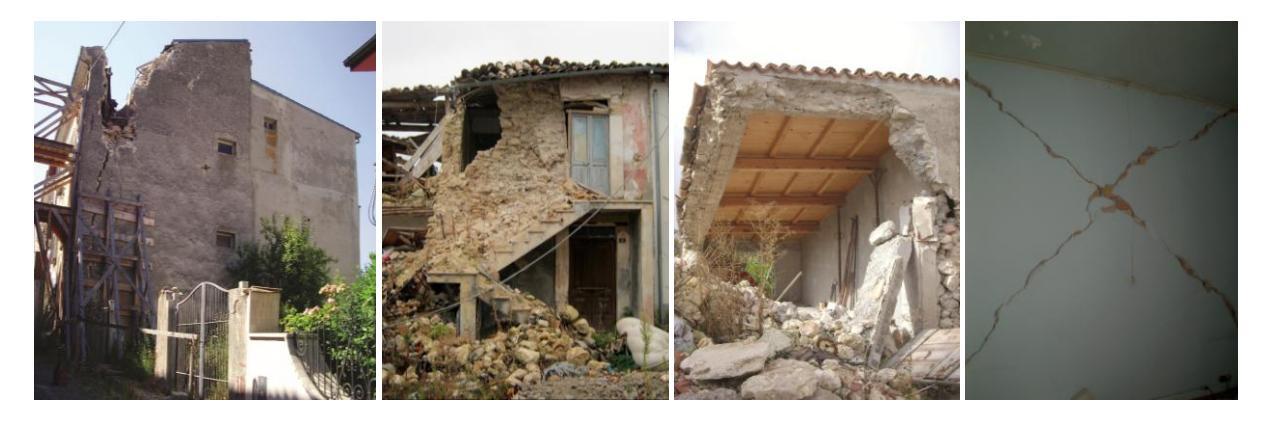
The extensive in-situ survey of aggregates allowed to systematize the possible activated mechanisms of collapse in a reference abacus. Out-of-plane mechanisms are typical of buildings subjected to horizontal actions orthogonal to their plane with lacking connections between floors and walls and among perpendicular walls.

Figure 4.2. Out-of-plane mechanisms: (a) Overturning of a facade and collapse of the roof. (b) Corner collapse and crumbling of panel. (c) Collapse of all panels. (d) Shear failure in the plane of panel

In the following, a description of the principal out-of-plane mechanisms is given; it is possible to distinguish between: overturning of a monolithic wall (O), overturning of a monolithic wall with corner (OC), vertical bending (overturning of a wall restrained at the top by a tie, VB), horizontal bending (arch effect in the thickness of the façade of wall, HB), corner collapse (CO) and total collapse of panel (C) (Valluzzi et al., 2004).

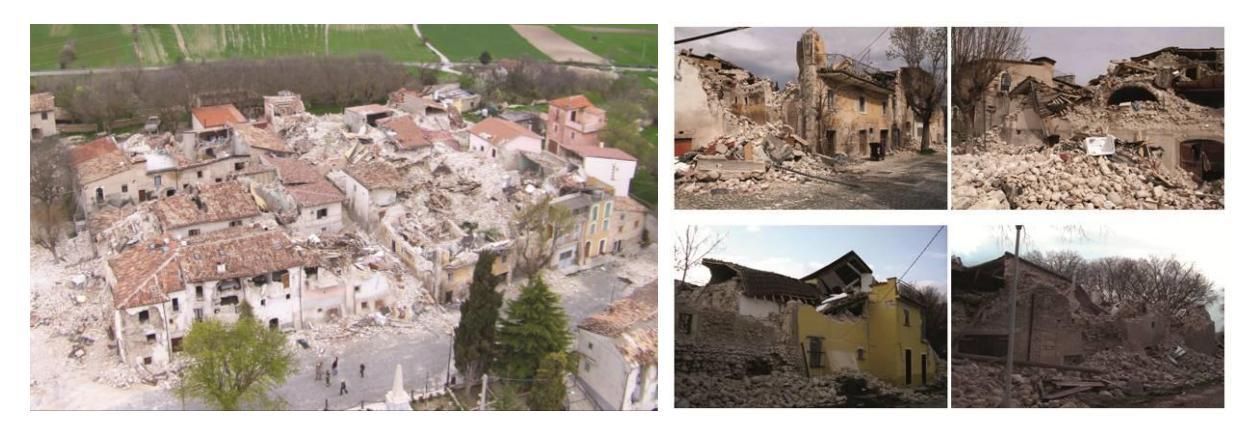
In particular, only 15.5% of the units has not suffered damages to the structural elements (D0 and D1 level) while 76.5% is characterized by considerable damages to structural parts (D3, D4 and D5). It is important to underline that the concentration of serious damages (D4 and D5) is mainly located on the top and central part of the village, where the older buildings were.

Figure 4.3. Photos of "Castello" after earthquake: high damage level compared to other areas of Castelnuovo

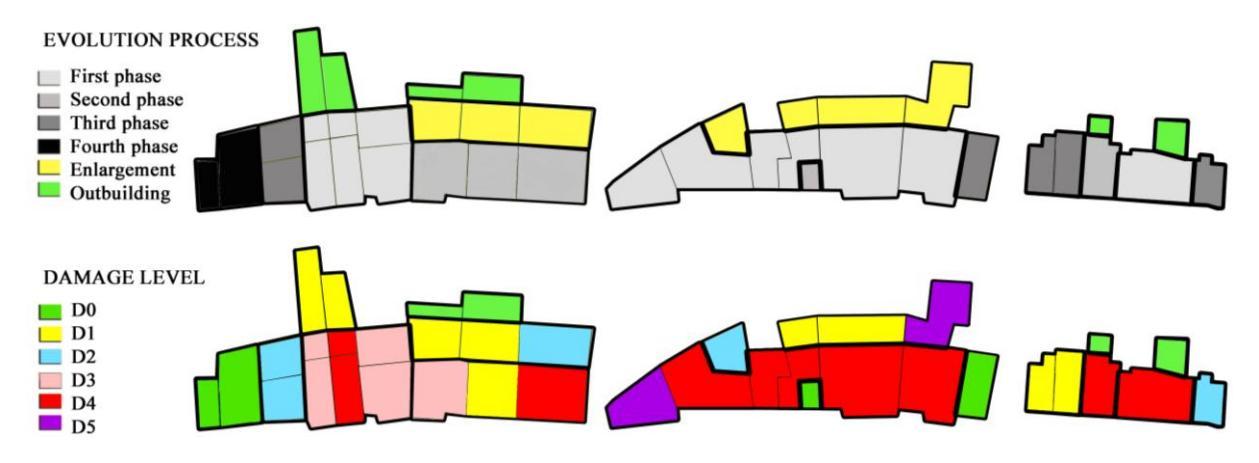
For each structural units construction evolution and damage level are indicated. It is important to notice that original core of the aggregates have generally suffered common high damage level (D4/D5), while the structural units built in succeeding times have shown lower damages to the structural elements. The outbuildings and enlargements have usually low damage levels (D0/D1) because they are made in reinforced concrete, their conservation status is excellent and, obviously, they are separated from masonry structures.

Figure 4.8. Three aggregates: process evolution and damage level for each structural unit

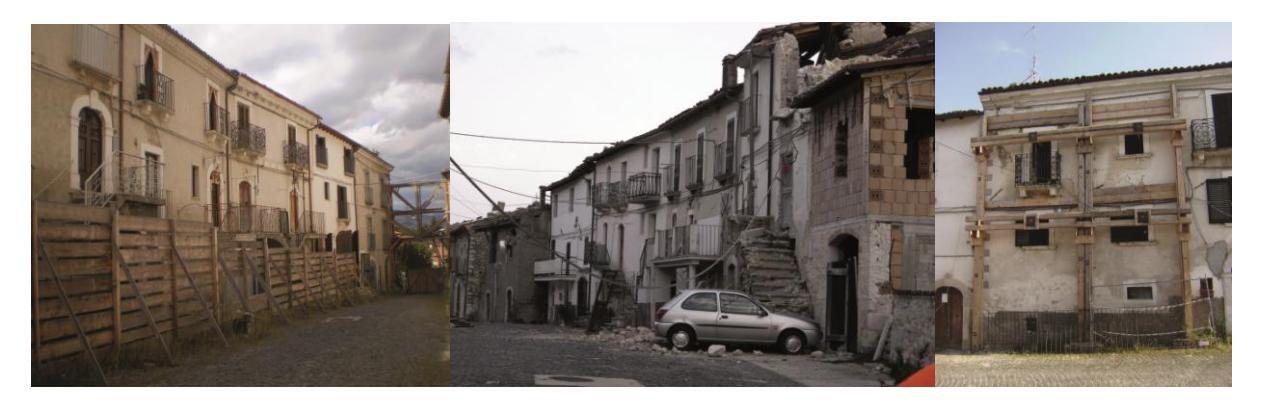
Figure 4.9. Three aggregates: some photos after earthquake
