TESTING OF AN EXISTING TWO STORY MASONRY BUILDING UNDER LATERAL LOADS

A. Aldemir⁽¹⁾, B. Binici⁽²⁾, E. Canbay⁽³⁾, A. Yakut⁽⁴⁾

2.1 Test specimens and instrumentation

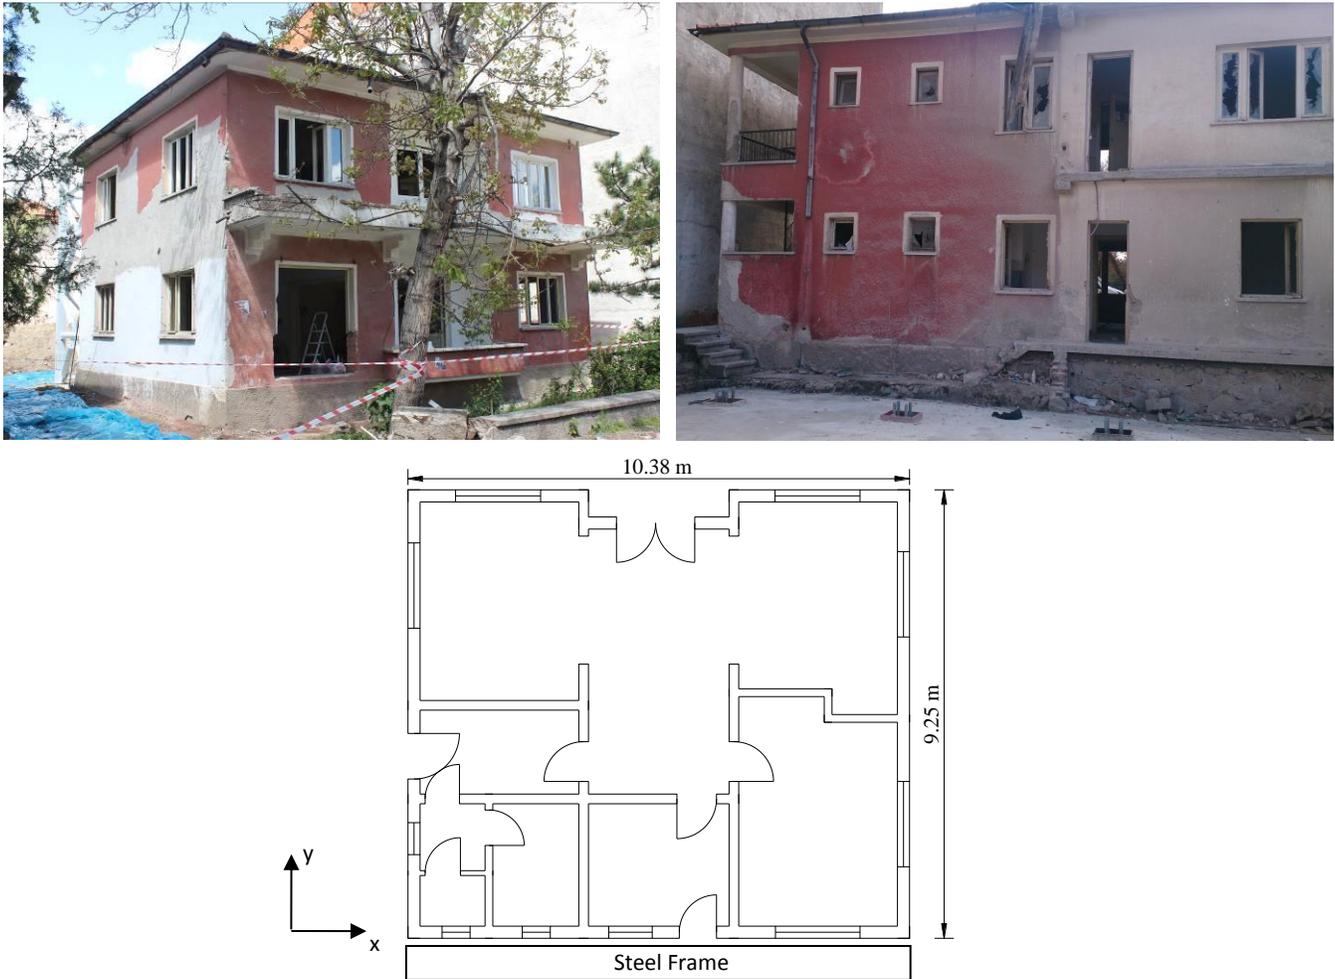
Fig. 1 – Photo and plan view of test structure

The test building with the floor plan shown in Fig. 1 is located in the Northern part of Ankara, Turkey. The building is a two-story masonry structure with a floor plan area of about 10 m × 9 m made of solid clay bricks. The building had RC bond beams underneath slabs with thicknesses of 0.13 and 0.10 m in the first and second stories, respectively. The material properties of the test building were determined before lateral load tests. For this purpose, rectangular wallets of 90cm × 90cm sizes were extracted under window openings. The wallet specimens were subjected to uniaxial compression, diagonal tension and triplet tests. The test results reveal that the average uniaxial compressive, diagonal tensile and shear strength were 2.14 MPa, 0.36 MPa and 0.17 MPa, respectively (Fig. 2). In Fig. 2, the test setups for uniaxial compressive, diagonal tensile and triplet tests are also shown.

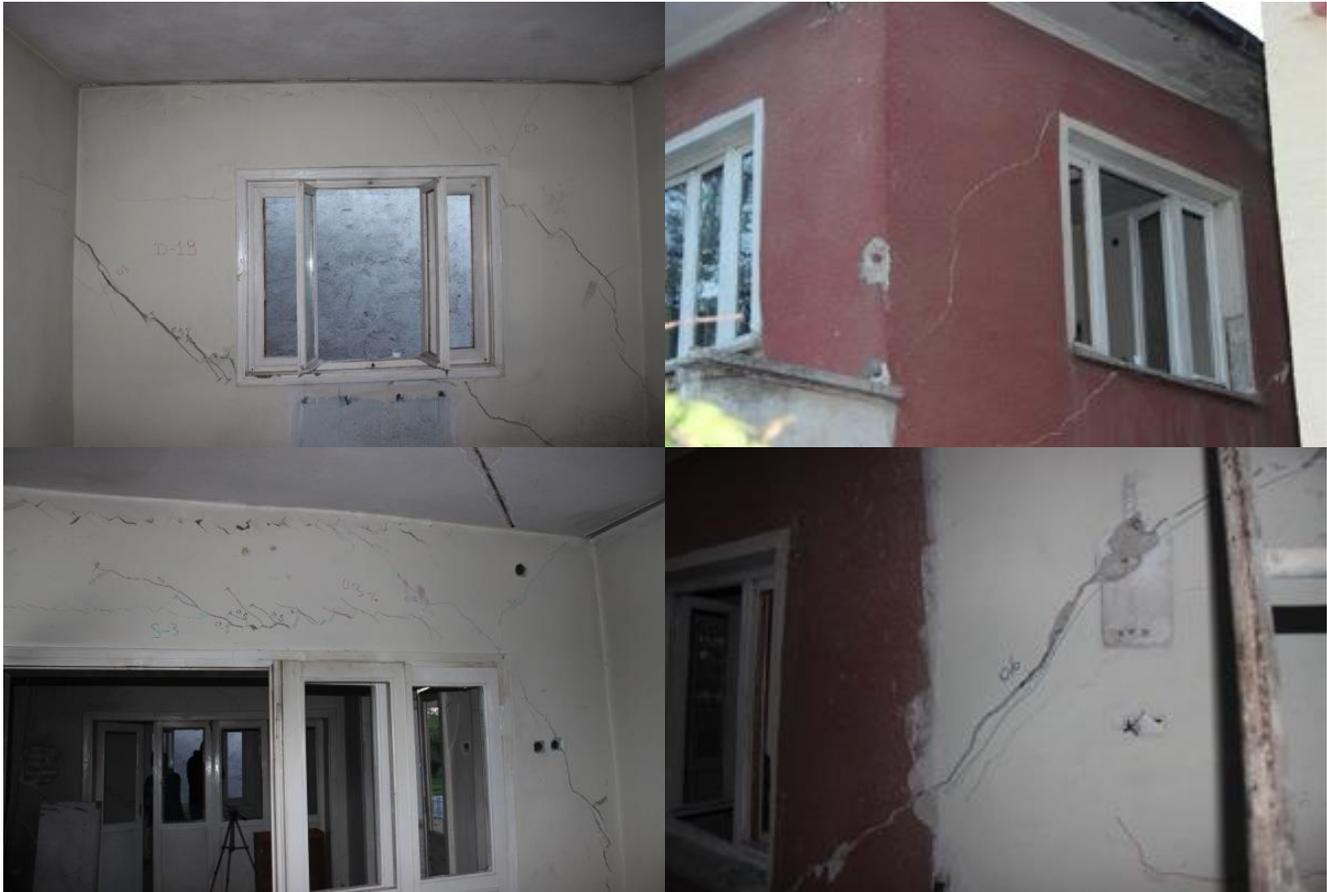
Fig. 9 – Different cracks observed during one-way cyclic test in the second story

Measured load deformation response of the building is shown in Fig. 7 for the center of mass location. In addition, the deformation profile along the height of the building and the plan deflections at different roof displacements are presented in Fig. 8. The damage pictures of the test building are shown in Fig. 9.

The ultimate base shear force recorded during the test was 990kN at overall building drift ratio of about 0.35%, corresponding to a nearly 0.25% of interstory drift ratio at each story level. The test was stopped when the second story drift ratio reached about 1.2% since the test second story lost 20% of its ultimate capacity. Plan deflection sketches of the test building shown in Fig. 6.b showed that the building experienced slight torsional rotations in the clockwise direction at both story levels with increasing nonlinearity due to asymmetric wall damage. The damage of the first story walls were relatively minor during the one-way cyclic displacement excursions whereas there was heavy damage on the second story walls, including severe diagonal cracks, sliding cracks at the slab interface and severe damage at the corners of doors and windows (Fig. 9).
