LARGE-SCALE TESTING OF FRP-STRENGTHENED RC-SMRF T-BEAMS WITH RECTANGULAR WEB OPENINGS

Keywords: openings, large-scale testing, fiber-reinforced polymer, reinforced concrete, moment resisting frame beams.

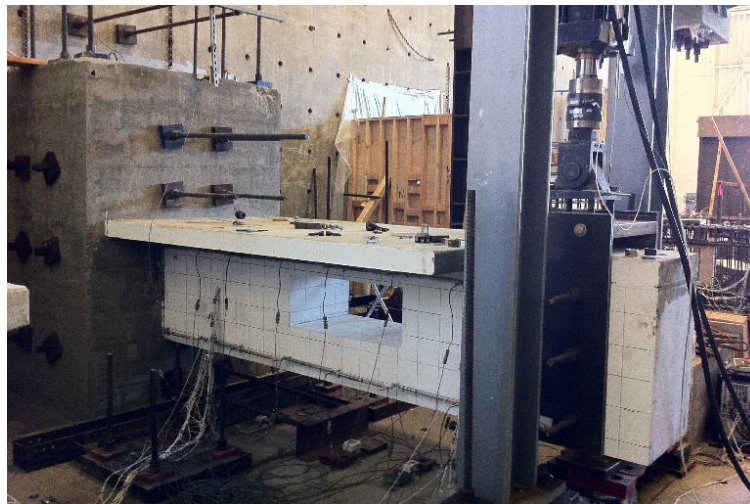
Fig. 3 – Test setup.

The test specimens were subjected to reverse cyclic loading in the vertical direction to simulate the effects of earthquake-induced deformations. Loading was applied at 61 cm (24 in) from the free-end by means of a 1334 kN (300 kips) capacity hydraulic actuator and a U-shaped steel clamping system, as shown in Fig. 3. The clamp embraced the beam from the top and was connected with the specimen via six post-tensioned horizontal dywidag rods to facilitate an even, slip-free load distribution profile across the beam’s depth. The reaction block was fastened to the strong floor and strong wall via post-tensioned dywidag bars, and additionally secured with two shear plates in the front to restrict any block rotation or sliding. Verification of zero block rotation and sliding was also monitored during load application and confirmed to be negligible.

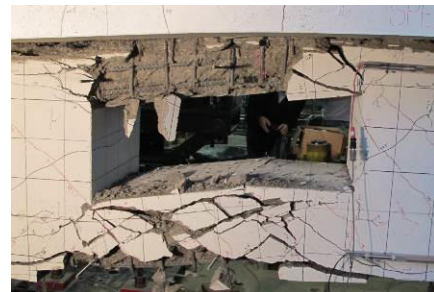
Fig. 5a & b: – Crack patterns in specimen S1 at drift ratio 4.5% (a, left) and photograph of opening region cracks and damage at drift ratio 4.5% (b, right)

Fig. 5 depicts the crack patterns of specimen I at complete structural failure. Initial, vertical, flexure-type cracks at the support and opening regions occurred at a drift ratio of 0.12% approximately $h/2$ from the beam-column interface (where h is the overall beam height). Cracking in the opening region started at both the opening corners and the chord members. Long diagonal tension cracks were initiated at 0.63% drift ratio along the beam segment comprised between the tip and the opening. Vertical flexural cracks along the chord members progressively turned into deeper and inclined flexure-shear cracks. As shown in photographs of Fig. 6, bond splitting cracks developed in a later loading stage along the jamb bars and main reinforcement of the bottom chord. Spalling of the cover concrete occurred first at the top chord. Extensive crushing and spalling of the confined concrete occurred at both top and bottom chord members at drift level of 4.5% and lead to collapse. Cracking patterns suggest that the top chord failed primarily by the formation of diagonal cracks in both directions (shear failure), while the bottom chord displayed a predominantly bond splitting failure mode. This type of failure was likely due to inadequate detailing provided around the opening, with neither added nor lapped reinforcing bars being continuously developed along the whole span of the chord members, thus creating an abrupt discontinuity of the longitudinal reinforcement close to the opening mid-section.

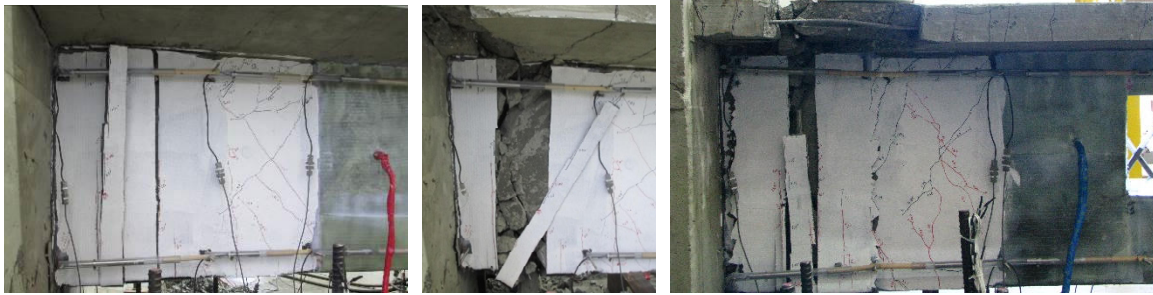
Fig. 6a, b & c – Crack patterns in specimen IA at failure region (i.e. fixed-end) at 3.0% and 4.0% drift (a & b, left & middle), and crack patterns in specimen IB at failure region (i.e. fixed-end) at 4.5% drift (c, right).

Specimen S1A: The first observed cracks in the concrete were vertical flexural cracks originating from the tension top face of the beam and appeared while loading in the downward direction at 0.19% drift ratio. A long diagonal tension crack developed simultaneously across the painted concrete region. First visible vertical cracks along the CFRP, originating from the top face occurred at 0.57% drift and continued through higher drift levels. No discernable cracks were observed in the opening region, attributed to the presence of the GFRP wrap. Widening of the cracks and crushing of the concrete at the hinging region, next to the support, eventually lead to vertical tearing of the CFRP laminate at 3.0% drift, as shown in Fig. 6a&b. Spalling of the cover concrete commenced at the same drift level at the portion of the slab next to the beam-column interface. At 4.0% drift, delamination of the CFRP progressed and the wrap ruptured along the soffit of the beam, resulting into concrete detachment previously prevented by the CFRP. Almost all of the bottom longitudinal reinforcement became visible. At the top part of the member, large pieces of concrete disintegrated but were contained by the transverse reinforcement.

Specimen S1B: Cracking initiated during the first downward cycle at 0.38% drift in both the concrete and the CFRP. Flexural cracks developed from the tension face and progressively turned into long shear diagonal cracks. During subsequent drift levels (i.e. 0.57% and 0.75%), new vertical cracks appeared along the lateral faces of the

CFRP wrap, at the same time as new flexural-shear cracks developed in the visible concrete section. Similar to Specimen S1A, Specimen S1B showed no apparent damage or severe cracking at the opening region throughout the entire test. At 2.30% drift, vertical cracks on the CFRP laminates widened substantially; complete detachment occurred at 3.3% drift. At 4.5% drift, an approximately 7.62 cm (3 in) wide strip of CFRP detached all the way around the opening (Fig. 6c), including the intact composite anchors, which resulted in significant concrete spalling from the soffit of the beam. Specimen IB failed at the plastic hinge developed next to the fixed-end of the beam, similar to Specimen IA.

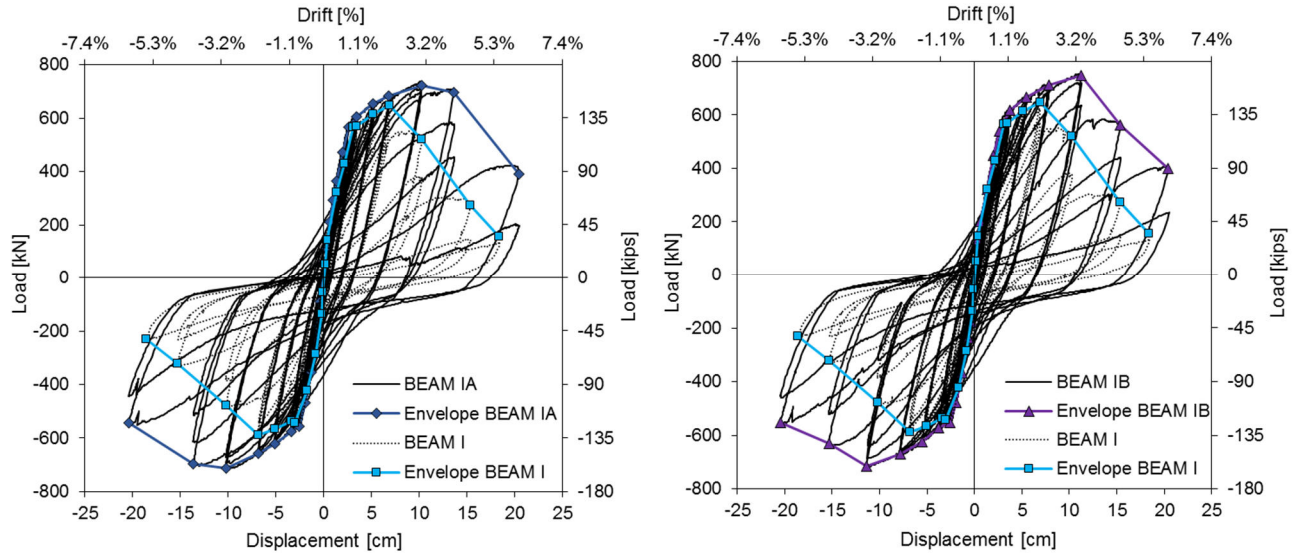
Fig. 7 – Vertical load versus tip displacement.

Vertical load-displacement relationships are presented in Figs. 7. Positive displacement values correspond to the downward loading direction (i.e. slab in tension), while negative values correspond to upward loading (i.e. slab in compression). The performance of the FRP-strengthened specimens S1A and S1B is compared to that of the unstrengthened specimen, S1. Test results indicate that considerable enhancement of the ultimate strength, the ductility and the energy dissipation capacity was achieved by means of both FRP-strengthening schemes. The

minimum and maximum increase in peak strength attained with the FRP reinforcement with respect to the unstrengthened specimen (i.e. S1) were 12% and 21%, respectively, and the range of increase in terms of ductility was 66% to 97%. In general, both wrapping schemes performed similarly, with the higher peak loads and displacements reached by S1B being mainly attributed to the higher drift applied on the beam (3.3% drift for S1B vs. the 3% drift for S1A).

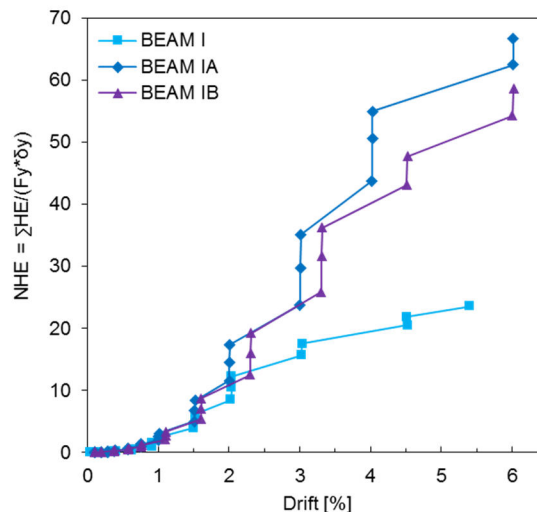
Fig. 8 – History of (cumulative) normalized hysteretic energy (NHE) dissipation.

The history of (cumulative) normalized hysteretic energy (NHE) dissipation for the discussed three specimens is presented in Fig. 8 with respect to the applied drift levels. NHE at a given cycle was computed as the summation of the dissipated hysteretic energies (HE) of the current and preceding cycles normalized by twice the elastic strain energy, where each HE was obtained as the enclosed area of the corresponding load-deformation hysteretic loop. The NHE at yield for specimens S1, S1A and S1B was 1.0, 1.0, and 0.9, respectively, and the corresponding NHE dissipated at peak capacity accumulated to 8.5, 23.8, and 25.9, which represents an increase of 178% for S1A and 203% for S1B with respect to specimen S1. Specimen S1 showed a much flatter increase rate of NHE than S1A and S1B associated with much more severe cyclic degradation than the FRP-strengthened specimens, which manifested in the form of intense pinching of the loops and dramatic strength loss after peak.
