INFLUENCE OF LOCAL SOIL CONDITIONS ON INTENSITY DISTRIBUTION IN CESI (ITALY) DURING THE UMBRIA EARTHQUAKES (SEPTEMBER 1997)

SUMMARY

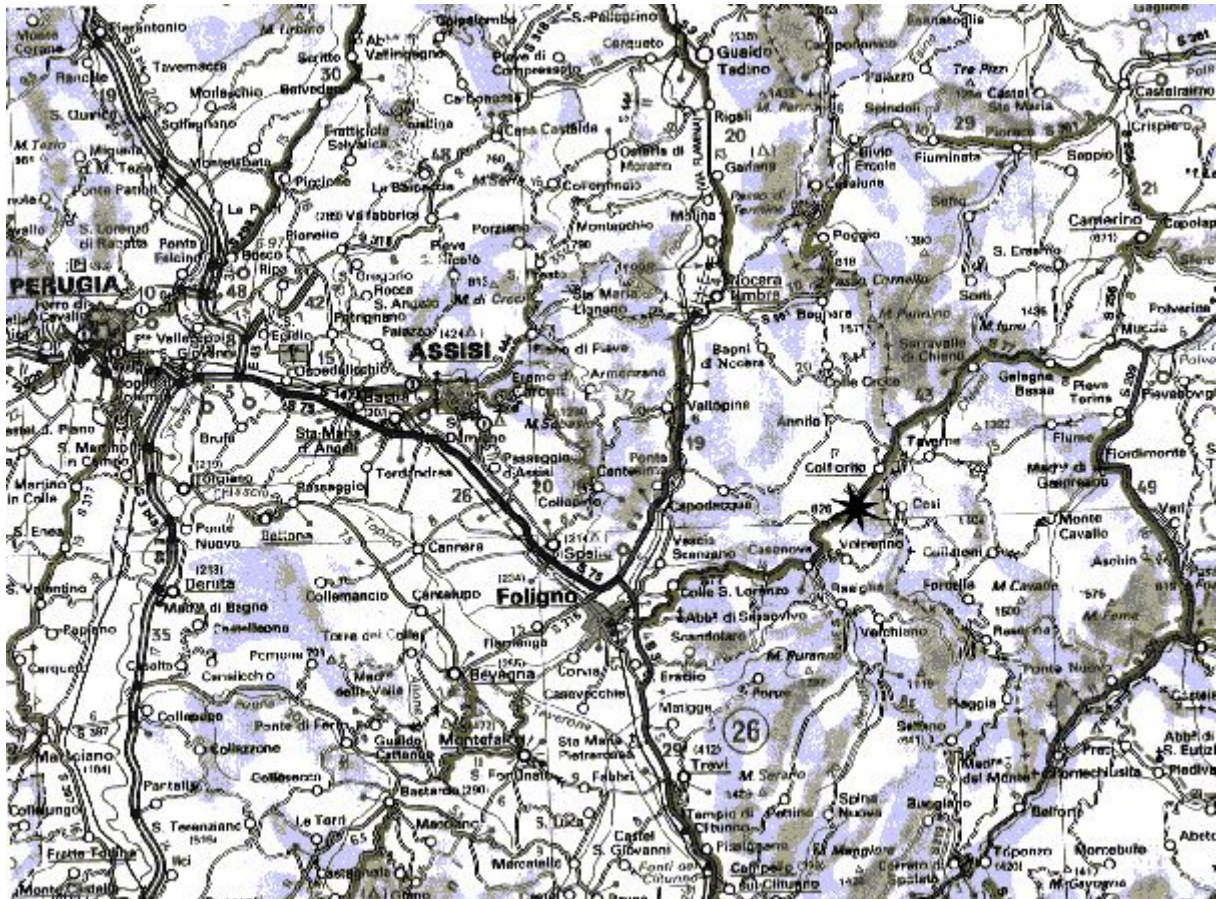
Figure 1: Geographical map of Umbria area in Central Italy showing the earthquake epicenters in Colfiorito and Cesi.

The earthquake sequence was located in Umbria, an area about 60 km east of Perugia (Figure 1). The first shock ($M_L=5.5/M_w=5.7$) of the earthquake sequence, which lasted for about more than a month, was located at 43°01.75'N, 12°51.08'E and occurred on 26 September 1997 at 02.33 local time. The epicentre of the largest shock ($M_L=5.8/M_w=6.0$) was located near the village of Colfiorito.

The most representative example of intense differentiation was in Cesi village, which lies about seven kilometers south of Colfiorito (Figure 1), located on the earthquake epicenter. The village comprises about 300 residences and some public buildings founded at the foot of a small hill (Figure 4). The western part of the village occupies an almost flat expanse which corresponds to the outcrops of post-alpine formations and specifically to 10-20 meters thick terrestrial deposits consisting of coarser and finer, loose and semi-cohesive, red-brown colored clastic material. These overlies unconformably the alpine basement (Figure 5).

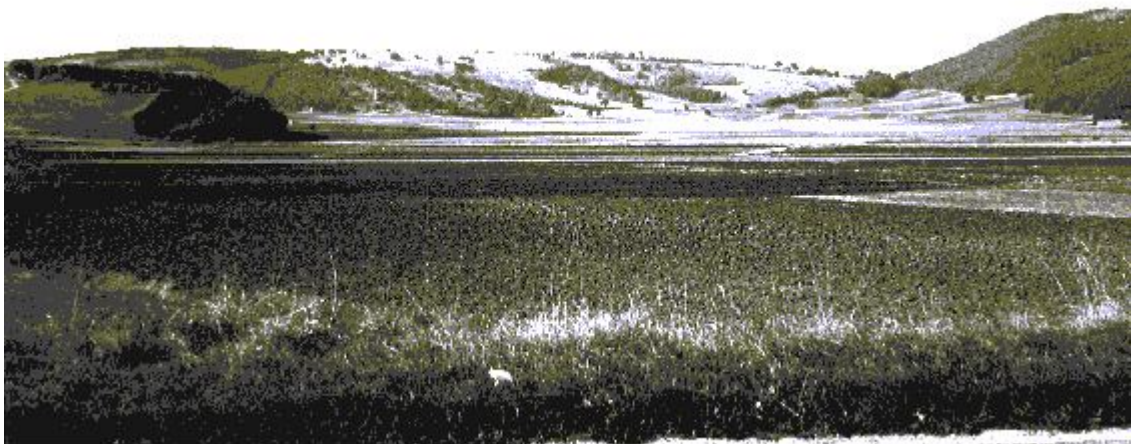
Figure 2: Pleistocene-Holocene deposits forming an almost plain relief and overlying unconformably the basement

Unconformably over the above-mentioned occurs a series of Late Pleistocene- Holocene clastic deposits. They outcrop in the low altitudes areas and intermontane valleys [Barberi et al., 1993, Boccaletti, et al., 1985, Calamita et al., 1986] (Figure 2).

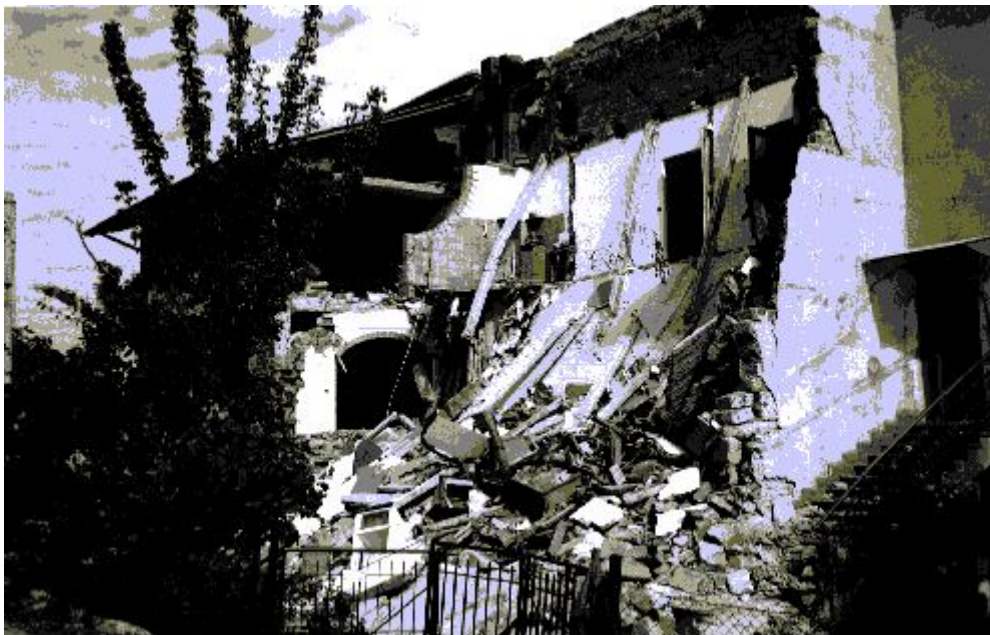
Figure 3: Construction partially collapse in the epicentral area.

The Umbria earthquake of 26th September 1997 induced extensive damage within an extended area in central Italy. Based on official reports, out of 32.865 private houses checked, 9.182 collapsed, were severely damaged or rendered inhabitable. According to official records, in about 20 villages and/or settlements, 25% of public buildings and 20% of schools were rendered demolishable, while 55% of churches received an important amount of damage (Figure 3).

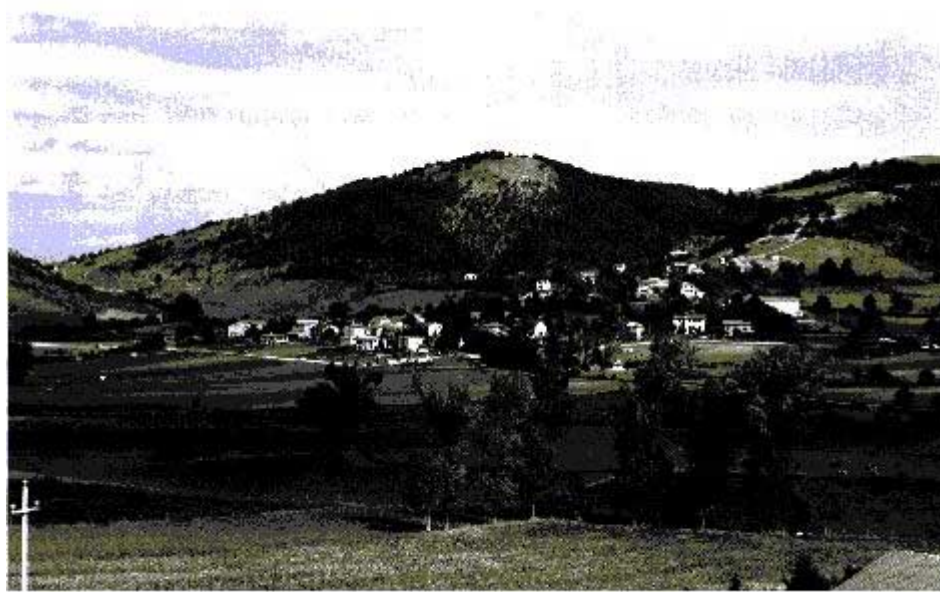
Figure 4: View of Cesi from the west.

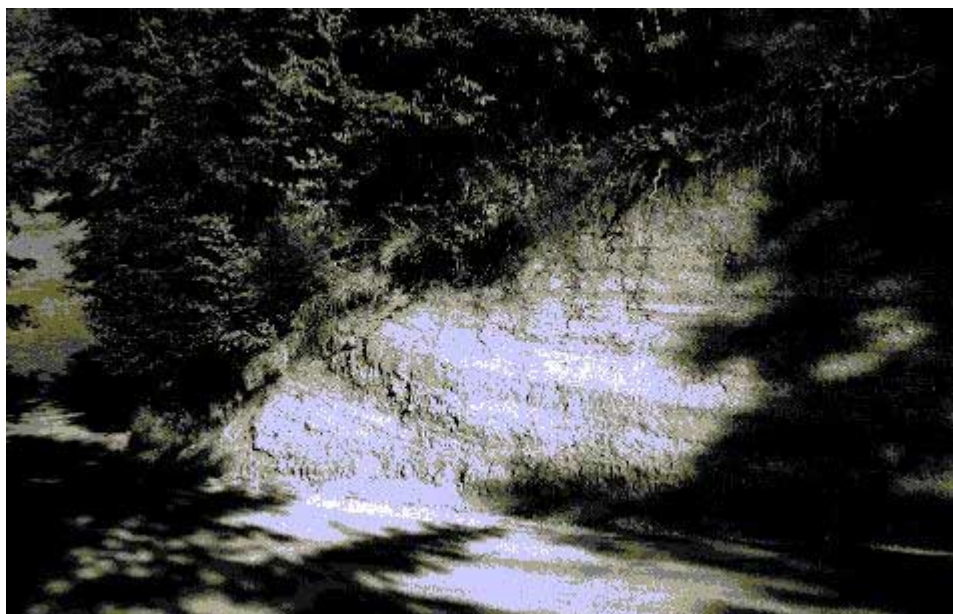
Figure 5: Recent terrestrial deposits, south of Cesi village.

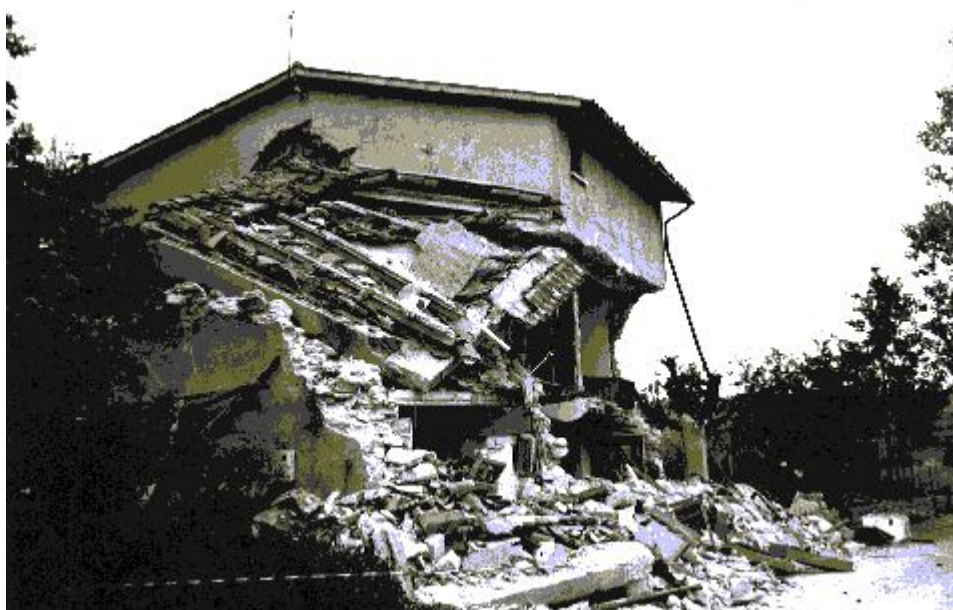
After the damage for each construction was recorded, it became clear that the damage was particularly serious in the western lower part of the village. Several buildings were collapsed totally or partially, while most of them had their walls and roofs seriously damaged, making the residences uninhabitable (Figure 6). The intensity in that part of the village were $I_{EMS92}=IX+$ [Grunthal, ed., 1993].

Figure 6: Damage and collapse in the west, low-lying flat part of Cesi.

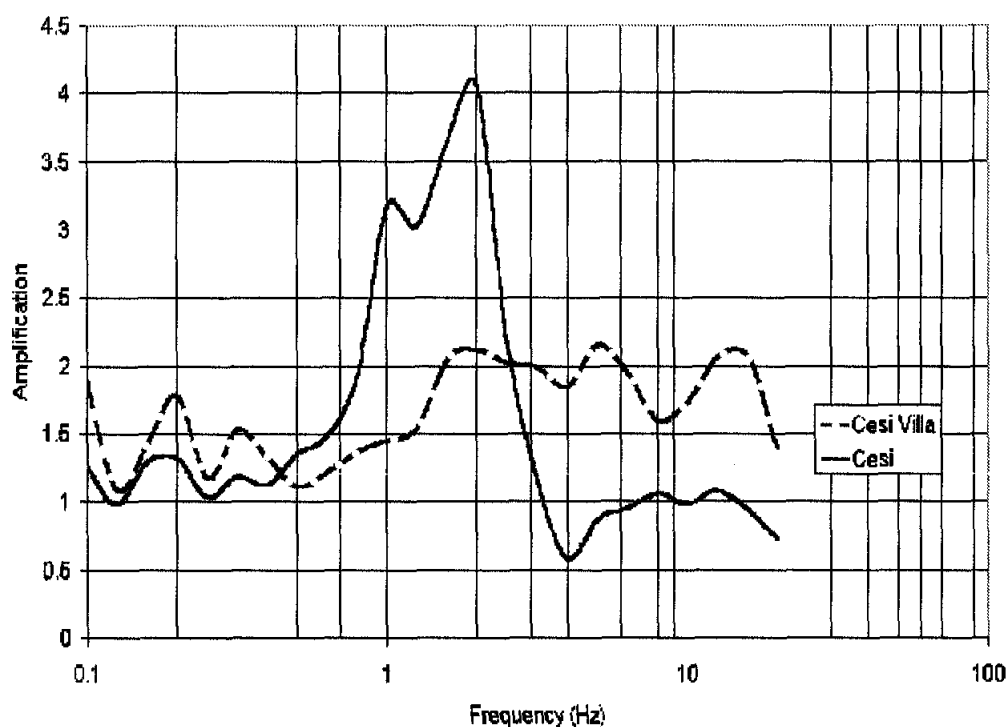
Our observations could be verified and interpreted by instrumental data (Figure 7) compiled immediately after the main shock [Mucciarelli et al., 1977]. Specifically, measurements show that the amplification values are 4 times greater, for the frequency neighborhood of 2Hz, in the western part of the village, which is built on the plain and where the intensities were high, than in the eastern part, located on the hilly part and where the damage was significantly less.

Figure 7: Frequency – Acceleration Amplification diagram. Dashed line represents lower part of Cesi and continuous line the upper one.

Cesi, which is the most characteristic case, is divided into two parts with VII and +IX intensities respectively. Instrumental data showed that amplification values were 4 times greater for the frequency neighborhood of 2Hz.
