# Experimental studies on the collapse of RC columns during strong earthquake motions

**ABSTRACT:** The RC column damage pattern differences between static cyclic loading tests and dynamic shaking table tests were observed. In this study, the spacing of shear reinforcement bars in columns were variable. Four types of spacings of shear reinforcement bar are used. As results of the tests, it was verified that the dynamic maximum horizontal strengths and the dynamic deformation capacities were almost agreed with the static ones. However, the damage patterns were changed with the shear reinforcement bar spacings, and also with testing method differences between statics and dynamics.

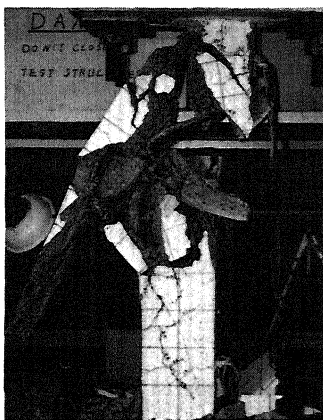
Figure 7 Collapse shape of CT1

steel bars of two columns in a frame were buckled at the middle height, with the separation of concrete and main steel bars, at last the roof fell down.

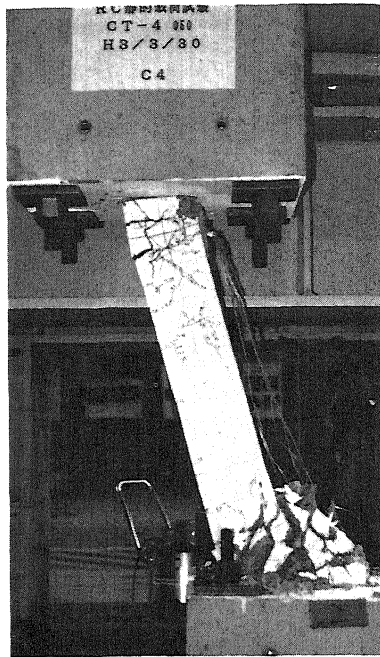
Figure 8. Collaps shape of CT4

In the static cyclic loading test of column CT4, the bending cracks concentrated in the area from two column ends till 1.0D or 2.0D positions at cyclic loading of 1/50 and 1/25. At cyclic loading of 1/5, the compressive

crushes of two column ends began to grow immediately. At last, the concrete of two column ends were crushed completely, and the main steel bars were buckled. The Load-Displacement hysteresis loops of these two static cyclic loading tests are shown in Figure 4 and 5. The crack sketches of these loadings are shown in Figure 6-8.
