Seismic retrofit of liquid storage tanks

ABSTRACT: We used the results of recent experimental and numerical studies on the dynamic response of above ground liquid storage steel tanks to develop an improved numerical model for two 1,000,000 gallon (3.8 million liter) water tanks in a highly seismic area. Detailed numerical analyses were used to evaluate alternatives to upgrade the seismic capacity of these tanks. The selected scheme included new steel straps, welded to the bottom of the tank shell and anchored in a new reinforced concrete ringwall, to prevent uplift and shell buckling. This paper presents practical information related to design and construction and the lessons learned during this project.

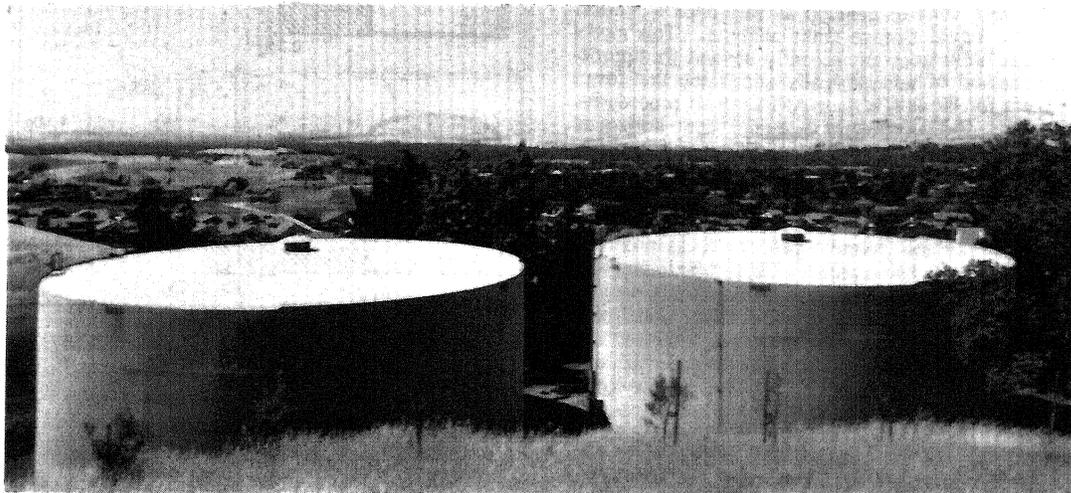
Fig. 1 General view of Clayton Valley tanks

The Clayton Valley tanks, shown on Figure 1, are located near Concord, California. These two above-ground steel reservoirs, 76 feet (23.2 m) in diameter and 30 foot (9.1 m) high, were built in 1958 about 4 km away from the Concord Fault, a historically active member of the California Coast Range fault system. Although assigned an upper bound of magnitude of only 6.0 on the Richter scale, the Concord Fault was concluded to be capable of generating a mean peak ground acceleration (PGA) of about 0.32g at the

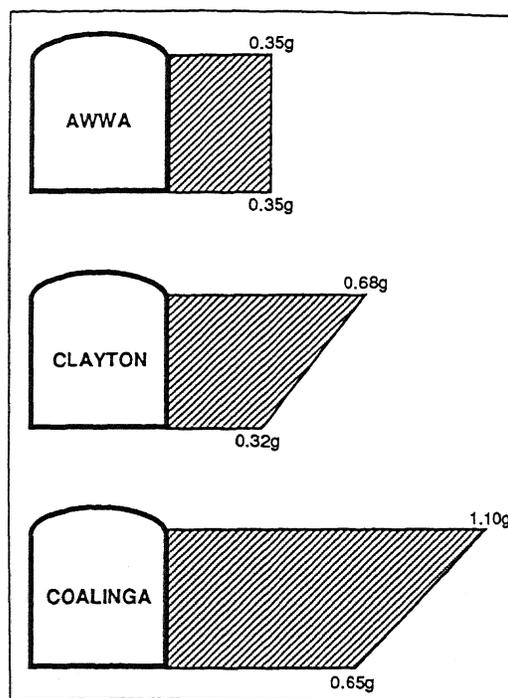
The calculated response was significantly larger than used in AWWA-D100. Figure 2 schematically compares the lateral loads of standard AWWA provisions for Seismic Zone 4 (maximum hazard in California), the loads calculated in the detailed model for the Clayton Valley tanks, and loads estimated by Manos and Clough (1985) for oil tanks of same size during the May 2, 1983 Coalinga, California earthquake (M 6.7). Significant tank damage occurred in Coalinga at short distance from the epicenter. Although the Clayton tanks comply with basic AWWA's design standards, rigorously calculated earthquake loads were substantially larger than those established through the code formulas. Figure 2 underscores possible shortcomings of a simple application of the code formulas.

Fig. 2 Comparison of seismic loads

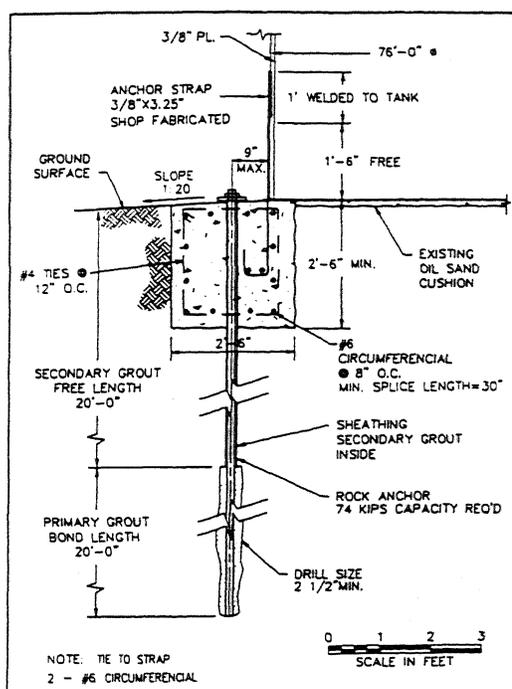
We calculated the anchorage forces required to resist seismic overturning moment and base shear. Our approach was conservative, as it ignored contributions to the hold-down capacity due to membrane forces in the tank bottom and limited uplift of the tank, should the anchorage be stretched. Conventional anchor bolt chairs, such as detailed in the Design Manual of the Steel Plate Fabricators, are known to introduce a large moment in the tank shell. This moment results from the eccentricity between the anchorage center of resistance and the tank shell. Instead, we decided to use steel anchor straps, regularly spaced, and welded to the tank shell. The use of straps considerably reduces the eccentricity and applies restraining forces around the tank perimeter more evenly than large bracket restrainers. To provide additional ductility, a specified length of the straps above foundation level was left unwelded to the tank wall. Dimensions and materials requirements for the anchorage system were established to provide stability against uplift and prevent tank buckling.

Fig. 3 Anchorage system cross-section

While foundation conditions at the Clayton site were excellent to support flat bottom reservoirs, there was no reinforced concrete mat or ringwall. A new reinforced concrete ringwall, in which the lower part of the anchor straps would be embedded, was required. The ringwall was designed to extend a minimum of six inches (0.15 m) under the tank bottom. Reinforcement was detailed to resist applicable forces and moments when the tank tries to uplift. It was necessary to hold-down the reinforced concrete ringwall with prestressed rock anchors.

We developed plans and technical specifications for the recommended retrofitting scheme. As an extra safety measure, the design included isolation of the main inlet/outlet piping and valve from the tank wall with a double-ball flexible coupling. The drain piping was extended beyond the tank bottom plate to provide additional flexibility and the lower part of the overflow piping was re-routed to avoid interference with the ringwall. Figure 3 shows a cross section of the anchorage system, which included 60 anchor straps around the tank wall and 30 rock anchors along the ringwall perimeter.

Detailed design included verifying anchors straps weld, yield, tensile, and pullout capacities; checking the concrete ringwall against shear, torsion, bending and punching loads; sizing the rock anchors (diameter, primary bond length, secondary grout length) to prevent pullout or bond failure; and checking secondary stresses in the tank shell to prevent tearing along the welded edges of the straps. The anchorage system was designed so that the lowest factor of safety would correspond to failure by strap yield or pullout. In this manner, an energy-absorbing mechanism is provided if unexpected earthquake loads exceed the specified criteria.

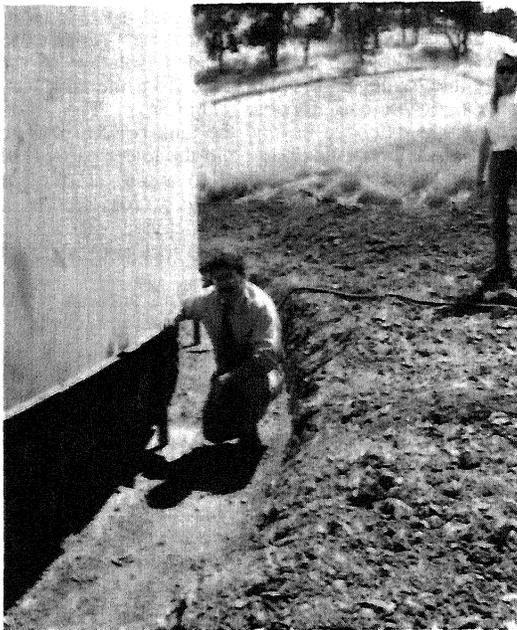
Field implementation of the improvements began late July 1991. They were completed in November. The tanks were dewatered one at a time to construct the new foundation. A critical task was to excavate the ringwall volume without overloading the tank bottom plate by the unsupported shell. The Design Engineer, Dames & Moore, had originally considered an excavation plan for diametrically opposed sectors along the tank perimeter to control the unsupported extent at any given time. The Contractor, Soil Engineering Construction, Inc. of Redwood City, California opted to carry the edge of the tank on thin intermediary metal shoring supports at 10-foot (3 m) centers, left in place after pouring the concrete ringwall. This solution did not affect the way ringwall and anchors are expected to perform and reduced the number of splices in the circumferential steel reinforcement. It also allowed the ringwall volume to be excavated all at once, as shown on Figure 4. The excavation resulted in an unexpectedly clean cut on the inner side of the ringwall and did not disturb the tank bottom. Therefore, releveling of the tank bottom was not required.

Fig. 4 Ringwall perimeter excavation

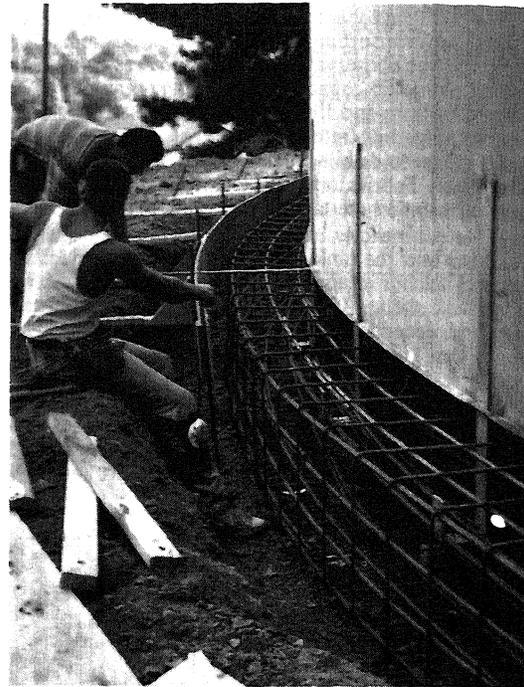
Following placement of the reinforcing steel in the ringwall excavation, the anchor straps were positioned along the tank perimeter by tack welds (see Figure 5) and the new foundation concrete was poured. The anchor straps were dip-galvanized and their hooked extremities shaped in the shop, prior to installation.

Fig. 5 Detail of tank anchorage

The design pullout capacity of each ringwall anchor was 74 Kips (329 kN). One-inch (2.54 cm) diameter DYWIDAG Threadbars[®] Grade 150, protected against corrosion with PVC sheathing, were used for such anchors. PVC guide tubes had been placed prior to pouring the ringwall to facilitate installation. A construction requirement was to center anchor heads at 9 inches (23 cm) or less from

the tank shell, to limit torsion of the ringwall when the straps are stressed under earthquake loading. Nine anchors were tested. Six proof tests (fast test to 1.3 times the design dynamic load) and three performance tests (long test to verify capacity, established free length, and residual movement) were performed on selected units. These tests confirmed that the required capacity would be achieved under earthquake loading. After testing, the anchors were post-tensioned to 20 percent of ultimate pullout capacity in a prescribed sequence to distribute loads uniformly around the ringwall perimeter. Lastly, the upper part of the anchor straps was final welded to the tank wall along the specified length.

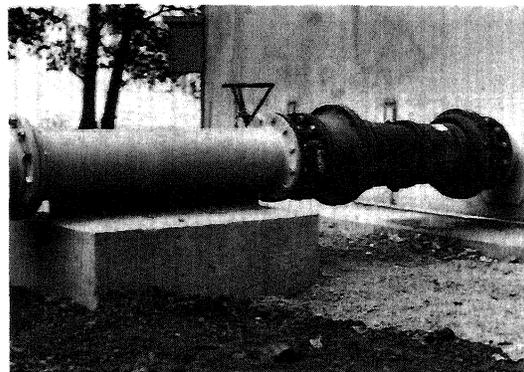
The main inlet/outlet piping and valve were isolated from the tank wall through installation of a double-ball "Flextend" coupling, manufactured by EBAA Iron, Inc., Eastland, Texas. This seemingly redundant protection will assure that relative movements between the tank and the surrounding ground due to seismic wave passage or unexpected anchor yield will not shear the piping off the tank and cause loss of content. The installation of the flexible coupling was straightforward (see Figure 6). A moderately sized concrete thrust block was constructed to accommodate any sudden expansion of the Flextends as a result of pressure head and water hammer when the valves are closed rapidly.

Fig. 6 Flexible coupling and thrust block

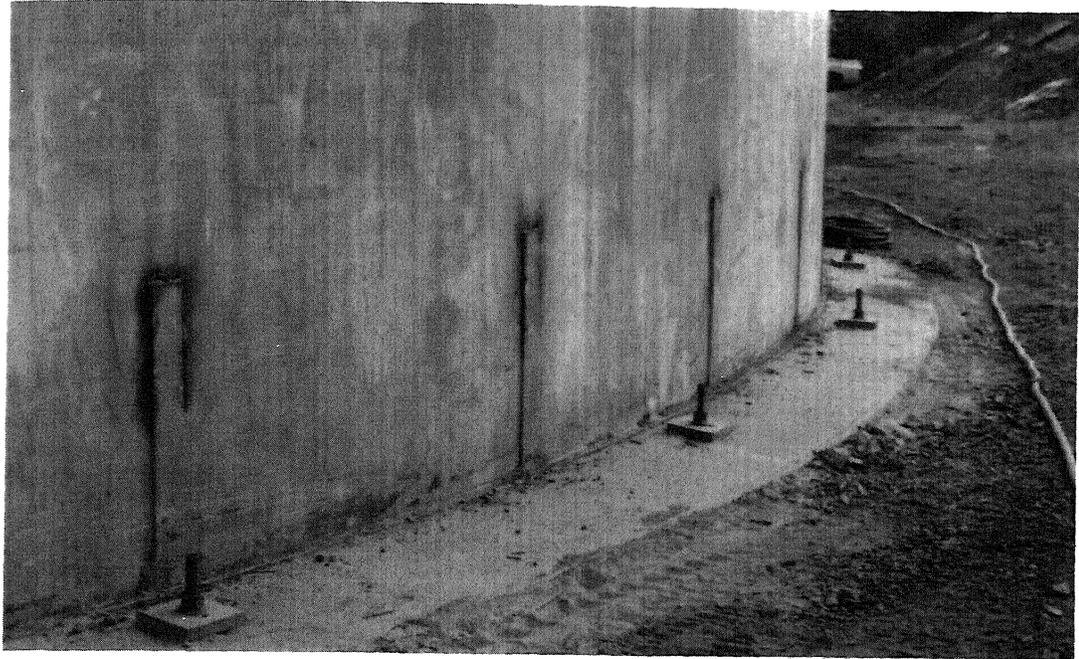
No problems were encountered during construction. The completed strengthening scheme is fairly

unobtrusive, see Figure 7. As is often the case with old facilities, we discovered during construction that the underground part of the inlet/outlet piping was positioned differently from the way shown on the original drawings, which resulted in a change order to relocate some pipes. This could have been avoided by indicating on the new drawings the need to verify key dimensions.

Fig. 7 Completed project prior to tank coating
