A MASONRY SCHOOL BUILDING RETROFITTED BY BASE ISOLATION TECHNOLOGY

SUMMARY

The old masonry chapel building of Rikkyo University, Tokyo, Japan was retrofitted by the base isolation technology. This retrofitting project is the first one in Japan for the application to the old masonry building. After the Screening of the seismic performance for sever earthquake, the seismic index (Is) is very low and retrofitting was planned. Several ideas were presented, and finally the base isolation technology was adopted in view of the construction cost and keeping the interior and exterior of the building. Before planning the detail of retrofitting method, the strength and deterioration of masonry material was examined by the loading test and the field investigation. Then, the base isolation system was decided after the nonlinear earthquake response simulation. Next, the construction work that is the most important one in the retrofitting project relating to the cost and the safety of upper building was done. Finally, the several verification tests comparing to the designed values, measuring of micro vibration, vibration test by human power and loading test were carried out. Now, a strong earth

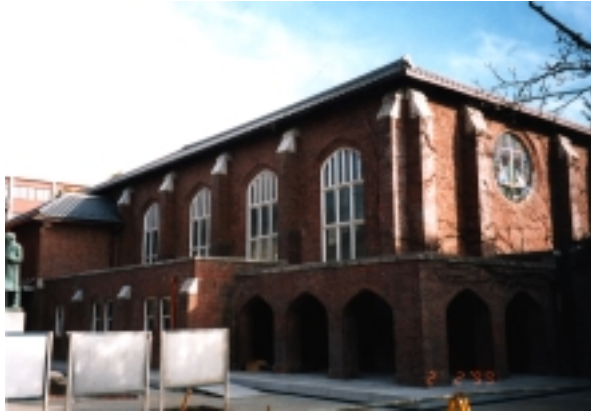
Photo. 1 Exterior of Chapel Building

Photo 1 shows the exterior and Photo 2 shows the interior of the building after the retrofitting. These two photo are almost the same as the before retrofitting. Photo 3 shows the base isolation devices under the building. This floor was newly constructed. This building was designed by Murphy & Dana Architects in USA and constructed in 1920. Rikkyo University is located inside Tokyo down Town in Japan. This is the Chapel and the historical and memorial building in university campus. Height of building is 12.63m, total area is 505.33 m², and one story building (partially 3 story). Longitudinal span is 27.5 m and 10.76m in transverse span. The

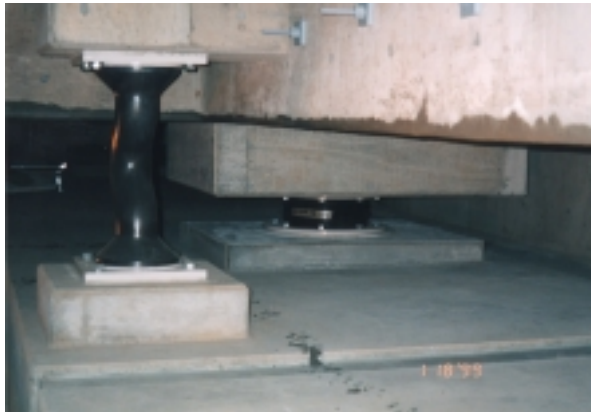
Photo. 3 Base Isolation Devices

The base isolation system that was used in this building is the combination of the laminated natural rubber bearing and the red bar damper. Photo 3 shows this system. Figure 1 shows the location of the base isolation devices. Total numbers of the natural rubber bearing are thirteen and two kinds of 50cm and 60cm diameters are used. The axial stress to gravity load are from 35 to 112 kgf/cm² and vary from 11kgf/cm² to 186kgf/cm² to the strong earthquake, level 2 (50cm/s). The vertical shear coefficient 0.33 due to the vertical ground motion is considered in this axial stress. As the damper, Ten of the red bar dampers are used which are located around the natural rubber bearings. The role of these dampers is to decrease the earthquake response displacement and to converge to the small displacement after the duration of the earthquake.

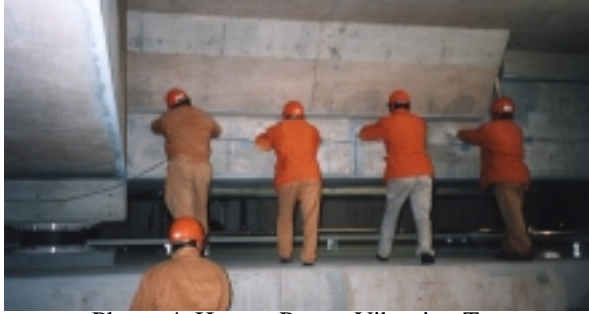
The verification tests were carried out after the completion of the construction work. Three kinds of tests were done; micro vibration measuring test, human power vibration test and horizontal loading test. These three tests were carried out in the state of only rubber bearings because of the limitation of loading capacity. Very small displacement within several μm was obtained by the micro vibration measuring test. From this test, about 1.6 sec of natural period was obtained. Photo 4 shows the human power vibration test. The vibration was caused by the human power. Figure 9 shows the result of this test for the transverse direction. About $300\mu\text{m}$ of displacement and 1.8 sec natural period were measured and about 8 % damping coefficient was also obtained. The horizontal loading test is shown in Photo 5. The two static oil jacks (total capacity 50tf) are installed between the foundation of the just above of rubber bearings and the retaining wall. Figure 10 shows the horizontal shear force and the horizontal displacement relationship. The predicted curve from the each rubber test result measured just after fabrication is also shown in this figure. These both curves show the good similarity. 30 mm is the maximum displacement that is the maximum capacity of oil jacks. Figure 11 shows the summary results of these three test comparing to the predicted values. The relationships between the stiffness and the horizontal displacement are discussed. From this figure, the dynamic property of rubber bearings in the wide range of displacement is obtained and is confirmed to be coinciding with the predicted values.

Figure 9 Human Power Vibration Test (Transverse Direction)

Photo. 4 Human Power Vibration Test
