SEISMIC VULNERABILITY OF NONSTRUCTURAL COMPONENTS OF HOSPITALS

This research is about vulnerability of nonstructural components in hospitals and health care facilities. Case study was performed and results were obtained. It is based on 1994 and 1997 NEHRP provisions and with visual inspection procedure of ATC 3-06. The hospital used for this particular study has 1000 beds and contains the most advanced medical instruments and its construction is ended in 2001. It has improved and advanced emergency water and power supply reservoirs. This research indicates that most of the nonstructural components of the hospital namely, architectural, mechanical, electrical and medical gas systems have not been designed accordingly and are therefore, vulnerable.

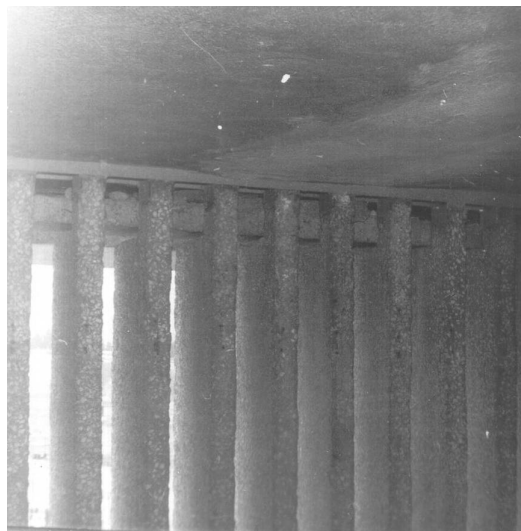
Figure 1: Preconstructed concrete exterior panels
MECHANICAL AND ELECTRICAL COMPONENTS

In this case study, in architectural type nonstructures, vulnerability of exterior walls and facades, glass windows, canopies, storage cabinets, suspended ceilings and interior nonstructural walls and partitions have been studied. The main exterior facing of the hospital is made from preconstructed concrete panels. It is connected to the main structure by preinstalled plates that are welded to plates that are installed in the structure concrete. These panels are not designed for drifts of the structure and so they are vulnerable. Figure 1 shows a sample of the panel:

Architectural nonstructural elements of the hospital have not been designed and constructed for lateral forces drifts and displacements and so they are vulnerable. Suspended ceilings especially in main entrance of the hospital is without and bracing and could collapse and close the egress of the hospital.

As a recommendation it can be insisted that nonstructural elements and equipments of the hospitals and health care facilities, which are the most important for operating of these centers must be designed and installed for lateral forces causing by earthquakes.

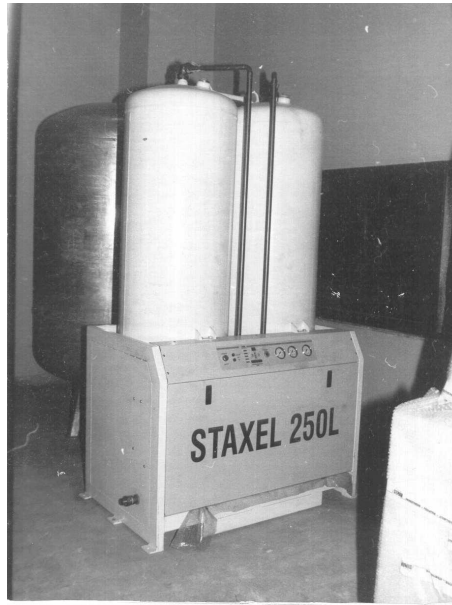
Figure 4: Medical gas tanks

In the hospital on the ground floor in the mechanical equipments room there is a separated room for medical gas tanks. As seen in figure 4 these tanks are not bolted to the ground a so during an earthquake it could topple and slide, so they are vulnerable:

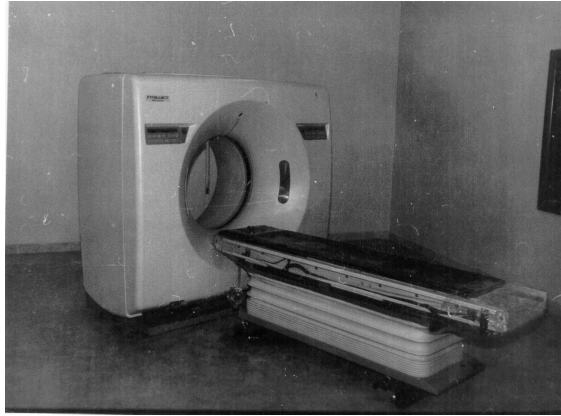
Figure 8: CT scan of the hospital

The CT scan of the hospital is in the 7th floor and is placed on the floor without and bracing or bolts. Because of the heavy mass of the instrument, during an earthquake it may slide and this cause damages to it and the supporting floor, and so it is vulnerable, figure 8. The control panel of the CT scan is on four wheels and without any slid lock and its large displacement during earthquake cause damage to it and its connections, figure 9.

Medical instruments and accessories are without any bracing or connection bolts so they are vulnerable.

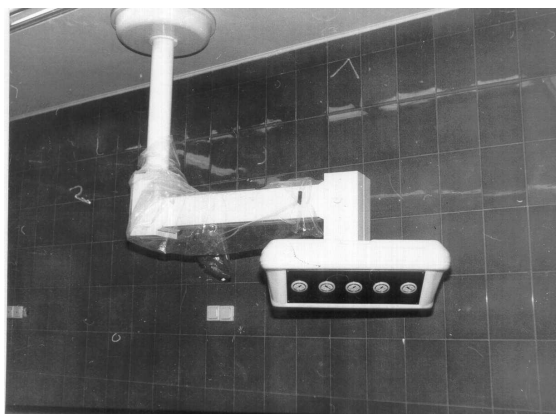
Figure 10: The medical gas panel in surgery room

To maintain the medical gas for surgery rooms and different departments of the hospital, high pressure pipes have been used. These pipes reach medical gas to special panels in surgery rooms, figure 10. As it is seen in the figure the panel can move and round and has no any kind of bracing to avoid large displacement during earthquakes and so it is very vulnerable.
