## **THE 31<sup>ST</sup> OCTOBER 2002 EARTHQUAKE IN MOLISE (ITALY): A NEW METHODOLOGY FOR THE DAMAGE AND SEISMIC VULNERABILITY SURVEY OF CHURCHES**

### **SUMMARY**

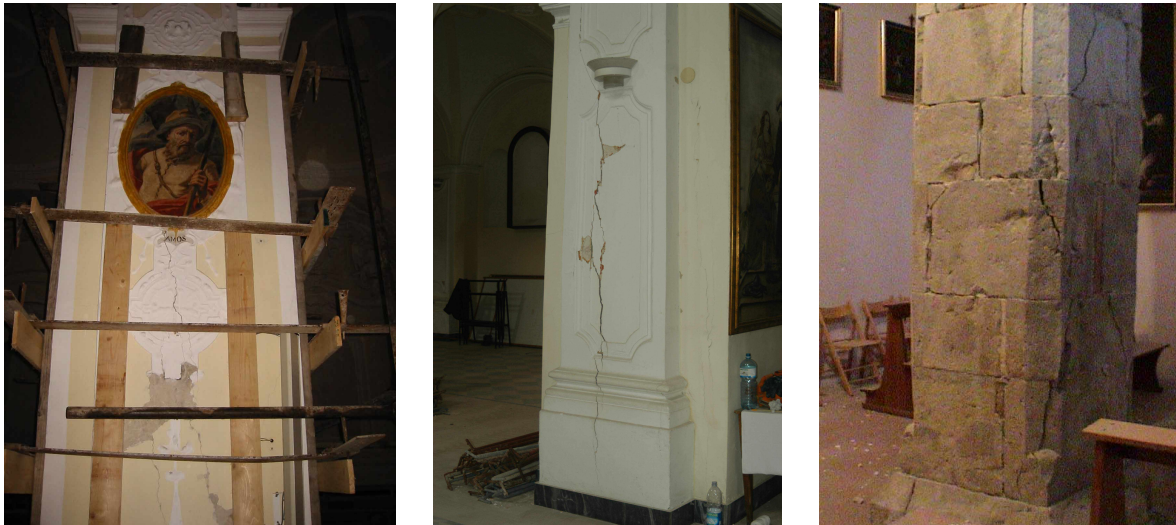
**Figure 5. - Three examples of crushing damage in masonry pillars**

Among the damage surveyed, the most frequent found is: 1) cracking and collapse of the vaults (owing to their limited thickness and the lack of tie rods); 2) damage due to the crushing and shearing of the masonry pillars in the churches with more than one nave (because of the increased weight after the intervention with reinforced concrete in the roof and over the vaults, but also as a consequence of the high energy content of the vertical component, measured in some historical centres on ridge or crest topographic configuration - Lagomarsino [9]; Cevasco [10]); 3) damage connected with the sliding or overturning of the spires over the bell towers (when rebuilt with heavy and rigid reinforced concrete slabs); 4) out of plane failure of the gable of the façade or in the apse (again in the presence of roofs reconstructed with reinforced concrete).

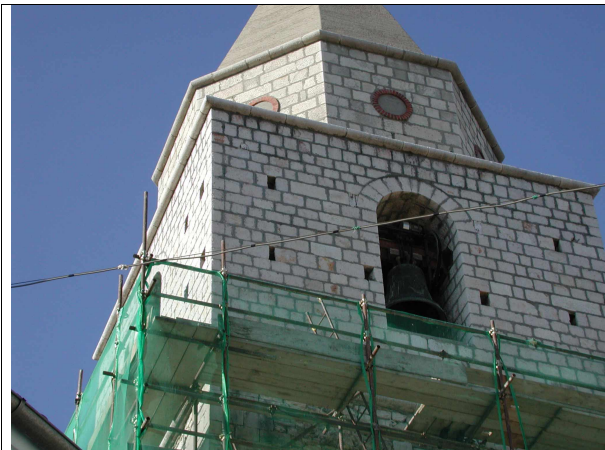
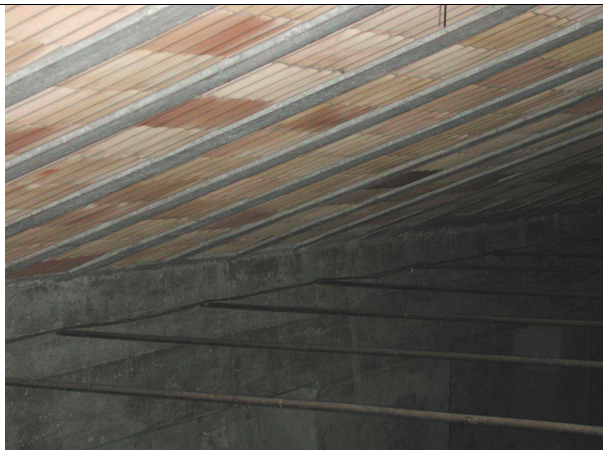
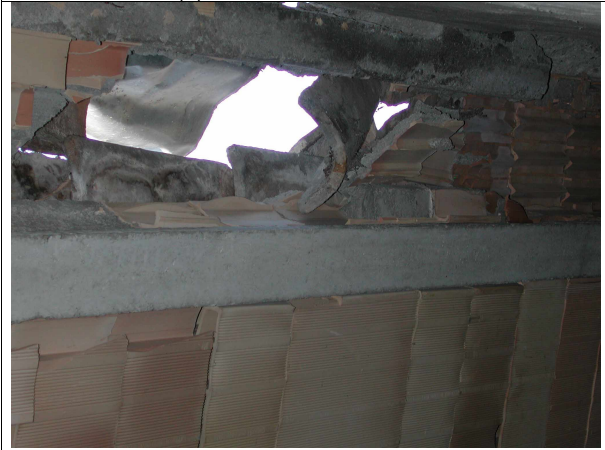
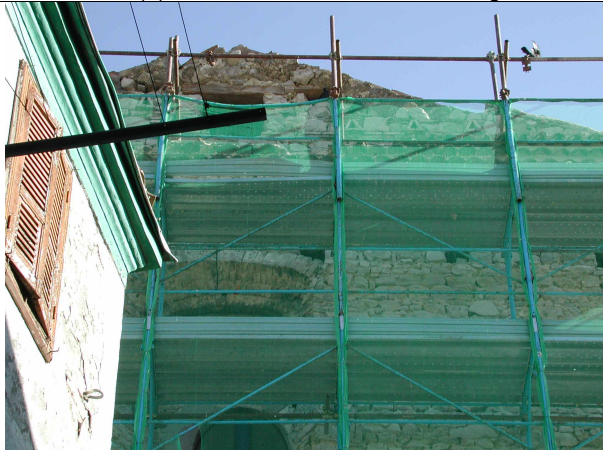
**Table 7 - St. John the Baptist church – Colletorto (Italy)**

Instead, in Table 7 is shown some of the damage suffered by, in Colletorto. This church is in the historical centre and has been extensively retrofitted in recent years; in particular, rehabilitation was in progress at the time of the earthquake, regarding the retrofitting of the lateral wall of the church. In the seventies, the bell tower and the roof were strengthened, substituting the original wooden roof with a new reinforced concrete structure, connected to a heavy reinforced concrete tie-beam (80 cm height), at the top of the

lateral wall. On 31<sup>st</sup> October 2002, the earthquake induced a hammering action of the roof that caused a different damage pattern. In proximity of the façade, the rigid constraint due to the presence of the bell tower caused the collapse of the first part of the roof-covering, while, in correspondence with the apse, the seismic action caused the out-of-plane of the masonry gable.

(a) Bell tower of the church	(b) Detail of the new roof-covering

(c) Damage in the first part of the roof-covering	(d) Overturning of the gable of the apse-wall
