## **SEISMIC PERFORMANCE OF EXISTING BUILDINGS DURING THE 2003 BAM EARTHQUAKE**

### **SUMMARY**

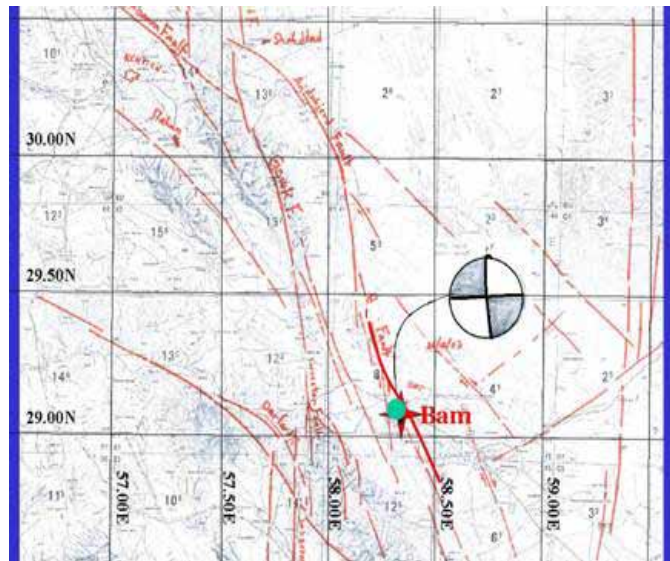
**Fig. 3: The fault map of the Bam earthquake prone area of the 26/12/2003 earthquake[1]**

The province of Kerman is surrounded by the depressions of Great Kavir in the north and Lut in the east, and Zagros ranges in the south and west. Due to the complexity of geology, tectonics of the region has been a controversial subject in the literature. The major Quaternary faults in the area are the Kuhbanan fault, apparently a high angle reverse fault, with northwest-southeast direction and Nayband fault with north-west trend. Some other faults in the region are Chahar-Farsakh Anduhjerd, Gowk, Sarvestan and Bam faults. The NW-SE faults (Kuhbanan and Ravar faults) and the north-south faults (Nayband, Chahar-Farsakh, Anduhjerd, Gowk, Sarvestan and Bam faults as shown in Fig.3) have determined the border of the north-south structures in the Lut area with the NW-SE structures. These intersection zones were some of the main sources for the disastrous earthquakes. The Gowk fault system is recognizable for its surface ruptures during the 1981, 1989 and 1998 earthquakes as well as a hot spring system. In the west of the Golbaf-Sirch valley, there is the Lut depression, where a vertical topographic offset of more than 4000 meters has occurred. However tension is predominant in the earthquake of central Iran. Therefore faultings in this region are mostly dip-slip normal or strike-slip, and the horizontal components of displacements are right lateral [1].

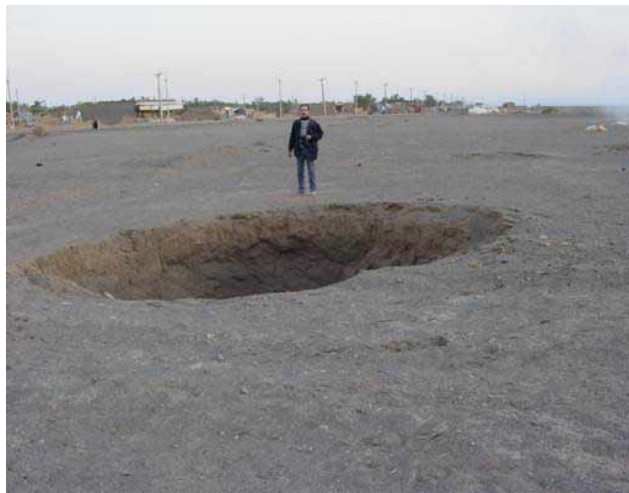
**Fig. 4: Sinkhole due to collapse of a Qanat tunnel at west of Baravat [2]**

The most important effects of Bam Earthquake on Qanat systems are damages to the access wells and tunnels. Several sinkholes induced due to the earthquake above the tunnels and wells due to the collapse of underground openings (Fig. 4).

Based on the previous experiences, underground openings should be more resistant against seismic loads, but the damages to the Qanats of Bam area were severe. Most of the damages observed at the access wells but near the Bam Fault underground tunnels also have lost their stability and collapsed. It should be considered that most of the Qanats of the area have been supported with hand made arcs, but these supporting systems could not affect considerably on the stability of Qanats when dynamic loadings applied on them.

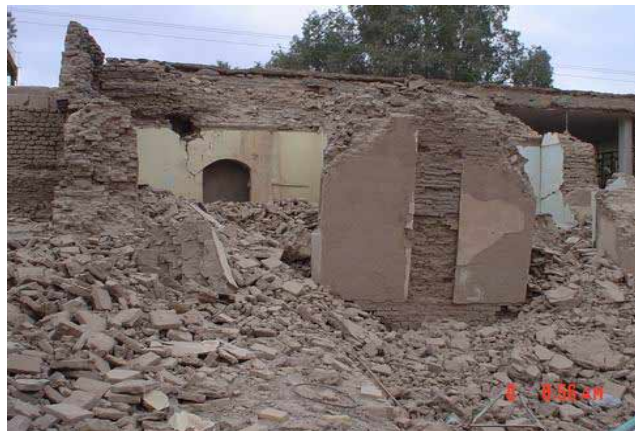
Most houses in the epicentral area are abode construction, usually one-story made of sun-dried brick walls, and domed roofs or vaults with clay or mud mortar. This type of construction is common in the dry areas of Iran because abode houses need only local materials and can be built by farmers when their work is tax. The walls and roofs of these houses are thick (usually 40 to 80 cm) and heavy so that they easily protect their inhabitants from the cold and hot weather, but they are very weak in resisting horizontal vibrations particularly at the junctions of vertical walls and domed roof (Fig. 5).

**Fig. 5: Heavy walls, thickness of wall in some abode houses reaches to about 1 m**

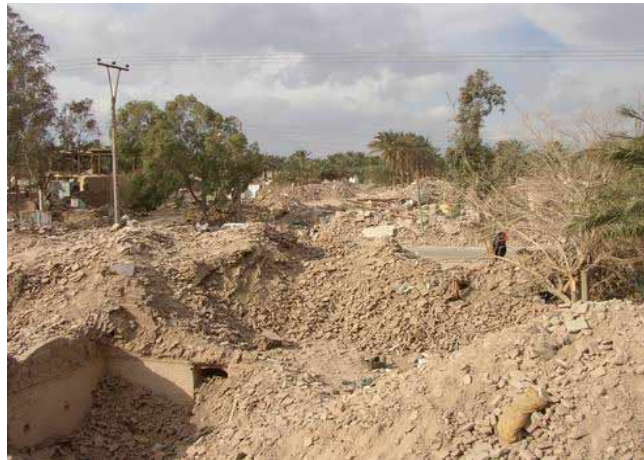
Based on the reconnaissance visit, most abode houses in the epicentral region are either partially or totally collapsed. Their failure normally started in a corner by separation of the walls from the domed roof. In

some region the ground shaking was so severe that the abode houses were turned into their original sun-dried bricks (Fig. 6).

**Fig. 6: ground shaking was so severe that the abode houses were turned into their original sun-dried bricks in the Bam 26.12.2003 earthquake.**

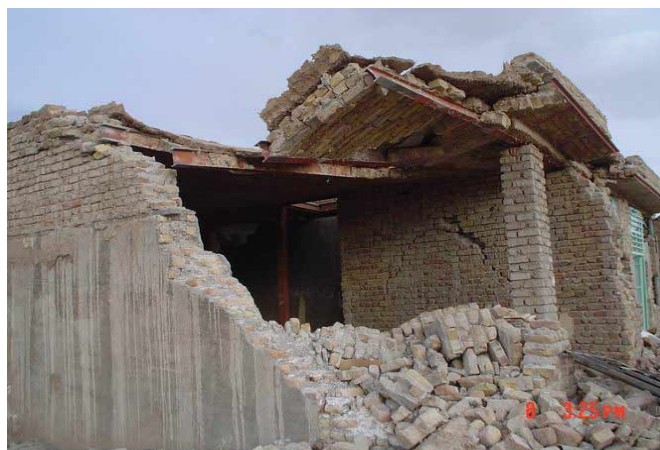
Masonry buildings are the second most common type of buildings in the earthquake-affected area. They normally consist of kiln brick walls with shallow Jack arch roofs supported by steel I shaped beams. The steel beams are laid at a distance of 90 to 100 cm apart, and shallow brick arches fill among them. The mortar used in these buildings is sand-lime-cement, or sometimes sand-cement. The performance of unreinforced masonry buildings was not any better than abode buildings. The common modes of failure of these buildings were shear failure of walls, separation of walls from the roof, and separation of roof beams from each other (Fig. 7). In most cases the steel beams of the roof were not braced together by steel re-bars or joists (Fig. 8). As a result, dropping of the bricks between them during the earthquake, could be expected.

**Fig. 7: shear failure of walls, separation of walls from the roof, and separation of roof beams from each other are observed in typical brick buildings.**

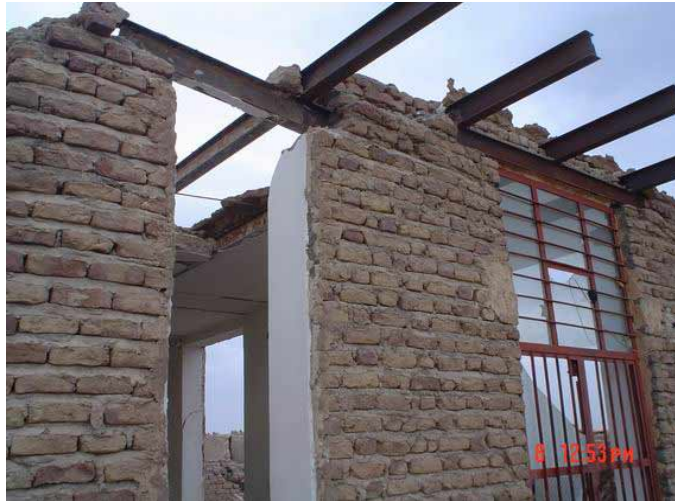
**Fig. 8: In most cases the steel beams of the roof were not braced together well by steel re-bars or joists**

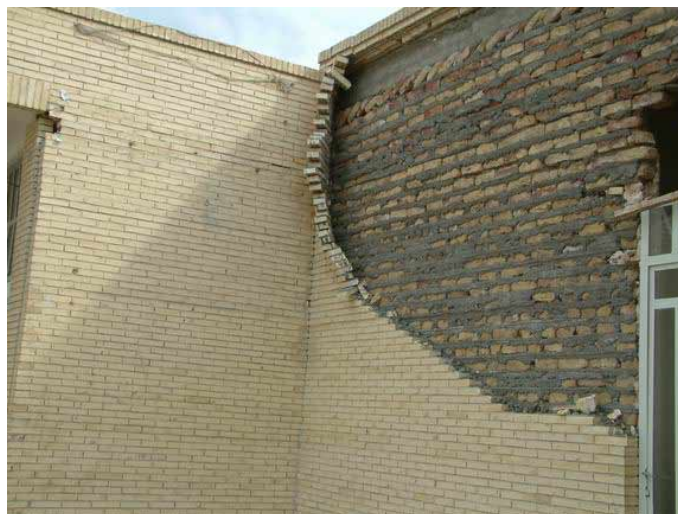
A number of reinforced masonry buildings, with vertical and horizontal reinforced beams, were recently built in the city. The performance of these structures was good and in many cases saved the lives of their inhabitants (Fig. 9).

**Fig. 9: an example of reinforced brick buildings in the earthquake-affected area with a relatively good performance.**

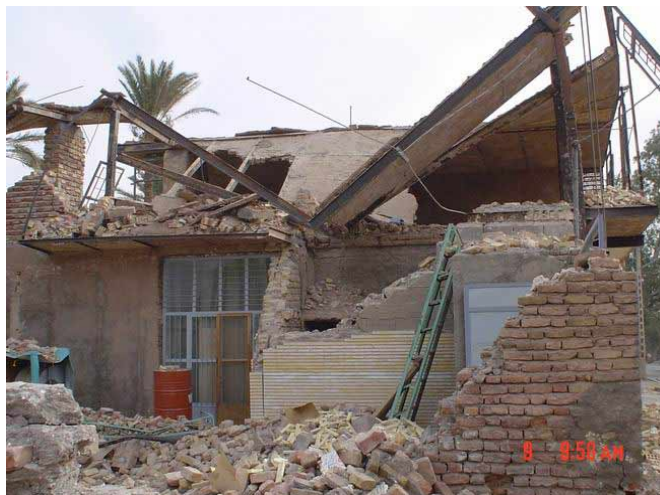
Many modern residential and office buildings in Bam are steel building structures that can be divided into two groups. The first group includes buildings with steel internal columns, load-bearing external brick walls, and roofs, often, made of shallow Jack arches with steel I-beams. The performance of this type of construction as a sort of unreinforced masonry structure was very poor. The flexible steel columns tended

to displace much more than the rigid external walls resulting in inclining of the steel columns and mostly the collapse of the whole structure (Fig. 10). This earthquake clearly demonstrated that the combination of relatively rigid load-bearing external brick walls and flexible internal steel columns is very hazardous. This type of structure is not limited to Bam, and it can be easily observed in most of the cities in the country.

**Fig. 10: first group of steel buildings, combination of steel internal columns and load-bearing external brick-walls.**

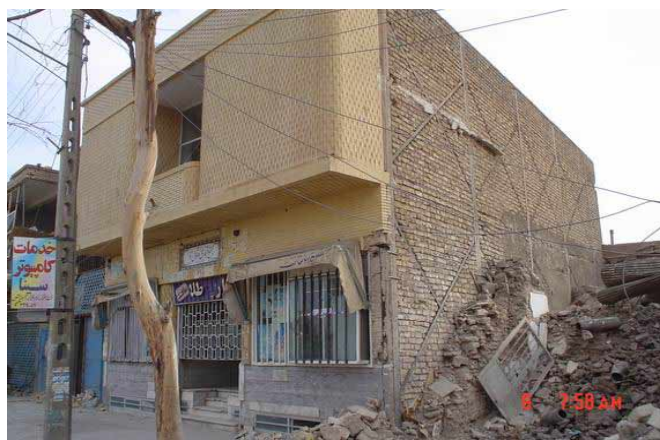
The second group of steel buildings consists of steel frames only in one direction with bracing in one or two directions. They are actually designed for some horizontal forces. The performance of this type of construction was generally satisfactory (Fig. 11). Exceptions are made when the bracing were placed eccentrically or incorrectly (Figs. 12 and 13). In these cases, the infill or curtain walls usually experienced severe damage.

**Fig. 11: steel building with good performance during the Bam 26.12.2003 earthquake**

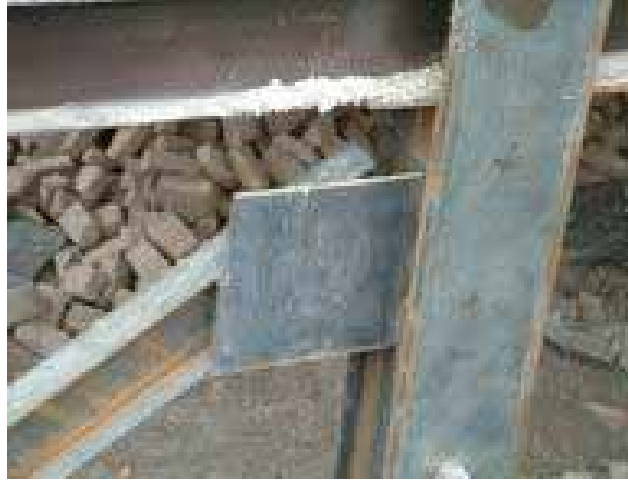
**Fig. 12: incorrectly bracing system and its gusset plate**

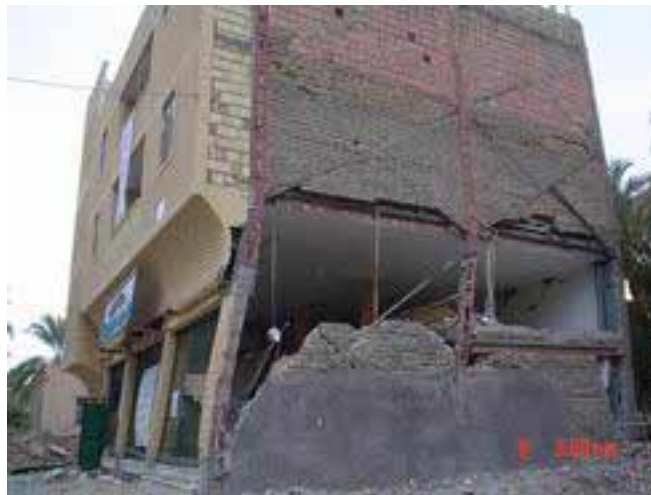
**Fig. 13: Unacceptable bracing system, the cross-section of bracing member is insufficient.**
