## SEISMIC BEHAVIOUR OF CAPACITY DESIGNED MASONRY WALLS IN LOW SEISMICITY REGIONS

Ekkehard Fehling<sup>1</sup>, Mahmoud Nejati<sup>2</sup>, Panayotis G. Carydis<sup>3</sup> and Harris Mouzakis<sup>4</sup>

### SUMMARY

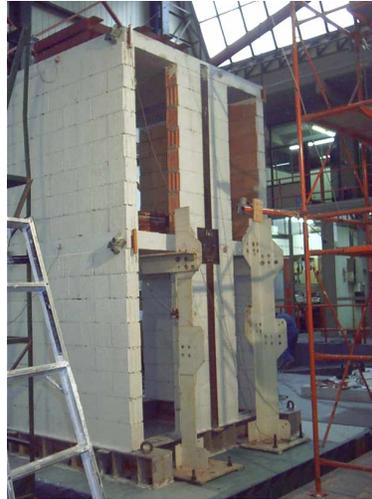
Fig. 4: Steel strip in lateral walls for prevention of out of plane failure

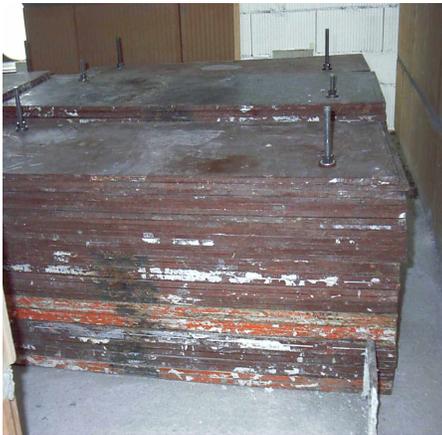
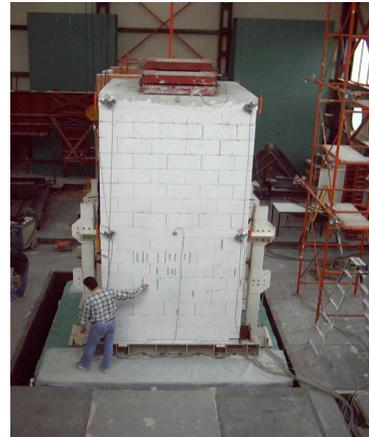
Fig. 5: Live loads on the first and second floor

After finishing of each story, a prefabricated roof has been pasted with a special type of glue on the walls. The steel masses for live loads were put on each story in a symmetric position to avoid slippery, were fastened to the floor with long bolts. The first story's live load consisted of 200 pieces of steel in six rows with  $980 \times 330 \times 10 \text{ mm}^3$ . On the second floor the mass consisted of only five big steel plates with symmetric distribution with dimension  $1000 \times 1000 \times 130 \text{ mm}^3$  (see fig. 5 showing live loads and their positions on the first and second floor).

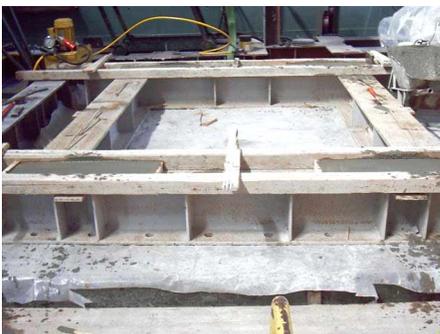
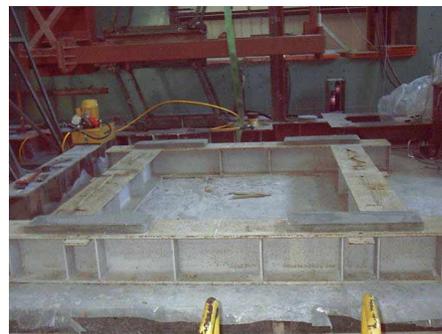
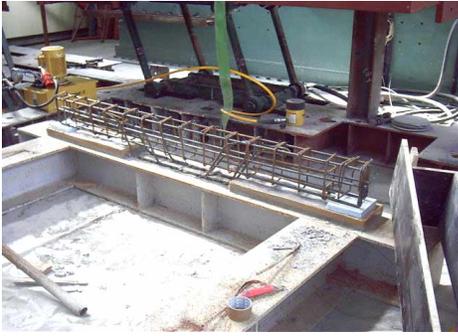
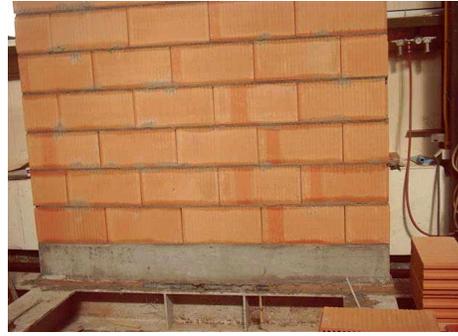
Fig. 7: Gap-Element building procedure

Specimen #2 as specified in table (I) is a specimen with Gap-Elements, but the other specifications are corresponding to the first one. The Gap-Element building procedure is shown in fig. 7:

In order to allow a rocking movement of the base-beam with the Corner-Gap-Elements, the middle reinforcement should not have any intentional tensile connection to the steel foundation frame that was mounted on top of the shaking-table (see fig. 7-d, where one finished corner gap beam under construction of main wall in specimen #2 is shown).

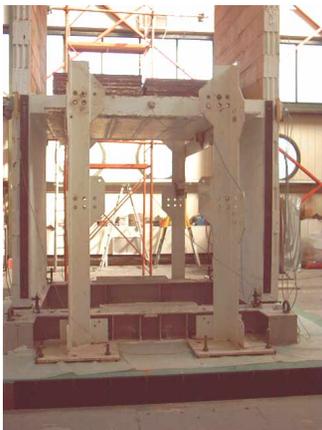
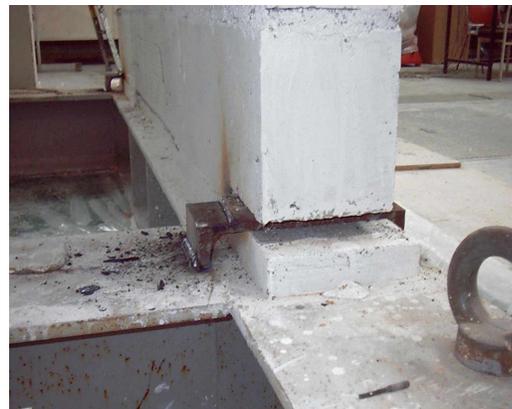
Fig. 8: Removal of all lateral walls and new type of sliding stopper for corner-gap beam, wall edges in first story reinforced with vertical steel strip

By attention to experiences with specimen #2, some changes have been implemented in specimen #3 as is seen in fig. 8. For example removal of lateral walls and putting of vertical steel strips between Gap-Elements and first roof, fig. 8.

- Lower total weight in comparison with previous specimens (because of removed lateral walls).
- Changing the shear system in Gap-Element as described in fig. 8-b.
- Put new steel strip between Gap-Elements and first floor fig. 8-a.

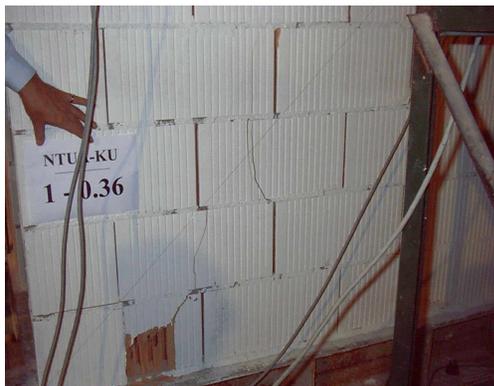
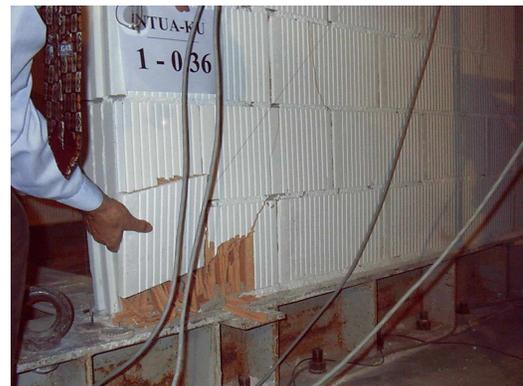
Fig. 9: Last test in specimen #1, shear failure caused collapse in first layer of main wall

- till 8 % (nominal input data) of  $g$ , no cracking or separation in the joints could be observed,
- when the excitation was increased until 20 % of  $g$ , the first cracks in the first layer of the main wall's bricks appeared,
- at 36 %  $g$ , 'jumping' between the last layer of bricks below the first floor slab and one layer below could be noted. In this load step, severe damage of a corner brick in the first layer above foundation appeared (see fig. 9).

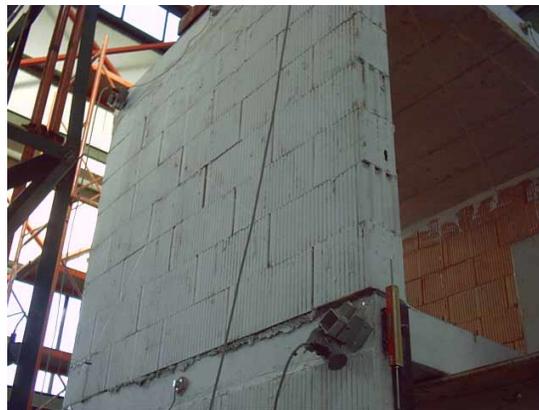
Fig. 10: Step-like diagonal crack through joints at 72 % g excitation

- At 72 % g, the rear main wall on the second floor showed step-like crack with horizontal movement (fig. 10).
- Failure of back wall on the second story occurred at nominal input of 80 % g (measured max. table acceleration 12.03 m/s<sup>2</sup>, see figs. 11 and 12).

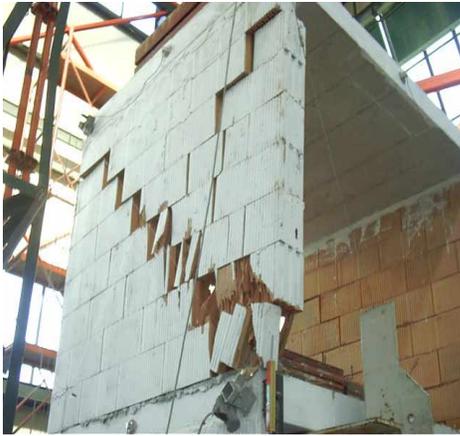
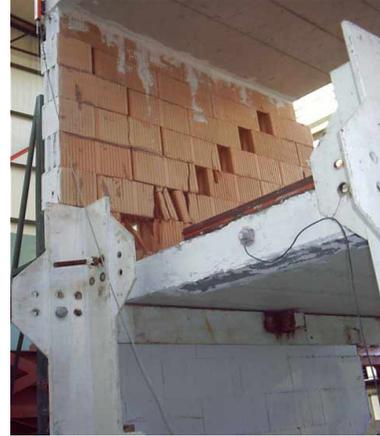
Fig. 11: Failure of the second floor at 80 % g excitation ( $12.03 \text{ m/sec}^2$ ) in Specimen #3

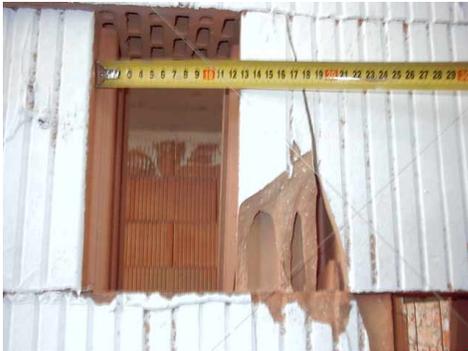
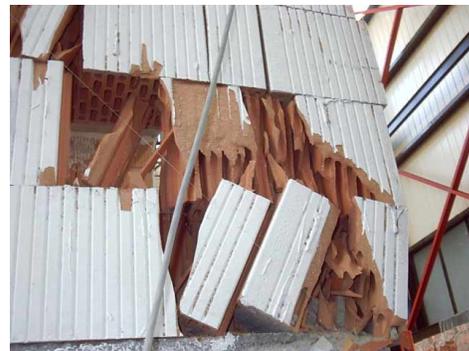
Fig. 12: Big horizontal movement in second floor's main wall (12 cm)
