EVALUATION AND STRENGTHENING OF PUBLIC BUILDINGS AFTER THE KAMASHI (UZBEKISTAN) EARTHQUAKES IN 2000 AND 2001

SUMMARY

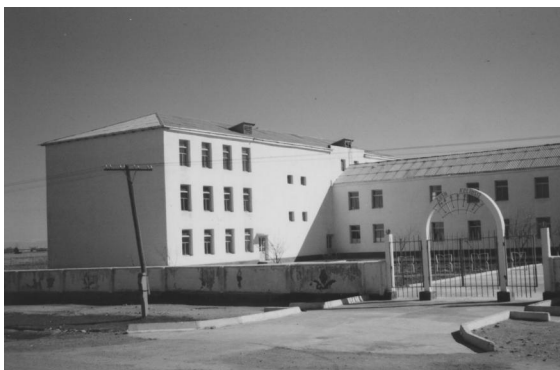
Figure 2. Block 2 – Public School *Ainakul*[3].

The school was built in the middle of the 1980's in the village of *Ainakul* located in a region of Uzbekistan called *Kashkadarya*. It consists of five blocks which are separated by joints of each other (Figure 3). Blocks 2, 3 and 4 accommodate the classrooms. Block 1 is a passage that connects all other blocks with each other. In Block 5 there are a gym and a dining room. The whole complex of buildings has two floors except for Block 2, which has 3 floors. For the following evaluation of the school, only Block 2 (Figure 2) is examined. The walls of Block 2 are made of brick masonry and the floors are made of concrete.

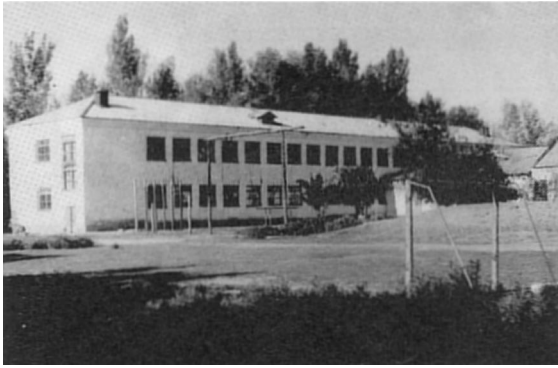
Figure 4. Block 1 - Secondary School *Kurchum*[7].

Block 1 of this school was built in 1963 in *Kurchum*, Kazakhstan. Block 2 and 3 were added later in 1982. Classrooms are located in Block 1. Block 3 contains the gym and the assembly hall of the school. In Block 2 the entrance area connects both of the other blocks. The whole school building was constructed with brick masonry. The floors in Block 1 are made of concrete. Since all blocks are connected with each other and are not separated by joints, all three blocks must be examined together for the evaluation.

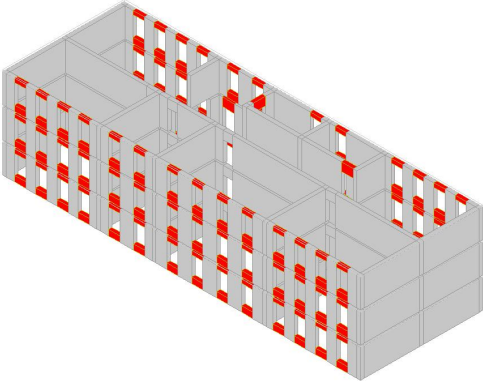
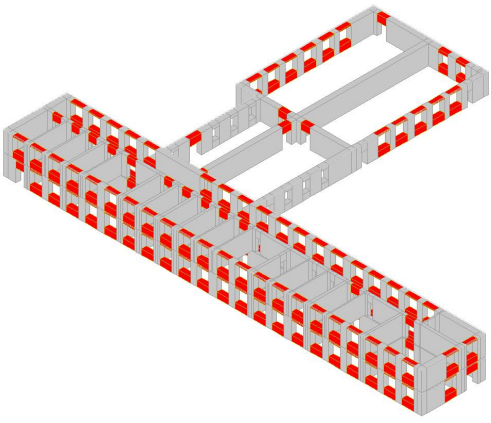
The marked elements are windows that were too wide for the construction type used. Nearly all windows of both schools are too wide.		
width of the pillars between the openings

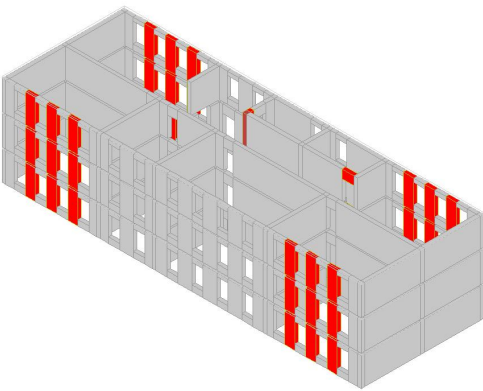
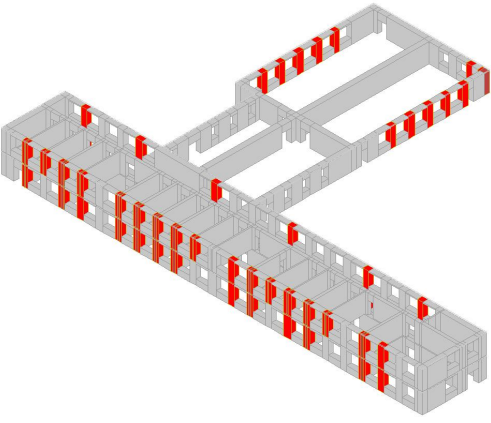
All pillars that are too narrow are marked in these figures.		
ratio of opening surface to the whole wall surface

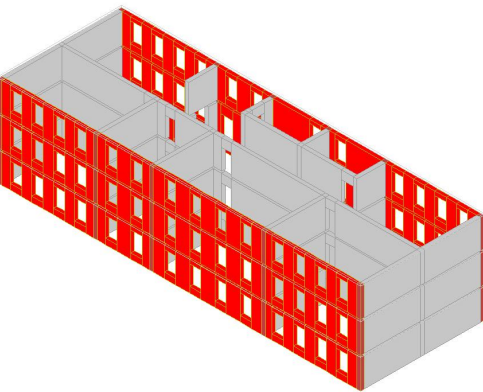
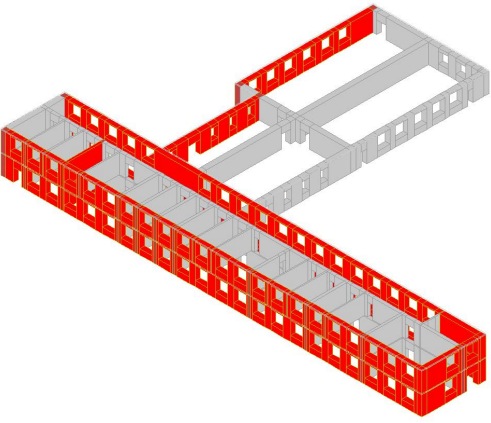
These figures show marked walls that have an opening surface equal to or greater than 30% of the whole wall surface. Walls with wide windows and narrow pillars do not satisfy this criterion. These walls are typical for school buildings, because the wide windows are needed to properly light the classrooms.

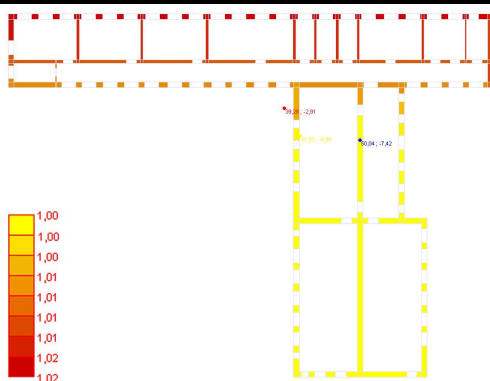
<p>Because of the absence of joints, the blocks of this building must be examined together. The ground plan of the building is L-shaped and vulnerable to torsion effects. Nevertheless, the maximum amount of additional load is only about 2% in the x-direction and therefore negligible.</p>
additional torsion-dependent wall load due to load impact in y-direction

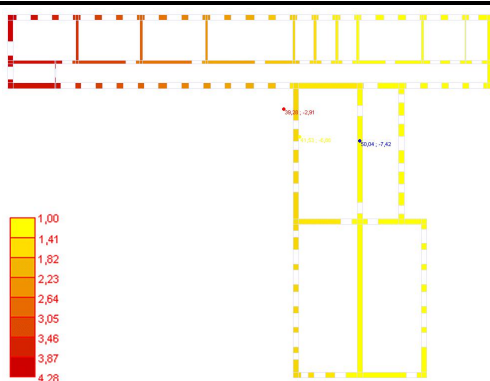
<p>The load impact in y-direction shows the disadvantage of the L-shaped ground plan. The max. amount of additional load rises up to >300% in the eastern part of Block 1. This will cause higher damage in this building part.</p>

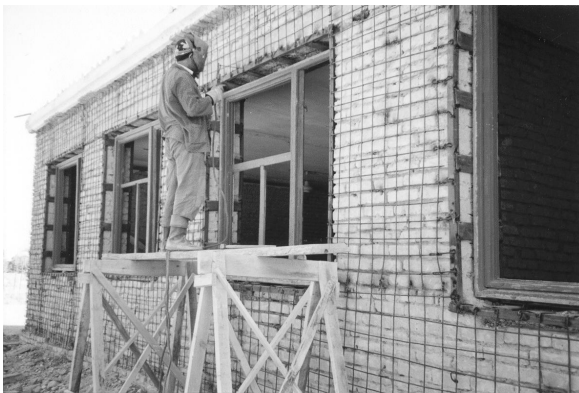
Figure 14. Strengthening measures – ductile shells and steel enframed windows [4].

The second constructional strengthening method insists in creating ductile shells inside and outside of all load-bearing walls. The shells are coupled by additional horizontal reinforcement.

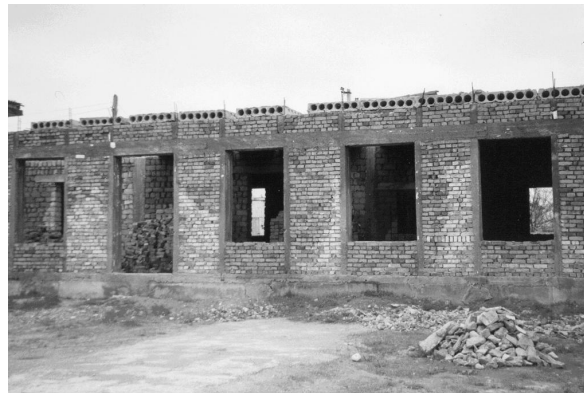
Figure 15. Confined masonry [6].

On the one hand, a continuous coupling of the walls takes place by means of reinforced concrete columns that reach from the foundation to the ceiling area. Foundation and ceiling areas are also made of reinforced concrete. Horizontally arranged reinforcement in the walls supports the concrete frame. In this way a confined masonry structure accrues. The openings are enframed with steel profiles.
