## **RAPID DAMAGE MAPPING TO SUPPORT POST-DISASTER RECOVERY**

### **SUMMARY**

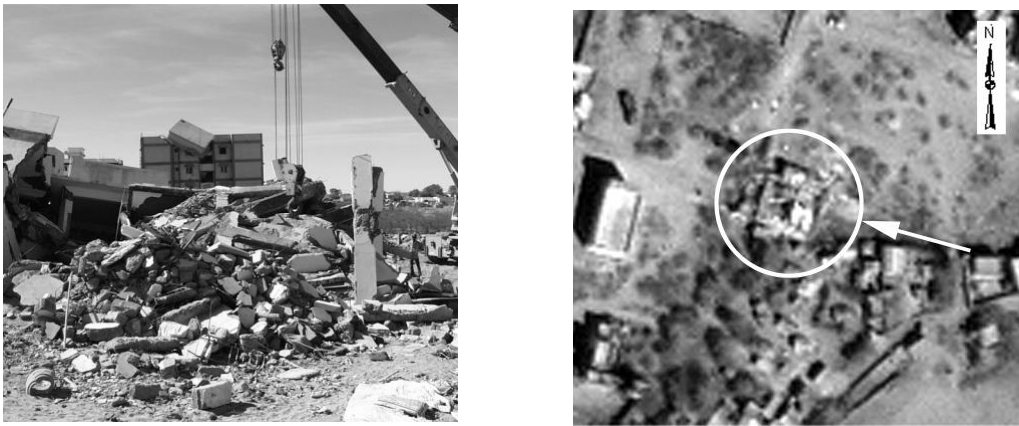
**Figure 1. Photo (left) and satellite image (right) of a collapsed single building in the north of Bhuj. The remains of the building are visible in the satellite image. The white arrow in the satellite image shows the look angle of the photo.**

24 buildings in the satellite image were compared with a set of photographs of the same buildings taken from the ground on the same date. The purpose of this comparison study was to see the extent of the damage satellite images can reveal. It became clear that severe structural damage to the buildings, debris and failure to building appendages could be identified, if the view is not obscured by shadows or the presence of nearby buildings.

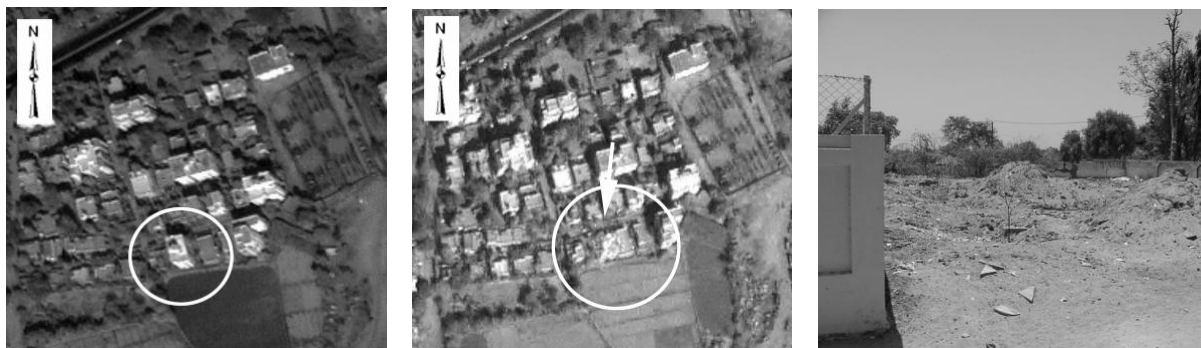
**Figure 3. Example of an image of a collapsed building. *Left:* pre-earthquake image; *middle:* post-earthquake image; *right:* ground photograph of the same site 15 months after the earthquake. The ground photograph was taken by the authors.**

Pre- and post-earthquake images of Ahmedabad, India, were compared side-by-side to see if changes caused by the earthquake are visible. Again, a grid was overlaid on the pre- and post-earthquake images and each grid-square was compared. A total of 121 km<sup>2</sup> was assessed (west half of Ahmedabad), which took 15 hours to complete by one interpreter. The result, followed by ground truthing proved that completely collapsed buildings can be clearly identified when pre- and post-earthquake images are compared.
