SEISMIC REHABILITATION OF REINFORCED CONCRETE BRIDGE COLUMNS IN MODERATE EARTHQUAKE REGIONS USING FRP COMPOSITES

Benjamin M. SCHLICK¹ and Sergio F. BREÑA²

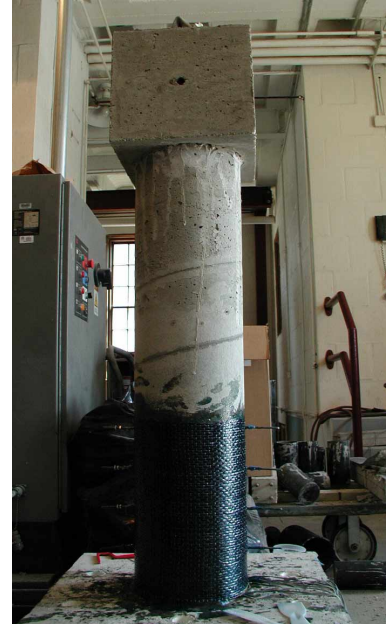
FRP wraps were used to provide concrete confinement and to eliminate the potential for lap-splice failure in the potential plastic hinge region of the columns. Significant lateral strength and stiffness degradation was expected to occur in the original columns at moderate displacement ductility levels because of the existence of a short lap splice at the base. The stiffness in the fiber direction of composite laminates plays a fundamental role in the confinement enhancement because of the linear stress-strain behavior of these materials. Therefore it was decided to investigate the confinement effectiveness of fiber composite jackets with different modulus and thickness. FRP composite jackets fabricated from carbon or aramid-fiber fabrics by wet layup were used to rehabilitate one of the specimens in each group of columns. The composites were formed using a single sheet of fabric in all the retrofitted specimens with an overlap of 150 mm (6 in.) in the hoop direction of the columns to avoid a localized failure at the fabric ends. The difference in composite stiffness was expected to affect the confining stress developed at a given lateral expansion of the concrete core. It was anticipated that the lateral confining stresses generated by the composites would preclude failure of the short lap-splice in the bottom region of the columns thereby increasing the deformation capacity and energy dissipation of the specimens. The fibers in the composite laminates were oriented in the hoop direction so that the contribution of the composites to the flexural strength of the columns was negligible. The jackets were started 6 mm (0.25 in.) above the foundation block and extended 345 mm (13.5 in.) above the base of the columns (Fig. 2). The jacket dimension was chosen to cover the entire lap-splice region of the columns. This rehabilitation scheme was selected to minimize cost of implementation for columns subjected to moderate displacement demands. Properties of the composite materials used in this study are listed in Table 1.

Figure 2 – Details of Column FRP-Jackets

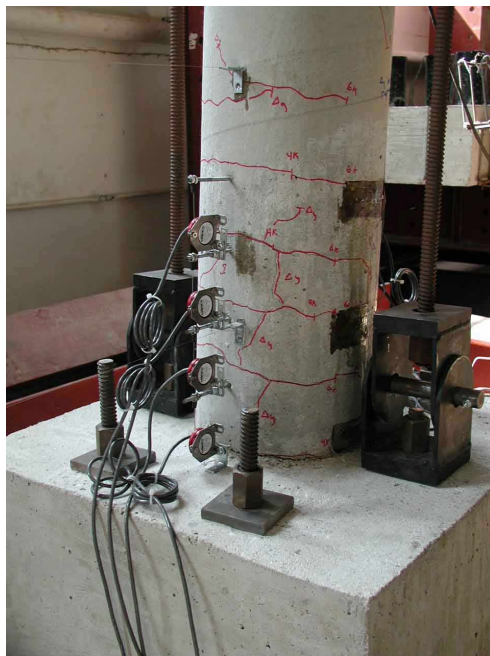
(a) Specimen C-15

Failure of the control specimens for both column groups was triggered by a lap-splice failure at the base of the columns at relatively low lateral displacement ductility. Longitudinal cracks started forming between flexural cracks on the concrete surface during the load cycles corresponding to yielding of the columns (Fig. 4a). Lateral load-drift response of the control columns for Groups I and II are shown in Fig. 5a and 6a, respectively. It can be observed that failure occurred at drifts between 0.05 and 0.075 in these columns. Significant strength degradation was observed during the second and third cycles at $2 \Delta_y$ and failure occurred at $3 \Delta_y$. Lateral strength loss was observed at $2 \Delta_y$ for specimen C-15 with only about 8% of the yield load remaining at a displacement ductility of 3. The lateral-load drift response of these columns was characterized by significant pinching during the cycles at 2 and $3 \Delta_y$ indicating the limited energy absorbing capacity of these columns.

Figure 4 – Observed Failure Modes of Original and Retrofitted Specimens

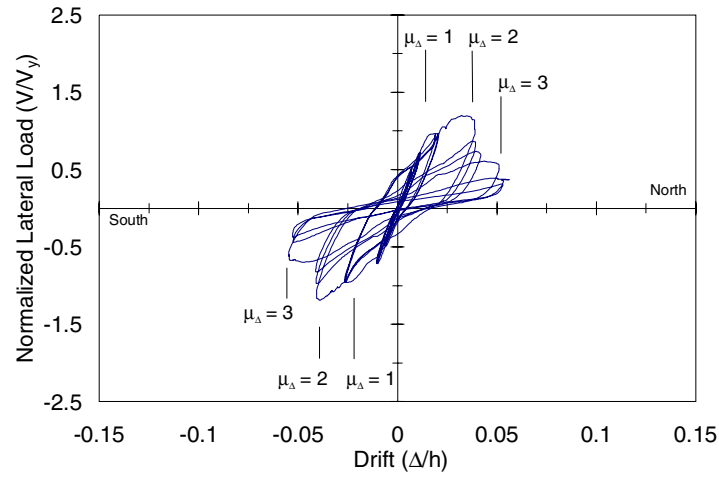
The columns rehabilitated with either carbon or aramid composite jackets maintained their lateral strength to significantly higher drifts than the corresponding control specimens (Figs. 5 and 6). This behavior was a result of a change in the observed failure mode from a non-ductile splice failure to a ductile flexural failure of the rehabilitated columns. The behavior of these columns was controlled by the formation of a plastic hinge within the lap-splice region (Fig. 4b) or directly above the composite jackets. The plastic hinge formed in the FRP-wrapped region of the column in three of the four rehabilitated specimens (specimens CFRP-05, KFRP-05, and KFRP-15) as determined from the recorded strain data. These specimens maintained their lateral-load strength approximately to a displacement ductility of 5. The plastic hinge in specimen CFRP-15, however, formed above the FRP jacket (Fig. 7), which limited the displacement ductility of this specimen to 4. In contrast to the control specimens, the lateral strength of all of the rehabilitated specimens increased significantly after yielding as a result of the confining effect provided by the FRP jackets. Higher strength increases were observed for the rehabilitated columns in Group I (approximately 40%) than for columns in Group II (between 19 and 30%). It is important to account for this increase in lateral strength when evaluating other members connected to the rehabilitated element in the structure. Table 2 lists the main load-drift parameters of all the specimens tested in this project.

Figure 5 – Lateral-Load Drift Response of Specimens in Group I ($P/A_g f'_c = 0.05$)

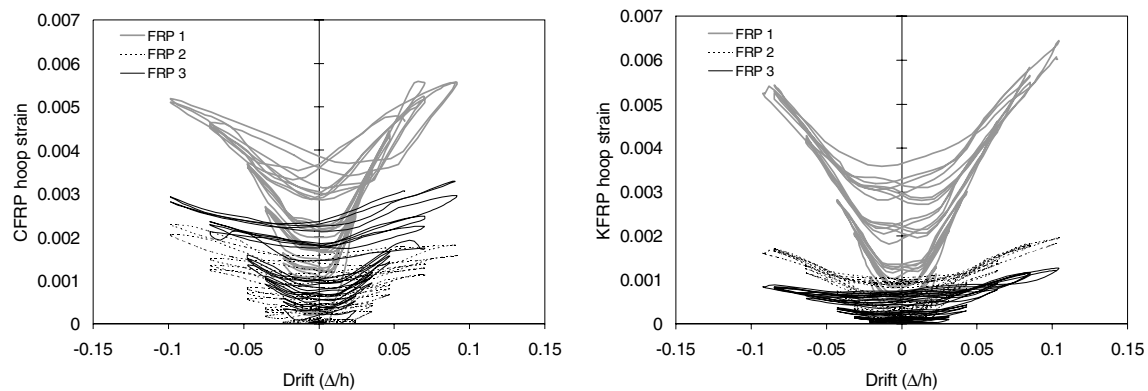
Figure 9 illustrates the variation of strain on the surface of the composite jackets in the hoop direction as a function of column drift for the rehabilitated specimens in Group II. Results from the specimens in Group I were similar so are therefore not presented in this paper. Each figure shows three plots corresponding to

the average of two strain gages at each of the three locations shown in Fig. 8. The instruments located closest to the base of both specimens (FRP 1) registered the highest strain as expected. The maximum hoop strain developed in the composite jackets near the base of the columns ranged from 0.0055 to 0.0065 at a drift of approximately 0.1 in both loading directions. The FRP hoop strains were expected to be highest at the base and decrease toward the top of the jackets as a result of lower moment in the columns. It should be recalled that these strains generate as a result of expansion of the concrete when subjected to axial strains. The FRP hoop strains in specimen KFRP-15 followed the expected trend in the results, with the measured strain at the top of the FRP jacket reaching values of 0.001 and 0.0015 at the maximum drift of the column. On the other hand the FRP hoop strains measured in specimen CFRP-15 near the top of the FRP jacket (FRP 3) were higher than those measured near the middle of the jacket (FRP 2). This result can be attributed to the formation of a plastic hinge above the composite jacket in specimen CFRP-15.

Figure 9 – Variation of FRP Hoop Strains along Height of Jacket

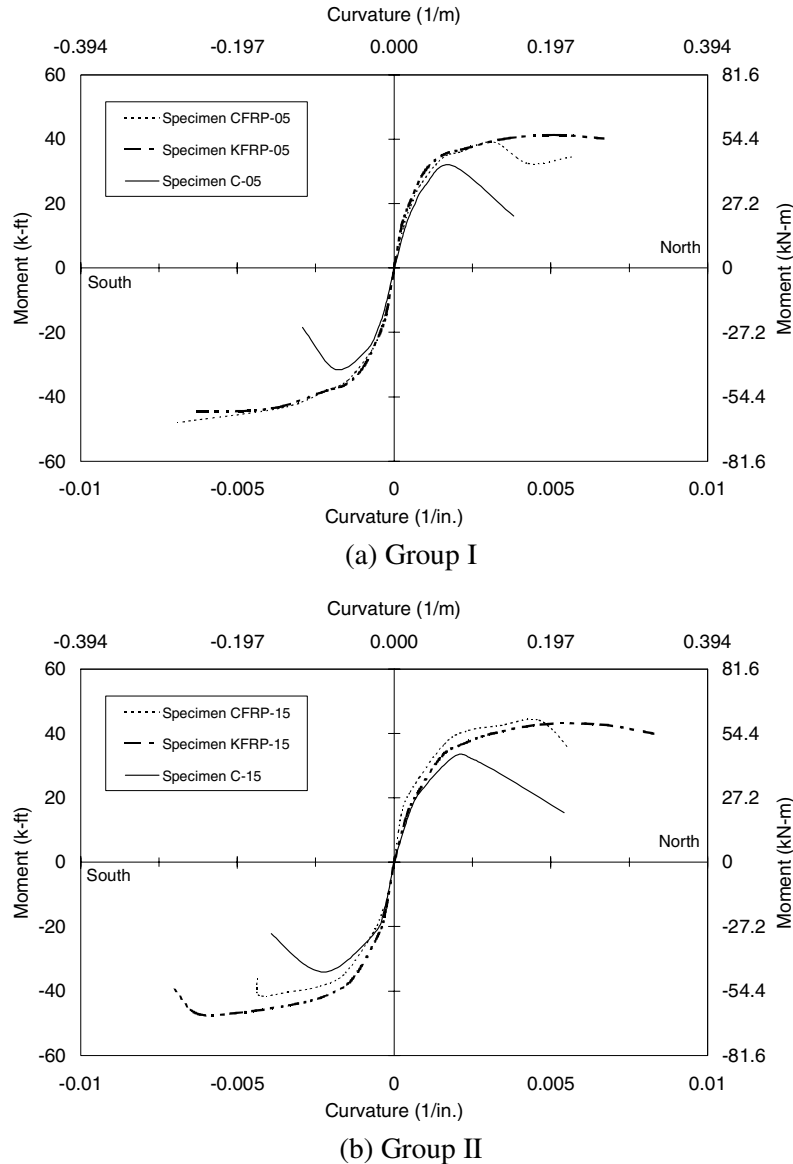
The section ductility of the specimens was evaluated by comparing the moment-curvature response of the specimens within the plastic hinge region. The rotation of the columns was measured at four sections near the base of the columns. The average curvature between two sections was calculated by dividing the rotation difference at two consecutive sections by the distance between the sections. The average curvature over the plastic hinge region was calculated as the average of the curvatures determined for each section. The values of moment and average curvature determined during the first cycle at each displacement level applied during the tests were used to develop the moment-curvature envelopes shown in Fig. 12. The curves shown in Fig. 12a correspond to the columns subjected to $5\% A_g f'_c$ while the curves shown in Fig. 12b correspond to columns subjected to $15\% A_g f'_c$. These figures show that the composite jackets had a significant influence in the increase of the curvature capacity of both groups of columns. The curvature capacity of the jacketed specimens increased 3 to 4 times from the curvature at the peak measured moment of the control specimens. The plots also show that in general specimens rehabilitated using aramid-fiber jackets developed slightly higher curvature over the plastic hinge length than specimens with carbon-fiber jackets.

Figure 12 – Comparison Between Moment-curvature Response of Control and Rehabilitated Specimens
