EXPERIMENTAL STUDY ON THE REPAIR EFFECT OF RC PIERS DAMAGED BY EARTHQUAKES

SUMMARY

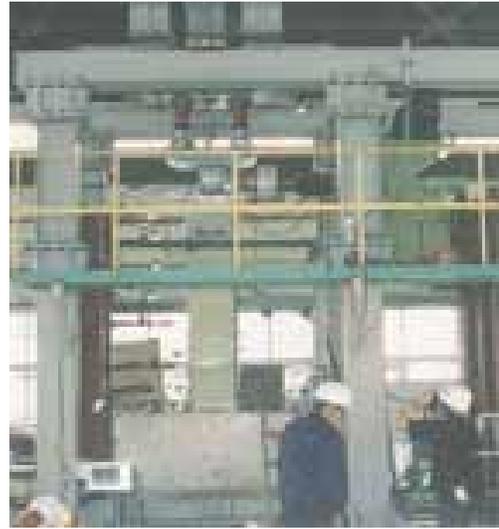
Photo 1 View of the experimental equipment

The wall-type RC pier, which is commonly seen in road bridges, was chosen to be the subject of this study. To reproduce conditions as close as possible to those of an actual structure, cyclic loading tests were conducted while the vertical axial force of 150 kN, which was equivalent to the dead weight of the superstructure, was maintained using a vertical loading jack. Photo 1 shows a view of the experimental equipment. In cyclic loading, the yield strain of the axial reinforcement was first set at 1890μ , which was obtained through material testing. Load was then applied by strain control until the strain of the tension-side reinforcement at the base of the pier reached yield strain.

The loading point displacement at this point was defined as yield displacement δ_y and the horizontal load was defined as yield load P_y . In the subsequent loading, displacement was controlled by gradually increasing the single amplitude by an integral multiple of the yield displacement ($2\delta_y$, $3\delta_y$...) and the loading was repeated three times for each displacement amplitude.

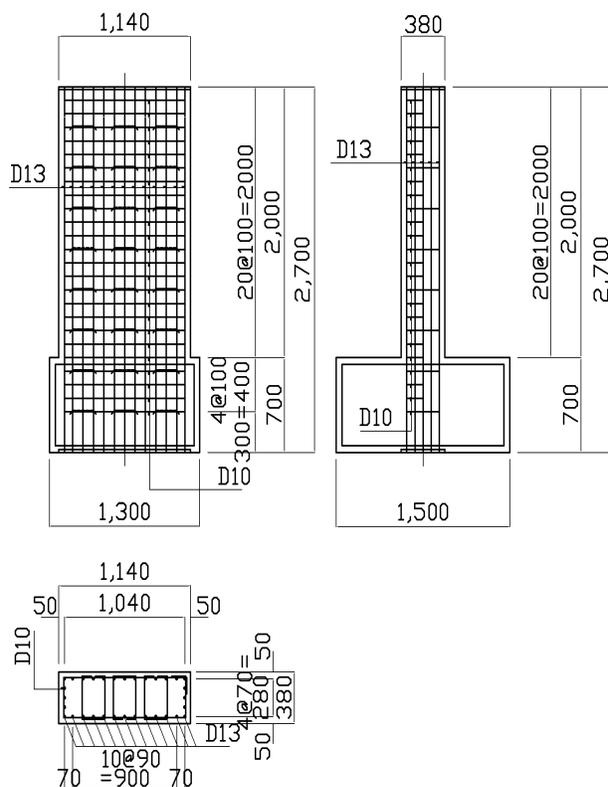
Fig.2 Reinforcement arrangement of the specimens

The specimens were constructed to simulate the wall-type RC pier, which is commonly seen in road bridges, and their size was approximately one-fourth that of an actual pier. Figure 2 shows a schematic diagram of the reinforcement arrangement of the specimens.

The specimens had rectangular sections (aspect ratio of side length 1:3) with a height of 2.0 m and section size of 0.38×1.14 m. The tensile reinforcement ratio was $P_t = 0.45\%$ and the volume ratio of the hoop reinforcement was $\rho_s = 0.2\%$.

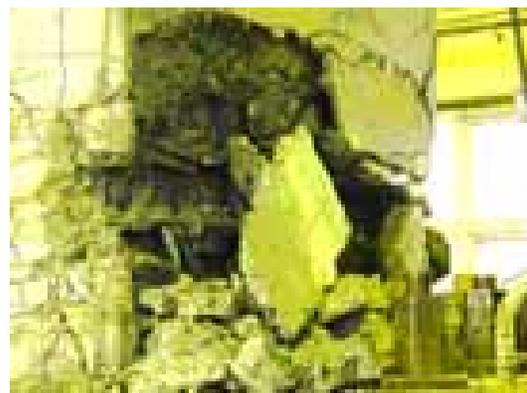
Photo4 Damage condition of the 2.0-R-5 specimen

Damage observed at the end of preliminary loading ($5\delta_y$) was the exfoliation of concrete cover within the range of approximately 300 mm from the base.

At the time of loading after repair, exfoliation of or other damage to concrete cover was not confirmed until the $8\delta_y$ loading stage in the same manner as the case of the 2.0-R-3 specimen.

Although the swelling of concrete cover was observed during the $9\delta_y$ loading stage, injected epoxy resin prevented exfoliation of concrete cover, and resulted in a peculiar form of damage in which the exfoliation of concrete cover did not occur even when swelling became significant at $10\delta_y$. Concrete cover exfoliated during the $11\delta_y$ loading stage and the ultimate stage was reached at 12 and $13\delta_y$ when multiple main reinforcement bars were broken.

The extent of the exfoliation of concrete cover was greater compared with the 2.0-N and 2.0-R-3 specimens, and within the range of approximately 500 mm from the base. Photo 4 shows the damage condition of the 2.0-R-5 specimen at the ultimate stage.

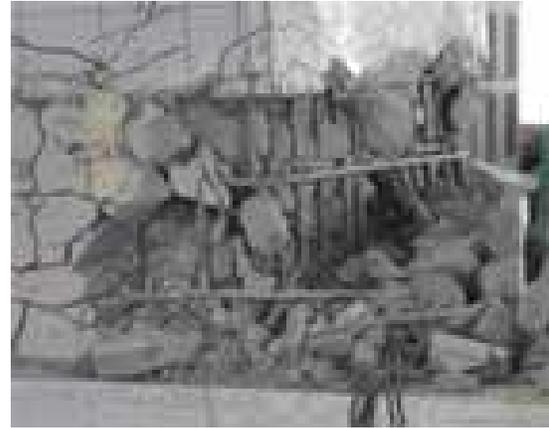
Photo5 Damage condition of the 2.0-M-5 specimen

Damage observed at the end of preliminary loading ($5\delta_y$) was the exfoliation of concrete cover within the range of approximately 300 mm from the base, in the same manner as the 2.0-R-5 specimen.

At the time of loading after repair, the expansion of the width of cracks was observed at the boundary between the non-shrink mortar part and the existing part during the $6\delta_y$ loading stage. Swelling of non-shrink mortar occurred during the $8\delta_y$ loading stage and the mortar exfoliated over a wide area during the $9\delta_y$ loading stage. The load gradually decreased through subsequent loading, and the ultimate stage was reached at $11\delta_y$.

The exfoliation of concrete cover occurred only within the range of 300 mm from the base where the section was restored, and the boundary between exfoliated and existing parts was clear. Photo 5 shows the damage condition of the 2.0-M-5 specimen at the ultimate stage.

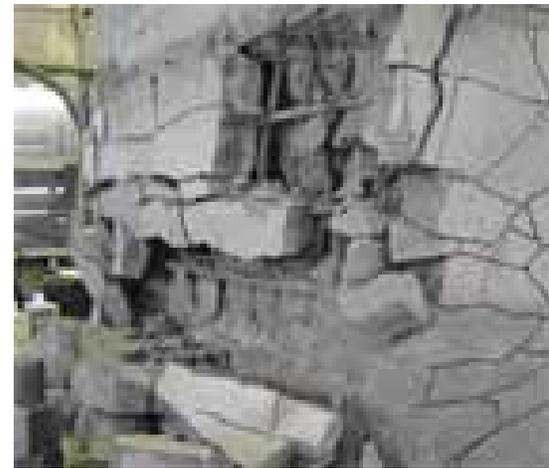
Photo6 Damage condition of the 2.0-M-7 specimen

Damage observed at the end of preliminary loading ($7\delta_y$) was the exfoliation of concrete cover within the range of 300 mm from the base. The main reinforcement was already buckled and the exfoliation of concrete cover was observed within the range of 500 mm from the base.

At the time of loading after repair, partial exfoliation occurred in the non-shrink mortar of the repaired part after the $5\delta_y$ loading stage. After that, the range of exfoliation gradually expanded with the increase in displacement amplitude.

Non-shrink mortar exfoliated over a wide area, the load decreased during the $9\delta_y$ loading stage and the ultimate stage was reached at $11\delta_y$.

The exfoliation of concrete cover only occurred within the range of 500 mm from the base where the section was restored, and the boundary between the exfoliated and existing parts was clear. Photo 6 shows the damage condition of the 2.0-M-7 specimen at the ultimate stage.

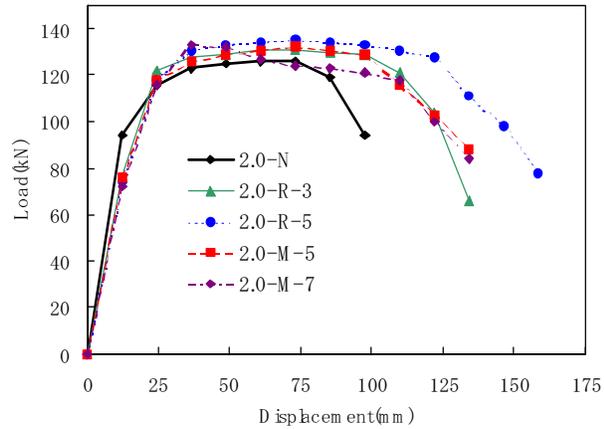
Fig.3 Load-displacement relation envelope

Table 3 shows the list of experimental results and Fig. 3 shows the envelope of the load-displacement relationship (first stage of repeat loading, mean push-pull values). In the table, δ_y and P_y represent the horizontal displacement at the loading point and the load at the time of yield of the main reinforcement, respectively; P_a is the maximum load (mean push-pull values) and δ_u is the horizontal displacement at the ultimate stage.

The table and figure show that, for all of the specimens after repair, the load P_y during the $1\delta_y$ loading stage was as small as 76 to 80% of that of the 2.0-N specimen, indicating that the initial rigidity was decreasing. This is probably because repair was only conducted for visible cracks and where resin injection was possible, and hair cracks and other fine cracks were not repaired. In addition, in the case of mortar repair, only the section restoration part was repaired.

During the $2\delta_y$ loading stage, the load of repaired specimens was larger than that of 2.0-N and the maximum load P_a also increased by 5 to 7%.

It can also be seen that the load on the 2.0-M-7 specimen gradually decreased after $5\delta_y$, when the exfoliation of non-shrink mortar occurred. On the other hand, the load did not decrease for the 2.0-R-3, 2.0-R-5 and 2.0-M-5 specimens even during the $8\delta_y$ loading stage when the 2.0-N specimen reached the ultimate stage.

The ultimate plasticity, which is evaluated by dividing ultimate displacement δ_u by yield displacement δ_y , was 11 for 2.0-R-3, 2.0-M-5 and 2.0-M-7 and 13 for 2.0-R-5, while it was 8 for the 2.0-N specimen, thereby indicating that tenacity increased dramatically compared with that before repair.

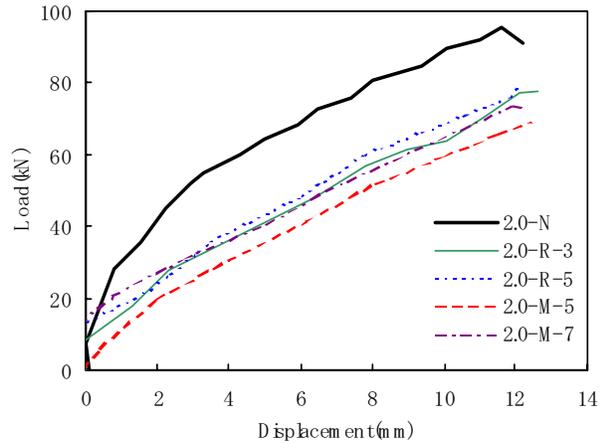
Fig.4 Load-displacement relation envelope (up to $1\delta_y$)

Figure 4 presents the load-displacement relationship from the beginning of loading to $1\delta_y$. The figure shows that, in the 2.0-N specimen, there was a clear difference in rigidity before (displacement: 0 – 3mm) and after the occurrence of cracking (displacement: 3 – 12mm). It can also be seen that the rigidity of repaired specimens from the beginning of loading was almost equivalent to that after the occurrence of cracking in 2.0-N. In the same way as mentioned above, it was probably because hair cracks and other fine cracks, for which resin injection was impossible, remained due to unloading after preliminary loading in 2.0-R-3 and 2.0-R-5, and because cracks outside the section restoration part were not repaired in the 2.0-M-5 and 2.0-M-7 specimens.

The starting points of loading differ in the figure because of the effect of the initial input caused by repair conducted while the displacement was maintained at zero.

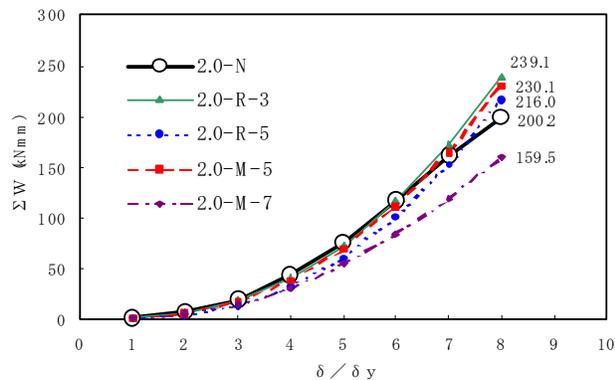
Fig.5 Hysteresis absorbed energy (in the terminal stage)

Figure 5 shows the relationship between the accumulated amount of hysteresis absorbed energy and displacement amplitude (δ/δ_y) up to the ultimate displacement of each specimen.

While the accumulated amount of hysteresis absorbed energy at the ultimate stage was 200.2 kNmm ($8\delta_y$) for the 2.0-N specimen, it was 366.6 kNmm ($11\delta_y$) for 2.0-R-3, 531.8 kNmm ($13\delta_y$) for 2.0-R-5, 371.7 kNmm ($11\delta_y$) for 2.0-M-5 and 274.9 kNmm ($11\delta_y$) for 2.0-M-7. These values were 1.4 to 2.6 times as large as that of the standard specimen.

Focusing on the $8\delta_y$ loading stage when the 2.0-N specimen reached the ultimate stage, however, the hysteresis absorbed energy was low after $5\delta_y$ when the exfoliation of concrete cover occurred in 2.0-M-7 and the accumulated value was approximately 80% of that of 2.0-N, while the values for 2.0-R-3, 2.0-R-5 and 2.0-M-5 were 1.1 to 1.2 times as high as that of 2.0-N.

It was thus revealed that, at $8\delta_y$ loading in which the standard specimen 2.0-N reached the ultimate stage, the amount of hysteresis absorbed energy was higher if the degree of damage before repair was low and that hysteresis absorbed energy equivalent to or higher than that before repair was observed in specimens for which repair was conducted at a stage before swelling of the concrete cover began.
