AN EXPERIMENTAL STUDY ON THE BEHAVIOUR OF REINFORCED CONCRETE COLUMNS USING FRP MATERIAL

SUMMARY

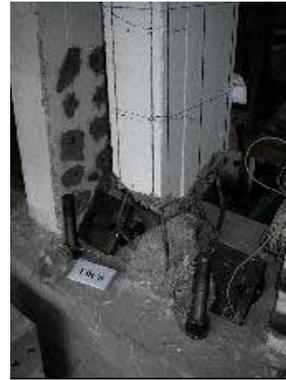
(a)
 Figure 5. Test of control column reinforced with continuous reinforcement

Prior the application of lateral load, the column was first loaded with a constant axial compressive force of 350 kN, which corresponded approximately to 25 per cent of the ultimate axial load carrying capacity. Observations during testing indicated that the first crack was formed at 0.75 per cent drift level. The cracks were widened during the subsequent cycles at the same displacement. At the 1.0 per cent and 1.5 per cent drift levels, new cracks appeared and continued to widen. The new diagonal cracks caused decrease in the load capacity from 77 kN to 70 kN at 1.5 per cent. Spalling of concrete cover was observed at the base of the column at 2.0 per cent drift level. After the completion of 2.0 per cent level, 0.5 per cent, 1.0 per cent and 1.5 per cent drift levels were re-applied to the column. At these cycles, the cracks were widened further. At 2.5 per cent drift level, the cover concrete experienced extensive spalling. Buckling of the column longitudinal bars followed the crushing of the concrete. Figure 5a shows the lateral load versus top displacement graphics and the backbone curve. It may be observed from the Figure 5b that the test was ended with the crushing of the concrete, buckling of longitudinal reinforcements.

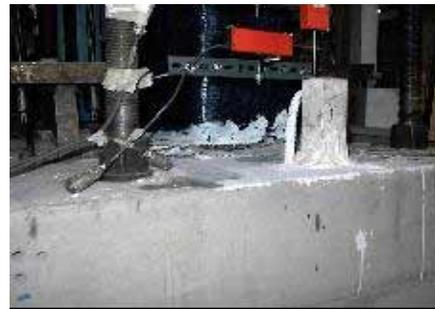
(a)
 Figure 6. Test of strengthened column reinforced with continuous reinforcement

The first cracking occurred when the specimen was subjected to a drift level of 1.5 per cent. Up to this drift cycle, there was no crack observed. New cracks formed at 2.0 per cent drift level. Shear cracks appeared near the base at 2.5 per cent drift level. The load did not increase significantly after the drift level of 1.0 per cent, but some spalling and crushing of concrete were observed at the base. Load-Displacement diagram and envelope curves are shown in Figure 6a. The damages, which the column experienced at the end of the test, are shown in Figure 6b.

After the test, FRP layers were removed from the column to see further damages occurred. Only, minor cracks were observed near the bottom section of the column and the rest remained undamaged.

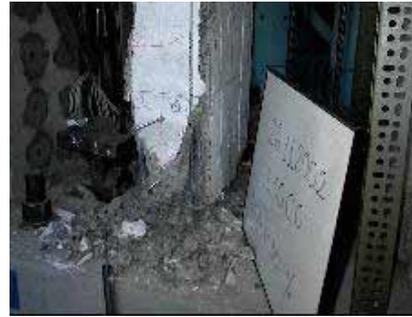
Figure 7. Test of control column reinforced with lap-spliced reinforcement

The control lapped-spliced column was subjected to the same loading program as described in preceding section. Load-Displacement diagram is shown in Figure 7a. At the first cycle, a drift of at 0.25 per cent was applied. The cracks formed around the lapped region. In the following cycles, these cracks widened and new horizontal cracks were formed. Crushing of concrete was observed during the cycles at 1.0 per cent drift level. The bond between the reinforcement and concrete was lost and the lateral force was decreased. Slipping of the reinforcements of dowels and column re-bars were observed and thus high degree of pinching effect was experienced. The picture showing the damage on the column is shown in Figure 7b.

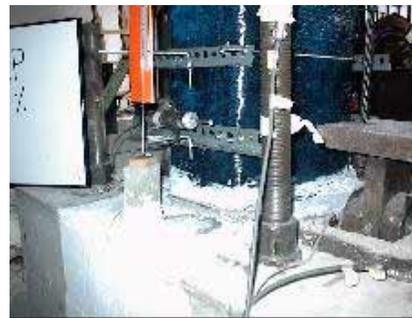
Figure 8. Test of strengthened column reinforced with lap-spliced reinforcement

Similar to the column with continuous bar, cracks were observed at the base of the column. During the 0.50 per cent drift cycles, first cracks were observed. Due to the FRP sheets, there was no crack observed on the surface of the column. The test ended at the cycles of 6 per cent drift while cracking at the column base was observed. Similar behaviour was observed with the control column that was reinforced with lap-splice longitudinal reinforcement. Figure 8a shows the load displacement and the backbone curve of the specimen, and the picture from the specimen at the end of the test are illustrated in Figure 8b.
