FULL-SCALE PSD TESTING OF A TORSIONALLY UNBALANCED THREE-STOREY NON-SEISMIC RC FRAME

SUMMARY

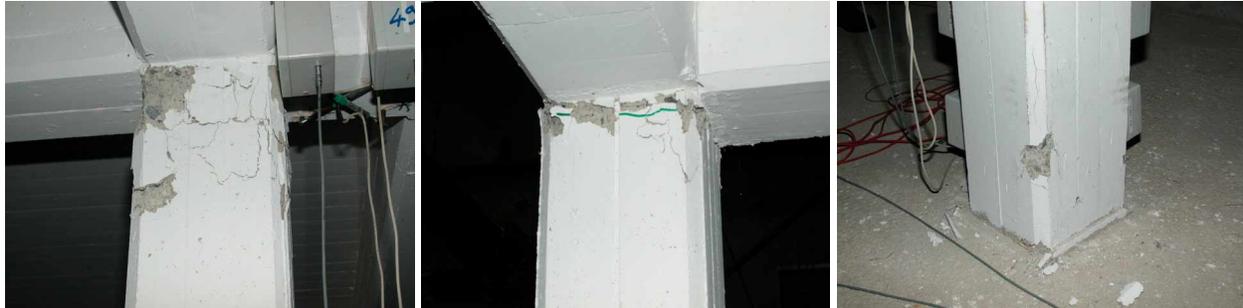
Figure 21 – Damage after the 0.2g PGA test: a) extensive spalling at the top of columns (C3); b) light spalling and flexural cracking at the top of corner columns (C1); c) base of column C3

During the second test the same damage trends were followed, only partly following the predictions. The damage was concentrated in columns, as expected. It was particularly evident at the top rather than at the base of the columns, and at the second floor rather than at the first; in Fig. 21 a) it can be seen that columns C3, the one with the highest axial load, suffered the most for extended spalling at the top and that also the flexible edge columns exhibited a significant level of spalling and cracking at the top.

Unexpectedly, though, the bottom parts of the columns did not show either cracking at the level of the lap splices, or spalling, except for some minor damage particularly evident in column C3, as it can be seen in Fig.21 c). Finally, some damage was detected in the beams and floor slabs connected to the strong column C6: due to its large stiffness, it did not suffer any damage in itself, but caused cracking in the surrounding elements.
