LESSON LEARNED FROM RECOVERY PROJECT OF BAM'S CULTURAL HERITAGE (RPBCH)

Eskandar Mokhtari¹, Mahmoud Nejati², Shirin Shad³

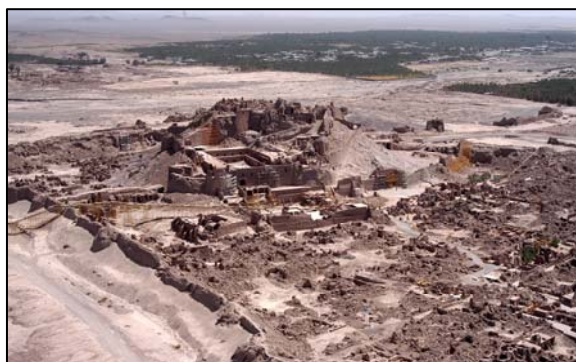
Figure 2 Bam Citadel with area around 200,000 m², (Hellishot, December 2007)

During the past four years, many activities have been defined in relation to planning and management of the built and natural environments. Soon after the earthquake the **Iranian Cultural Heritage, Handicrafts and Tourism Organization (ICHHTO)** with international supports tried to protect the remains and pass the critical time period. Since the earthquake in 2003, the RPBCH has started as a governmental body responsible for the conservation the historical buildings and organized one of the largest restoration projects in the world (Figure 2). The main measures have been done including the following parts:

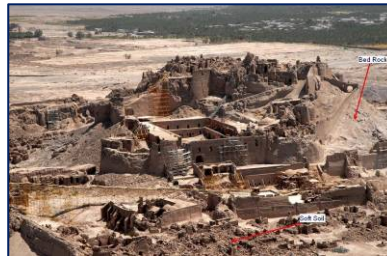
- Damages are caused by dynamic load of earthquake (around 0.8g in 3D) and the relevant response of the monument based on the dynamic specification of the structure. (Figure 3).

Figure 3 The bed rock in District of Governor caused different dynamic response in comparison with other parts

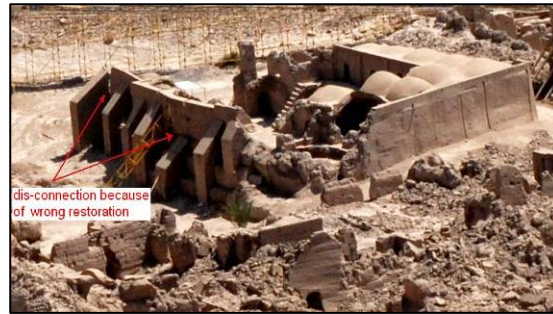
- Lack of any earthquake base design in previous interventions and measures for example disconnection between the walls and buttresses in the west part of Caravansaray (Figure 4).

Figure 4 Incorrect interventions, the butters behind the west wall of the Caravansary

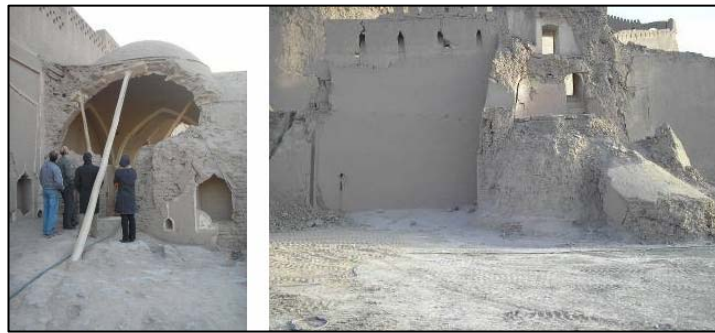
- Regarding to the long return period of earthquakes in Iran, mostly the earthquake load was not considered as a design load for the buildings in Citadel. For example the disconnection between the load-bearing parts and dome (Figure 5-left).

Figure 5 Disconnection between dome and walls in Stable (left) - although the First-Wall acted as a shear wall but finally the tower crashed with 45° pattern (right)

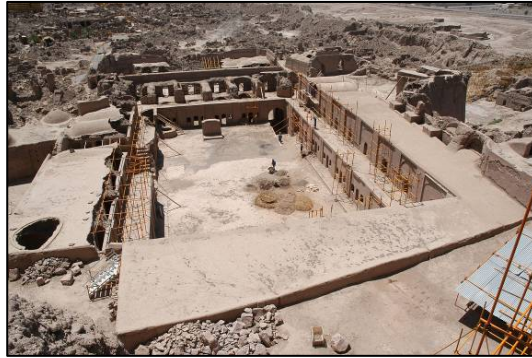
Figure 7 Restoration of Barrack, Bam Citadel

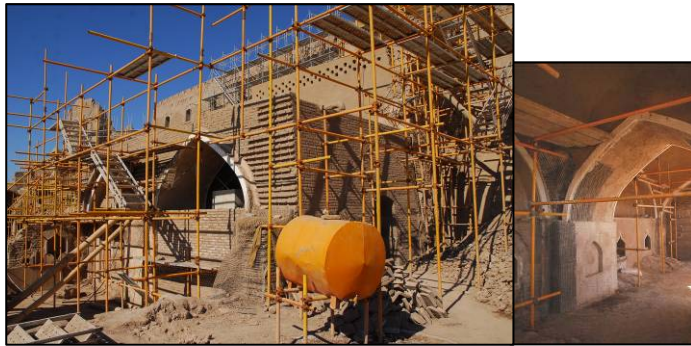
Figure 8 Strengthening of the Stable, by SES Consulting Engineers, Iran

- Strengthening & injection for the cracks with the 2^{cm} width (Sistani House and Stable),
- Strengthening with replacing the tensile elements, with or without the ending plates (Sistani House and Stable),

- Setting vertical elements under the walls (Sistani House), the vertical elements replaced 1.5 m inside the ground level to omit the uplift effects,
- Integration of the outer surfaces like the arches and the domes with Geo-Grids (Stable),

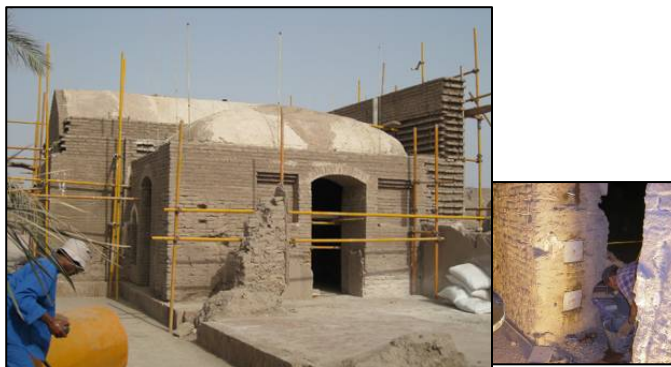
Figure 9 Strengthening of the Sistani House, by Dresden University of Technology-Germany

- Sub-soil stabilization to avoid resonance effect in next earthquakes (District of the Governor),
- Increasing ductility with reinforced adobes by palm fiber (Sistani House),

- Increasing the box effect in top of the walls with the use of ring beams (Sistani House),
- Natural fibers such as Guni to improve the resistance of adobe building, as prototype pilot project in laboratory in Bam Citadel (under construction).

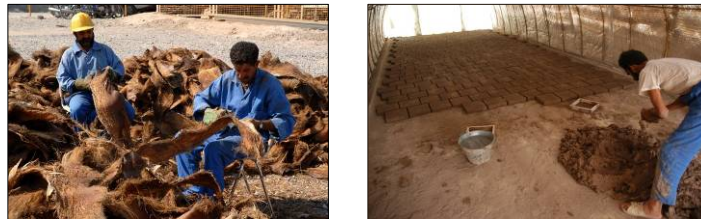
- Finding a suitable source to provide appropriate soil quality,
- To earn proper percentage for producing the retrofitting adobe bricks,
- To search for the natural additives to improve the mechanical quality of adobes(for example the palm fibers (Figure 10),

Figure 10 Process of producing the reinforced adobes with the palm fibers
