SHAKING TABLE TEST AND NUMERICAL INVESTIGATION OF RC STRUCTURES WITH SPECIALLY SHAPED COLUMNS IN HIGH SEISMIC INTENSITY ZONES

PAN Wen¹ and LIU Jian²

¹ Professor, Dept. of Civil Engineering, Kunming Univ. of Sci. & Tech., Kunming, China

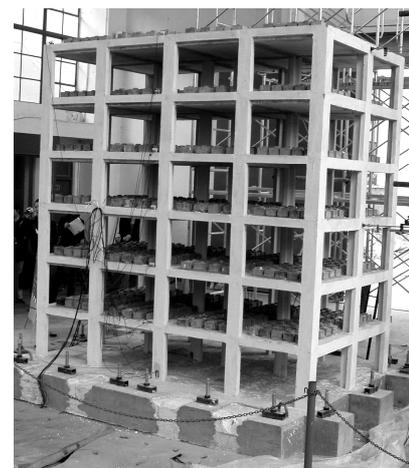
Figure 3 Finished frame model

In order to make sure that the model structures can simulate the seismic resistance performance of the actual structures, great effort in construction to make the models as similar to the original as possible. Microparticle concrete is selected as the material for the main model body to simulate concrete materials of the real structure, the galvanized wire is used to simulate reinforcement bar. The construction method, pouring method, and maintenance conditions of microparticle concrete are similar to those of ordinary concrete so that it is extremely similar to it in terms of material nature. Similar to concrete used in the original structure, the microparticle concrete also has several geometric continues grading and grits of different sizes take their corresponding proportion. As a result, its mechanics functions and grading present good similarity with the original concrete. Test can be conducted on the model using microparticle concrete until it cracks or even is damaged. Therefore, test results are quite easy to observe. At the same time, because the cohesion and anchoring between galvanized wires and concrete is comparatively weaker than that between actual deformed bars and concrete, the anchor measures of wires in concrete is strengthened. For the models were constructed to a smaller scale, there is high demand for precision, which requires high-level construction. The wood is used for outside mould while the combination plate mould built up with wood and foamed plastics used for internal mould. Before the construction of models, the moulds are arranged to be a certain shape so as to form spaces required by the components, the pouring of microparticle concrete is started after the moulds were fixed reliably. In the process of pouring, the concrete was vibrated and consolidated. Concrete was poured for one storey each time and the reinforcement and moulds of the storey above are laid when it reached certain strength. The above procedures were repeated until the pouring for the whole model was completed. See Fig. 3 and 4.

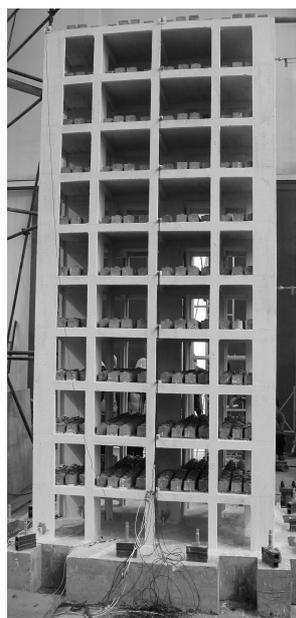
Figure 4 Finished frame-shearwall model

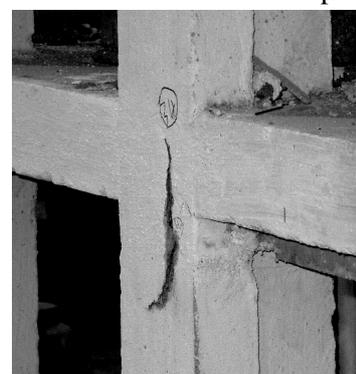
Figure 5 Concrete spall near joints

After the input of El Centro with PGA 0.4g (one in X and another in Y), cracks on the outside of the model continued to develop. The number and length of the cracks continued to grow. Circular or semi-circular peeling off of the concrete cover occurred on the outside surface below some beam and column joints (see Fig. 5). This is particularly obvious on the top of the 2nd and the 3rd stories. Visible cracks appeared in some beam and column joints corner and concrete peeled off there. At some individual joints, the concrete cover protruded out. Cracks also appeared in the core area of the top beam-column joints on the 3rd story (Fig. 6).

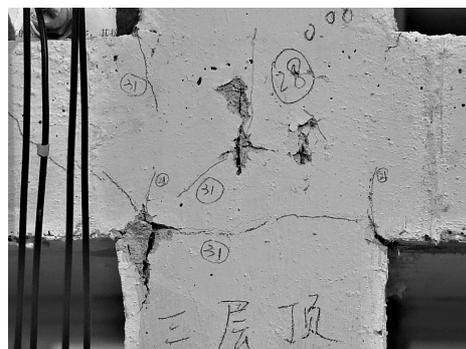
Figure 6 Cracks cross the core of joints in floor 3

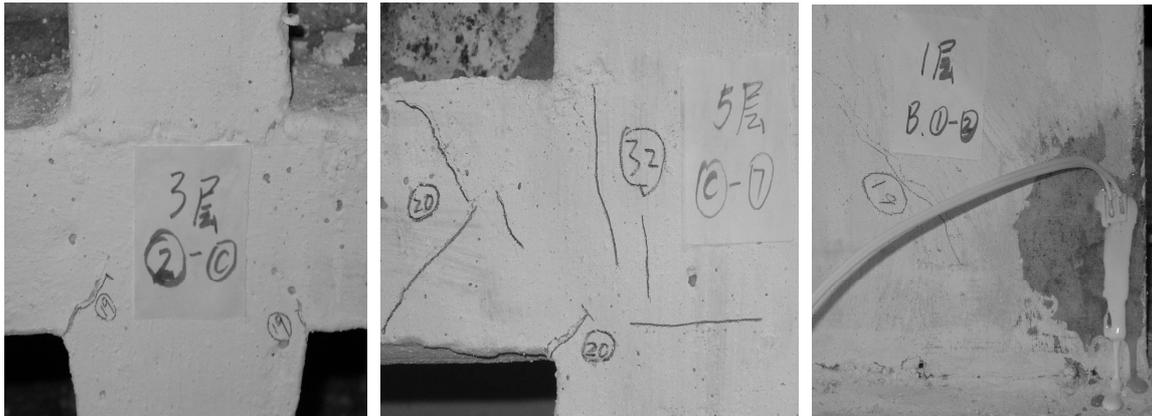
(a) Oblique crack in beam-column joint

(b) oblique crack in beam-wall joint

(c) oblique crack in shearwall

Figure 7 Crack after the input of first two one-way synthesized record of rare intensity

(c) Rare intensity: After the input of two synthesized records with PGA 0.4g (one in X direction and one in Y direction), a large number of cracks appeared, but did not expand yet, crack width was around 0.5mm. Most of them was oblique cracks occurred near conjugation of beam and column (Fig.7a), or beam and wall (Fig. 7b), a few occurred on shearwalls (Fig.7c). In addition, some vertical
