Characteristics of engineering damage and human mortality in Mianzhu areas in the great 2008 Wenchuan, Sichuan, earthquake

ABSTRACT: The great Ms 8.0 Wenchuan earthquake caused huge seismic damage and high casualty in the areas along the Longmenshan fault zone. Mianzhu is a city among those severe damaged areas. Mianzhu city is located near the central Longmenshan fault and crossed by the front range fault, Dujiangyan-anxian fault. After the earthquake occurred, a field team of IEM reached Mianzhu city at the earliest time, and the field survey were carried out. Investigations into the engineering damage and human mortality in Mianzhu show that the seismic intensity attenuates fast with the distance to the fault trace, and it dramatically decreases from X to about VII degree within a distance of about 60 km; Whereas, seismic intensity along the fault trace shows almost no attenuation within the distance of about 20 km in Mianzhu. Except for the effect of site condition, topography and path, this phenomenon may also effected by the rupture direction of the long extended Longmenshan fault and it's front range fault.

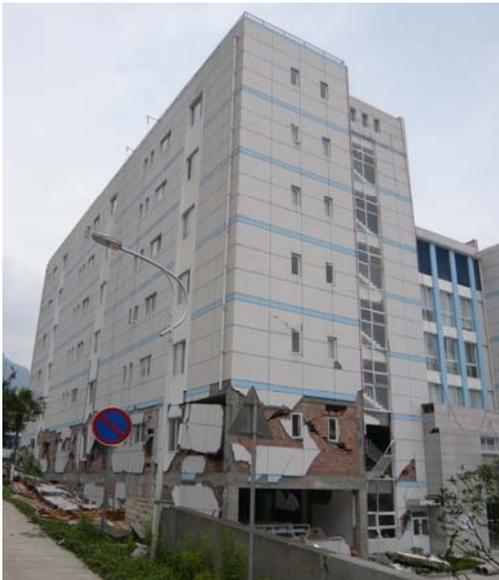
Fig. 3 Shear crack of the bottom two stories of an office building in Dongfang Steam Turbine Works, Hanwang town, May 15, 2008

The Reinforced Concrete (RC) structure, mainly frame structure in Mianzhu, account for less than 1% in area of Mianzhu city (Dai *et al.*, 2008), and most of them located in the relative economically developed urban district and Hanwang town. The RC structures are often used by some buildings like hospital, school, shopping centre, hotel and etc. Figure 3 and 4 provide two examples of the typical damage pattern of RC buildings in Hanwang town. Hanwang town is about 13 km to the central Longmenshan fault (Sun *et al.*, 2008) and was crossed by the surface rupture of the front range fault. It is well known that earthquake damages to RC structure are relatively small compared with that of the masonry-concrete and masonry-timber structures. Damages in RC structure are mainly concentrated in shear failure of walls, short-column failure, reinforcement yielding and etc. The below two pictures show the shear crack of bottom walls of an office building and collapse of exterior walls of a three-story cast-in-situ frame structure, respectively.

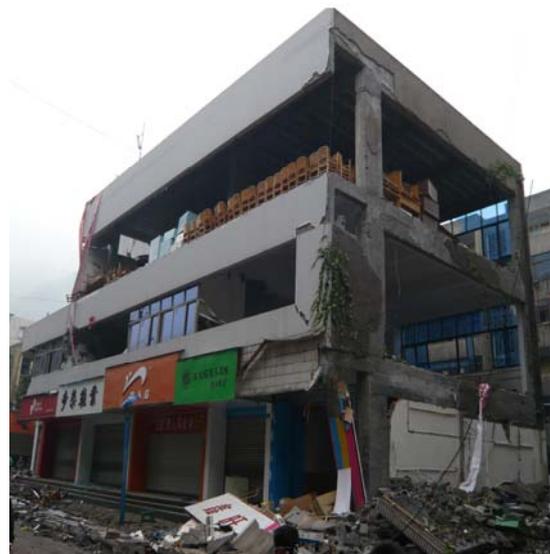
Fig. 4 Collapse of the exterior walls of a three-story cast-in-situ RC frame structure in Hanwang town, May 15, 2008

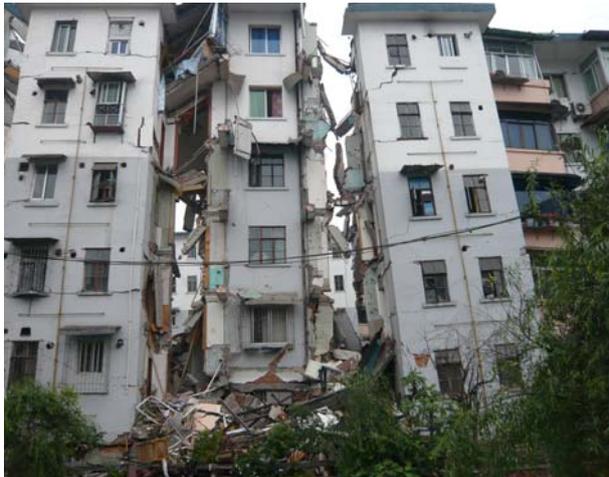
Figure 5 and Figure 6 show a severely destroyed building near the sub-surface rupture (front range fault of Lonmenshan, Dujiangyan-anxian fault) in Hanwang town. Analysis points out that the special damage may be caused by the collision of the adjacent parts of the building and by the change in horizontal stiffness of the building. Figure 7 and 8 provide the pictures of an old residential building and the nearby seismic ruins in Hanwang town, from Figure 7 we can see that the four-story building became a three-story building, and the second story disappeared. Figure 9 and 10 show the pictures of a heavily destroyed building which was one of the rather rare standing buildings in Jinhua town. The bottom-frame brick-concrete structures are often used by stores near the street. Figure 11 and 12 provide two typical damage pattern of the bottom-frame structure. Figure 11 shows the collapse of the top story of a bottom-frame building in Zundao town, and Figure 12 shows the inclination of columns of an imitation of ancient building in Jiulong town.

Fig. 5, A special destroyed building near the secondary surface rupture in Hanwang town, May 15, 2008

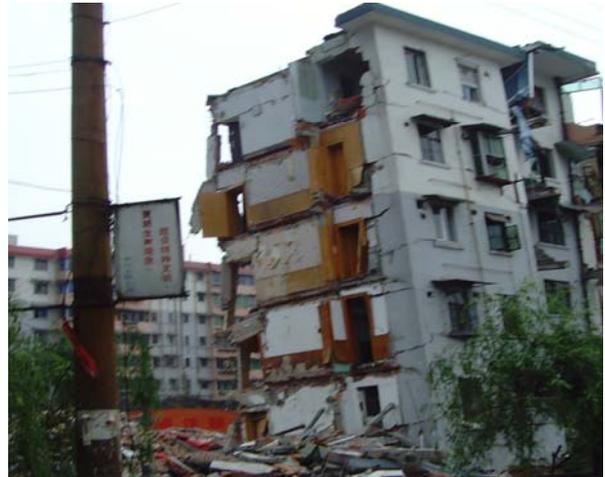
Fig. 6, Partial collapse of the former building (Fig. 5), viewed from the left side, Hanwang town, May 20, 2008 (photograph by Wang Dongming)

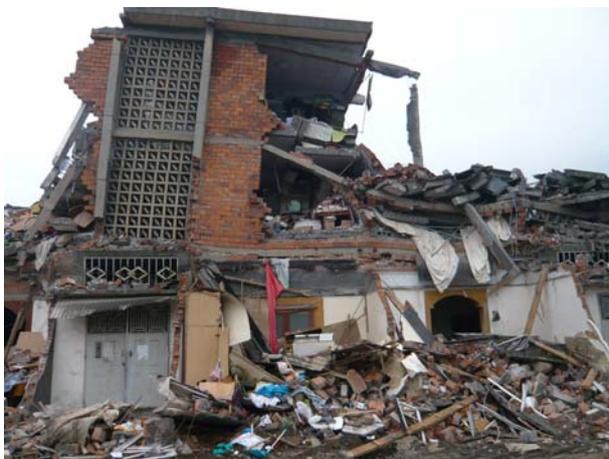
Fig. 7, Collapse of the second story of a residential building (the second story was disappeared), Hanwang town, May 15, 2008

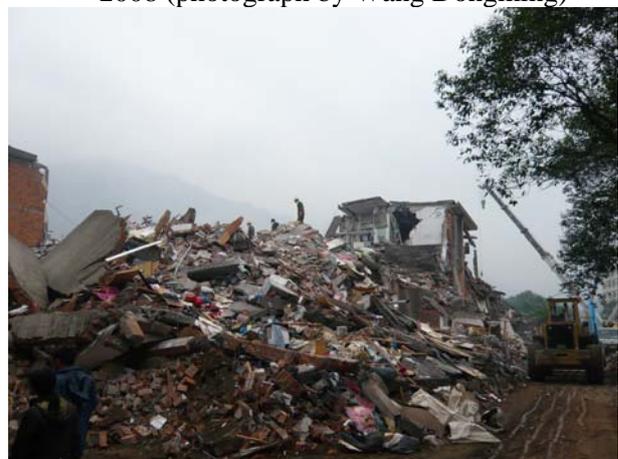
Fig. 8, Seismic ruins near the only standing part of the former building (Fig. 7), viewed from the left side, in Hanwang town, May 15, 2008

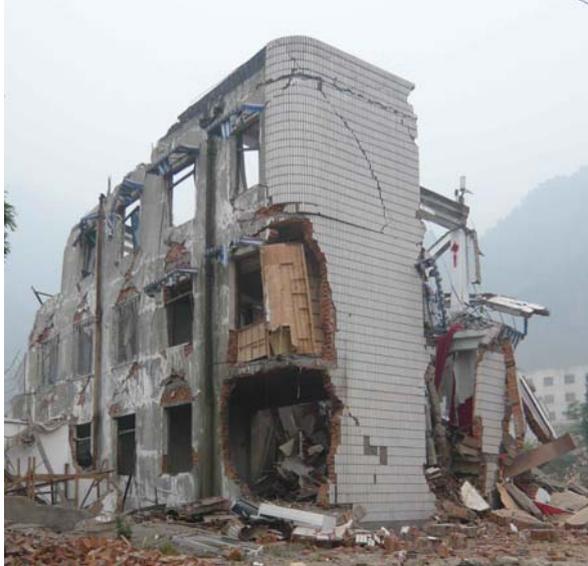
Fig. 9 A shattered building and fragments in Jinhua town, May 23, 2008

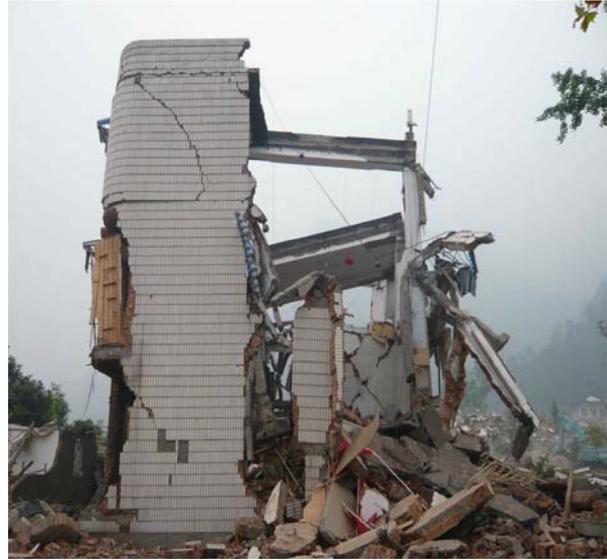
Fig. 10 The former building (Fig. 9), viewed from the right side, Jinhua town, May 23, 2008

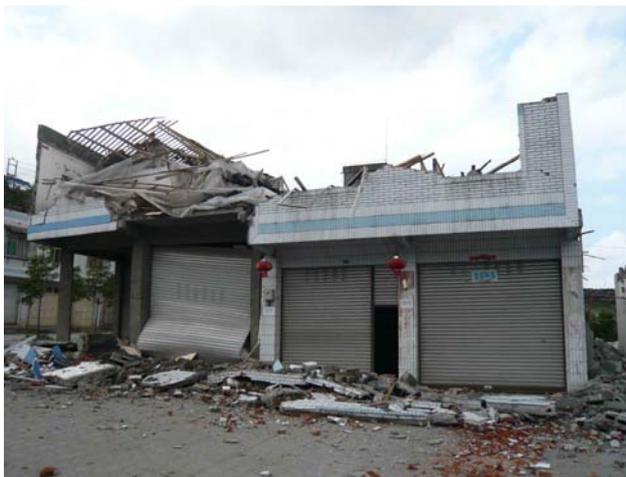
Fig. 11 Collapse of the top floor of a bottom-frame building in Zundao town, May 14, 2008

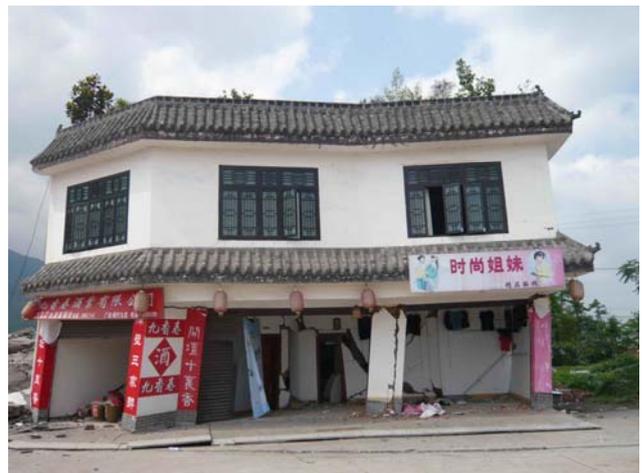
Fig. 12 Inclination of columns of an imitation of ancient building in Jiulong town, May 14, 2008

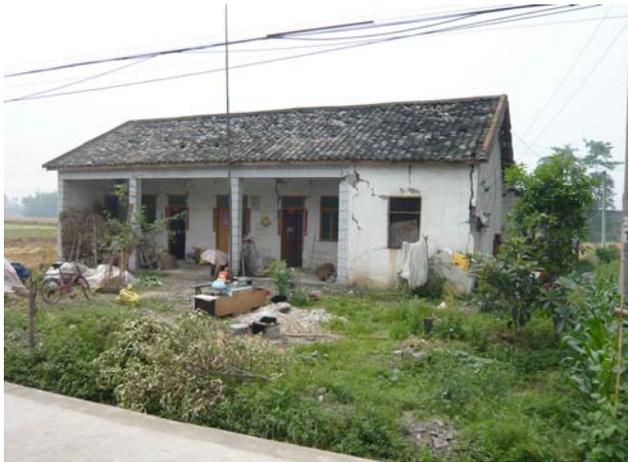
The masonry-timber structure is more vulnerable compared with the RC structure under the earthquake. During the Wenchuan earthquake, thousands of rural houses collapsed, resulting from the badly construction quality and unreasonable structure system. Figure 13 shows a moderate destroyed rural house with severe cracked walls in Mianyuan town. Figure 14 and 15 show the collapsed walls and roof of two rural houses in Zundao town. Figure 16 shows the collapse of walls and wood roof of a rural house in Guangji town as of May 14-16, 2008.

Fig. 13 A moderate destroyed rural house with severe cracked walls, Mianyuan town, May 16, 2008

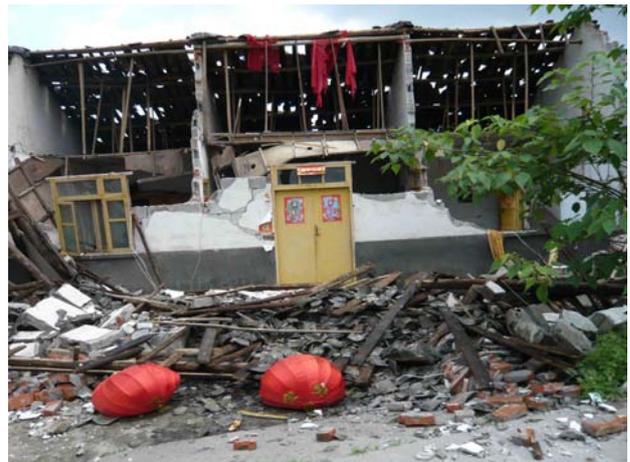
Fig. 14 Collapse of the front wall of a rural house in Zundao town, May 14, 2008

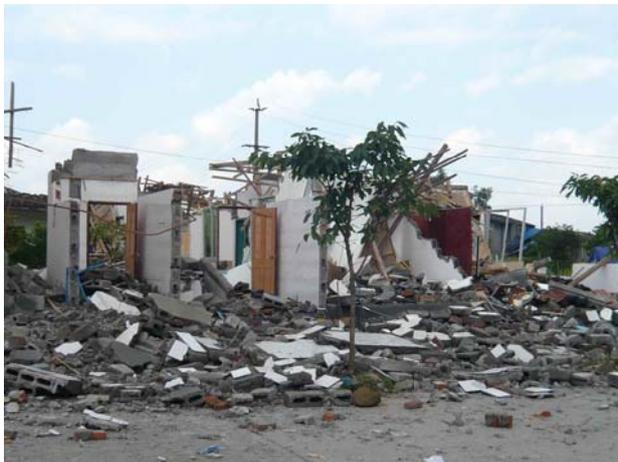
Fig. 15 Collapse of walls and roof of a rural house in Zundao town, May 14, 2008

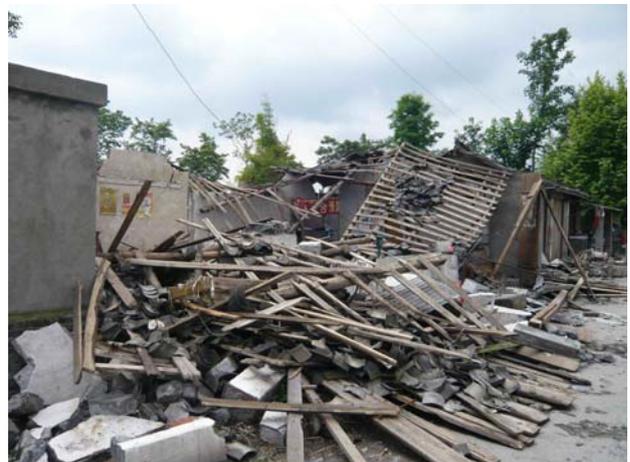
Fig. 16 Collapse of walls and wood roof of a rural house in Guangji town, May 14, 2008
