Investigation of landslide and rockfall caused by Wenchuan earthquake of Ms8.0

Zhao Jisheng, Zhou Zhenghua and Wu Jingfa

Institute of Engineering Mechanics, China Earthquake Administration

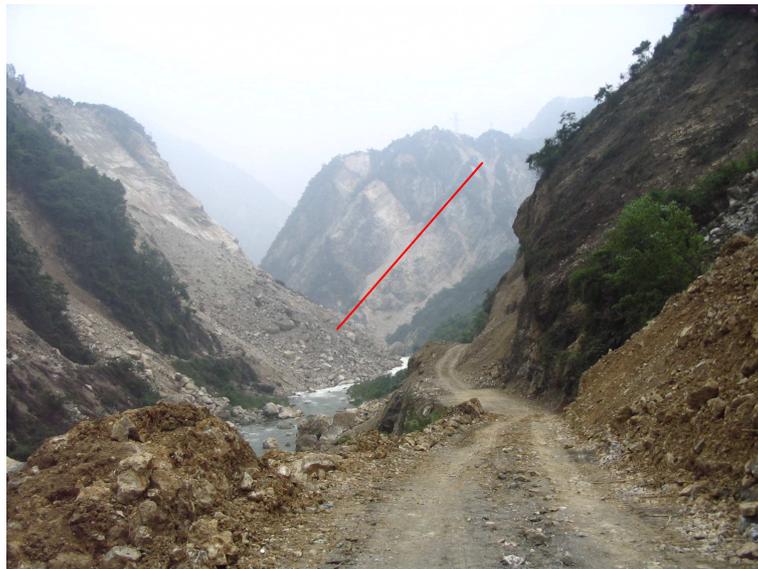
There are 7 huge scale landslides on the road about 1km from Hanwang to Qinping, where is on An-Guan fault. The middle one marked with line in photo 1 is caused by high level of strong ground motion, ground surface rupture, and weak bedding in the rock body. The site is located at $104^{\circ}10'35.8''$, $31^{\circ}28'32.5''$.

Photo 1 Landslide on the An-Guan fault ($104^{\circ}10'35.8''$, $31^{\circ}28'32.5''$), the line denotes weak bedding in the rock body

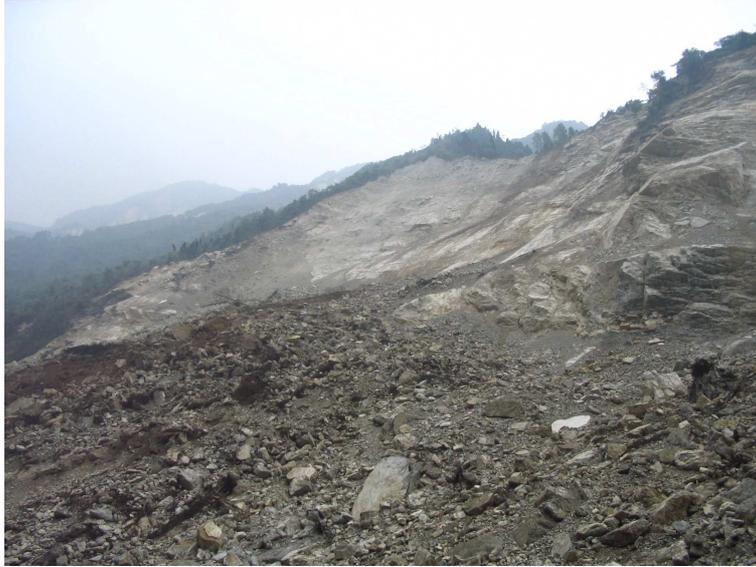
There is a landslide on the road about 1km from Hanwang to Qinping, where is on An-Guan fault. The landslide in photo 2 is caused by high level of strong ground motion, ground surface rupture, and poor bond between soil layer and rock body. The site is located at $104^{\circ}10'32.0''$, $31^{\circ}28'22.4''$.

Photo 2 Landslide on the An-Guan fault ($104^{\circ}10'32.0''$, $31^{\circ}28'22.4''$), the interface between soil layer and rock body is slippery or friction free

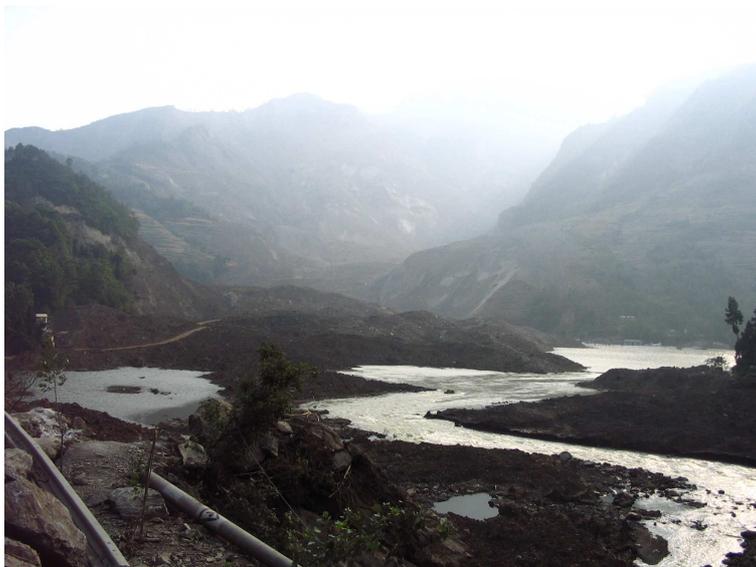
A landslide in photo 3 takes place in Qingchuan county (the phenomena also can be found in other disaster areas, such as Tangjiashan). What should be noted is this kind of 'the landslide' is not traditional one, where mountain is high and the slope is very steep and bond between soil layer and rock is poor. The soil layer and rock will be separated and soil layer will be thrown out as Cement Mortar of wall falling, and the mass of soil will block river, which mountain under strong action of horizontal acceleration.

Photo 3 Landslide on alpine gorge region ($105^{\circ}17'51.1''$, $32^{\circ}32'22.9''$), the bond between soil layer and rock body is lost, which caused by asynchrony vibration

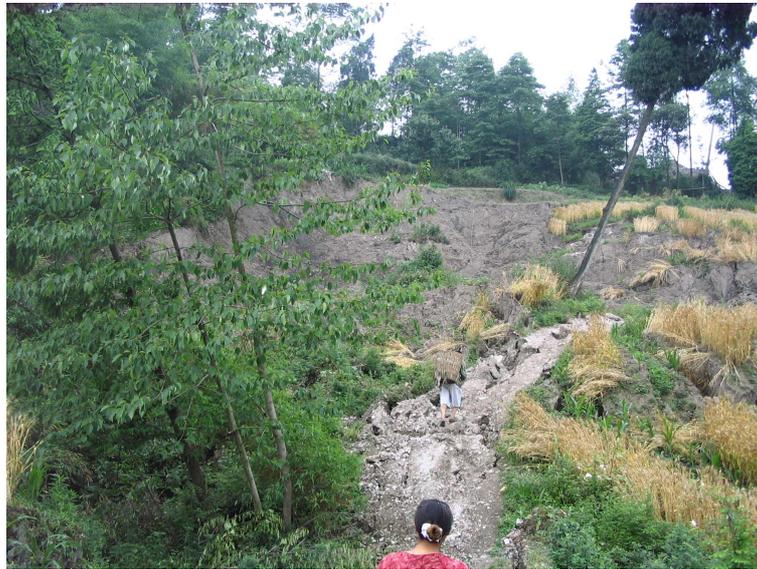
A huge landslide in photo 4 takes place at Chifeng, Shifang city, the length is about 1.5km and the height is 500-800m, and several small slides embed in the huge one, see photo 5. A small fault in photo 6 is found on the slide foot, which crosses the hill. Surely, the small fault is touched by Longmenshan fault, in despite of the displacement can not be quantitated. Adjacent hills are intact. Based on above statement, the landslide is caused by the small fault movement.

Photo 4 Landslide in Chifeng ($103^{\circ}46'58.4''$, $31^{\circ}08'18.8''$) , A small fault crosses the hill.

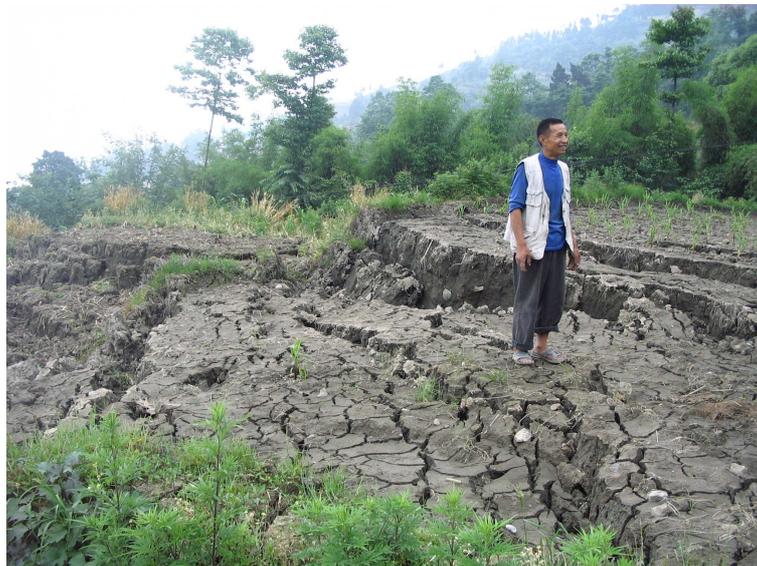
Photo 5 A small slides embed in the huge landslide

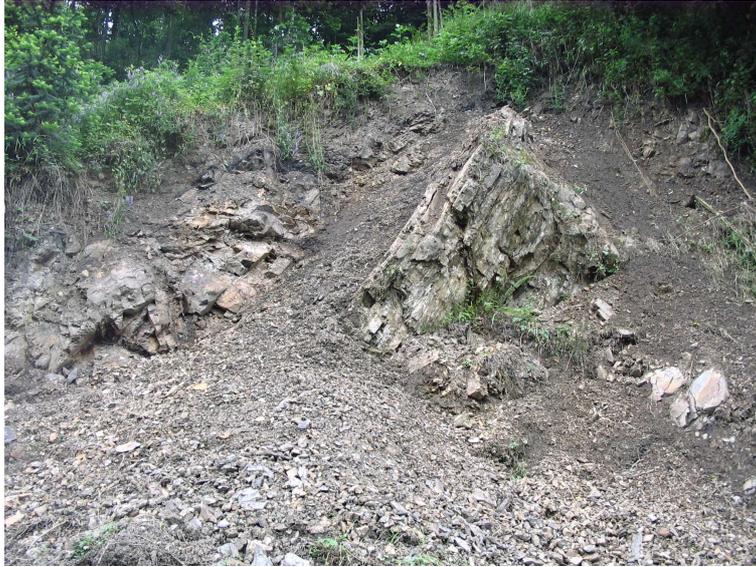
Photo 6 A small fault is touched by Longmenshan fault

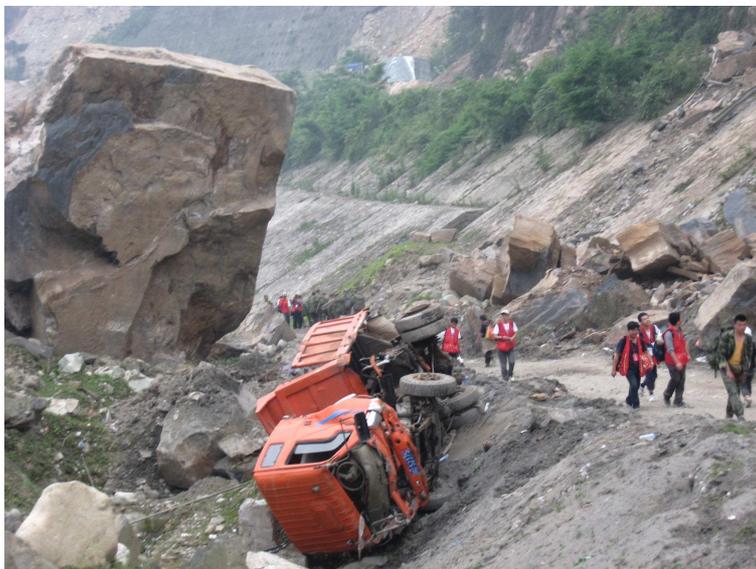
There is a cuboid rockfall on the road from Dujiangyan to Yingxiu, where locates on Longmenshan central fault. Intact rock body, stable system, was cut by joints and beddings in case of deposition and environmental weathering, and change as an unstable system. Several blocks will be separated form rock body and fall down with gravity, which unstable system under strong ground motion and surface rupture.

Photo 7 A rockfall on the road from Dujiangyan to Yingxiu

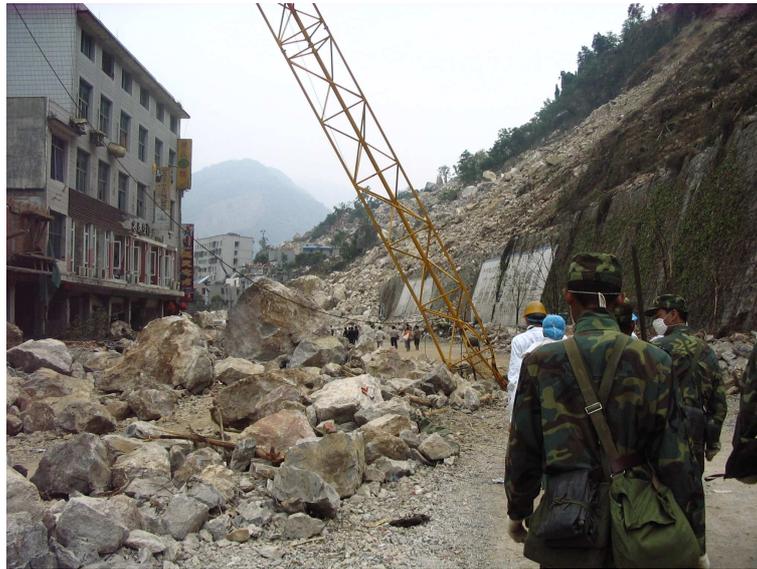
There is one of several rockfalls on the road from Renjiapin to Beichuan County(photo 8), where locates on Longmenshan central fault. The fall blocks are round or angularity blur, and joints and

beddings is full-fledged, and the interfaces of among block-block and block-soil are clear. The blocks fall down under strong ground motion and surface rupture (photo 9).

Photo 8 A rockfall on the road from Renjiapin to Beichuan County(104°27'43.2", 31°49'22.7")

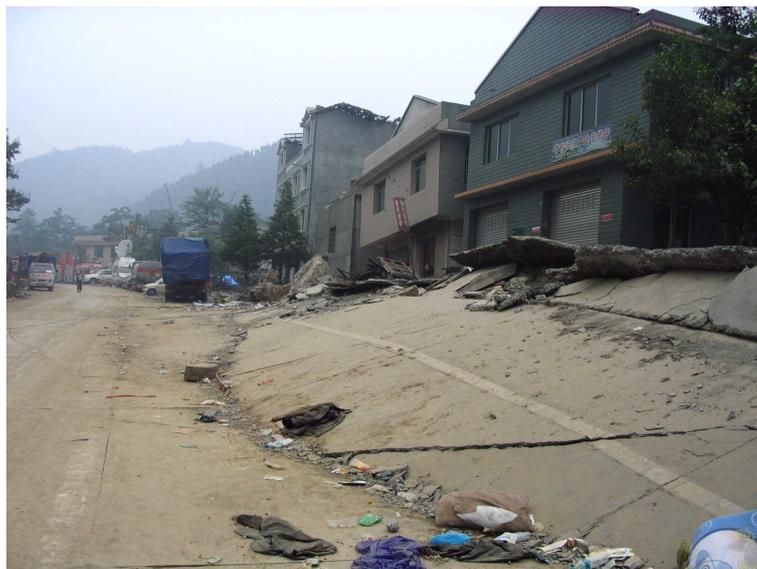
Photo 9 A piece of surface rupture at Renjiaping(104°26'50.3", 31°48'54.0"), which direction turn to Beichuan county, fault scarp is 1.7-2.5m
