EXPERIMENTAL STUDY ON THE BEHAVIOR OF CONFINED MASONRY WALLS SUBJECTED TO OUT-OF-PLANE CONCENTRATED LOADS

J. Varela-Rivera⁽¹⁾, D. Navarrete-Macias⁽²⁾, L. Fernandez-Baqueiro⁽³⁾

Abstract

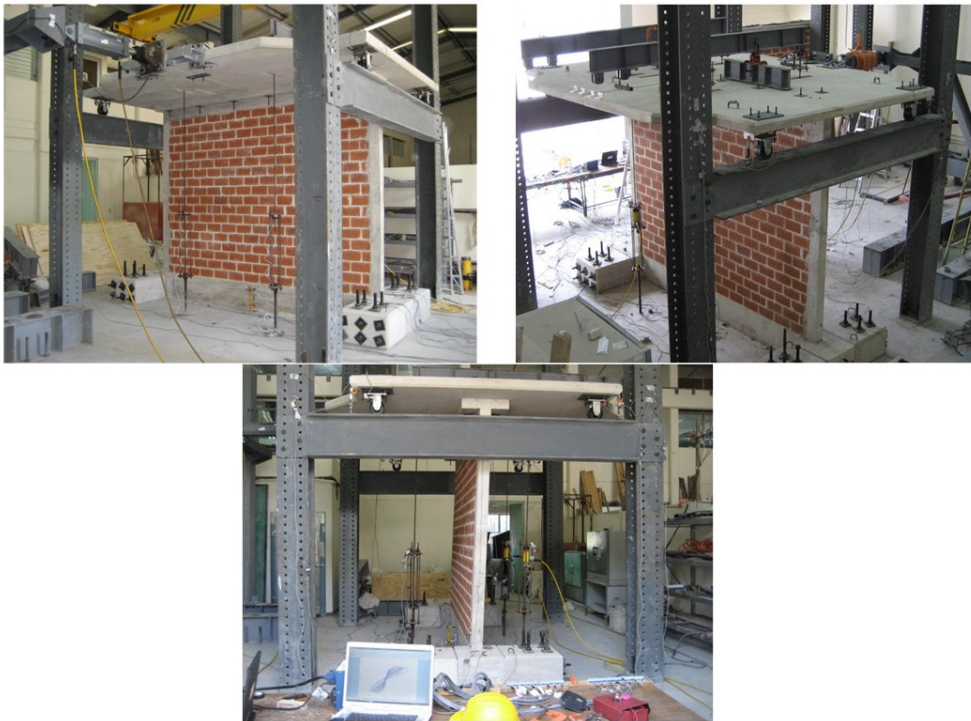
Fig. 2 – Views of wall test set up

Walls were tested using axial stresses of 0.11, 0.23 and 0.35 MPa, respectively. These stresses correspond to interior walls of 1, 2 and 3 stories high, respectively. Each wall was subjected to constant axial stress and reverse cyclic out-of-plane concentrated loads until failure. Axial stress was applied first and later the concentrated loads. The wall test setup was divided into three parts: an axial load system, a support system, and an out-of-plane load system. The axial load system was formed by two swivel beams, two simple supported spreader beams, four steel threaded bars and two hydraulic actuators with capacity of 117 kN. Axial stress was maintained constant by using a mechanical "load maintainer" [33]. The support system consisted of a reinforced concrete slab, two structural steel frames, and four steel wheels. The concrete slab was connected along the length of the wall by using steel threaded bars. Wheels were placed between the concrete slab and the structural frames. This support system allows the out-of-plane horizontal displacement and restricts the rotation at the top of the wall. Walls were attached to the laboratory strong floor by using concrete blocks and steel threaded bars.

The out-of-plane load system consisted of a reaction steel frame, a two-way hydraulic actuator and a connection steel beam. The walls, as tested, represent interior bearing walls subjected to out-of-plane seismic loads. The total length of the top slab parallel to the direction of loading was defined by the midlength of the left and right spans. Views of the wall test set up are presented in Fig. 2.

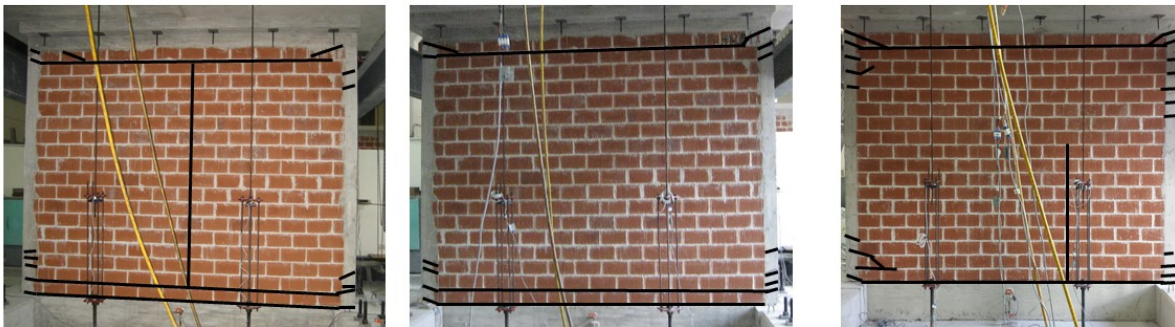
Fig. 3 – Final cracking patterns of walls

The behavior of the confined walls was in general similar. Horizontal cracks were observed first in the two bottom brick courses of the west wall face and between the two top brick courses of the east wall face, while loading to the east direction. When the load was reversed, horizontal cracks formed between the two bottom brick courses of the east wall face and between the two top brick courses of the west wall face. These horizontal cracks, initially, did not form along the entire length of the wall. Yielding of the flexural reinforcement was observed at the top and bottom ends of the vertical confining elements. Yielding was observed in both loading directions. Horizontal cracks were observed along the top and bottom parts of the vertical confining elements over a length of about 0.45 m. A vertical crack, located at the wall center, was observed for walls M1 and M3. Crushing of masonry was observed at the two top corners of the wall panel in both wall faces. Failure of walls was related to crushing of concrete at the top and bottom ends of the vertical confining elements. Testing of walls was stopped at a maximum out-of-plane top displacement of 175 mm because the hydraulic actuator ran out of stroke. The final cracking patterns of the west face of the walls are presented in Fig. 3. The out-of-plane load – drift ratio curves for the walls are presented in Fig. 4. Drift ratios reported were calculated using the out-of-plane displacements measured at top of the walls. Out-of-plane strengths were equal to 10.95, 11.22 and 14.07 kN for walls M1 to M3, respectively. Corresponding drift ratios were equal to 2.4%, 2.8% and 2.6%, respectively.

The final cracking pattern of walls was in general similar. Horizontal cracks were observed first between the two top and the bottom brick courses on both wall faces. Horizontal cracks were not formed between the top brick course and the top confining element because concrete penetrated in the brick cells during pouring. The length of these horizontal cracks was initially smaller than the wall length. Horizontal cracks were observed later at the top and bottom parts of the concrete confining elements. A vertical crack was observed for walls M1 and M3 at the end of the tests. This vertical crack was related with the relative displacement observed between the wall panel and the bottom horizontal confining element. This displacement caused an out-of-plane bending of the wall panel about the vertical direction.

The final cracking pattern of walls was in general similar. Horizontal cracks were observed first between the two top and bottom brick courses on both wall faces. Horizontal cracks were observed later at the top and bottom parts of the concrete confining elements. For walls M1 and M3, a vertical crack at the center of the wall was observed at the end of the tests.

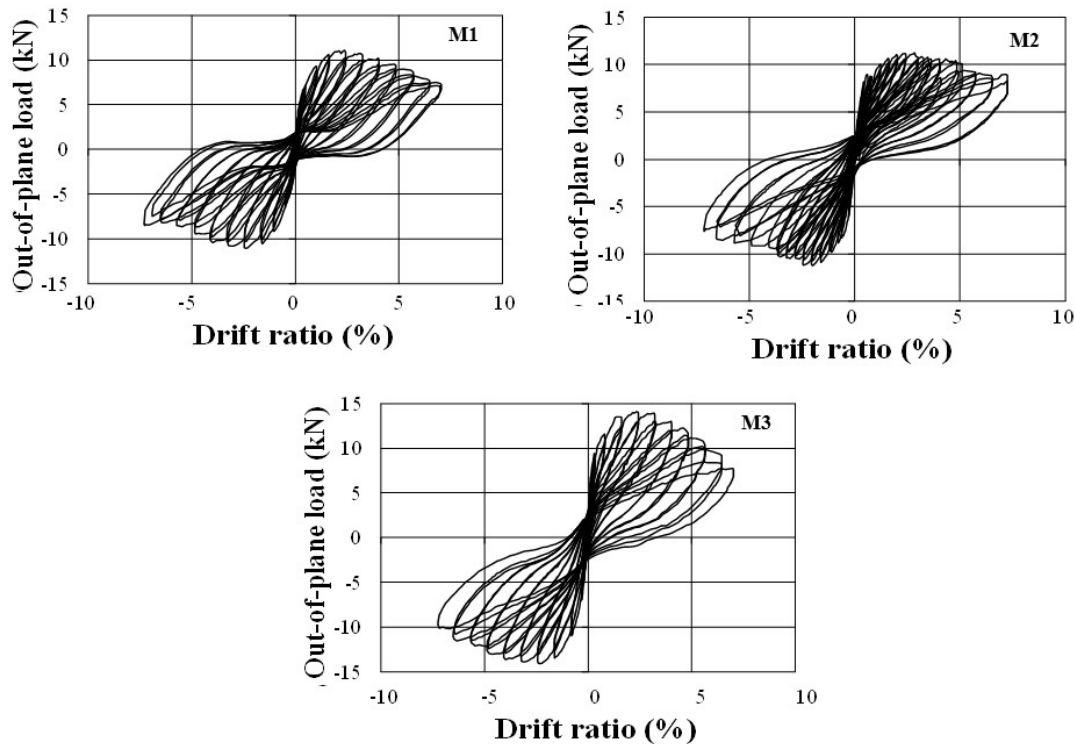
Fig. 4 – Out-of-plane load – drift ratio curves for the walls

The out-of-plane behavior of each wall was linear elastic up to the formation of the first horizontal cracks. After this, the behavior was nonlinear. This nonlinear behavior was related to the presence of new horizontal cracks in the wall panel, horizontal cracks in both vertical confining elements and the yielding of the flexural reinforcement of these elements. After the out-of-plane strength was reached, the wall strength decreased. This reduction was associated with the progressive crushing of masonry observed in the two top brick courses.

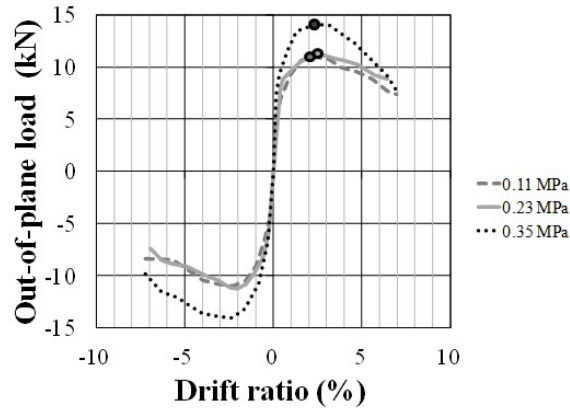
Fig. 5 – Ascending envelope curve of walls

Fig. 5 shows the ascending envelope curves of walls. In this figure, circular markers represent the out-of-plane strength of the walls. Fig. 5 shows that as the axial stress increased the out-of-plane strength increased. This was related to the additional vertical displacement restriction provided by the axial stress. The slight difference in the out-of-plane strength between walls M2 and M1 is associated with the lower axial compressive strength of concrete of wall M2 compared with M1. The ratio between the out-of-plane strength of wall M3 and M1 was 1.28.

Fig. 5 shows that the out-of-plane strength of the walls was associated with drift ratios between 2.4% and 2.8%. In-plane allowable drift ratios for confined masonry walls [32] are smaller than out-of-plane drift ratios observed in this work; therefore, out-of-plane and in-plane strengths cannot be added. The out-of-plane strength contribution must be calculated using the drift ratio associated with the in-plane strength. Even though

maximum wall drift ratios were greater than 5.0% (Fig. 5), walls did not collapsed. Vertical confining elements provided enough out-of-plane support for the walls to avoid snap through of wall segments.
