## 2015 Three-dimensional Shaking Table Test of a 10-story Reinforced Concrete Building on the E-Defense

### Part 2: Specimen Fabrication and Construction, Test Procedure, and Instrumentation Program

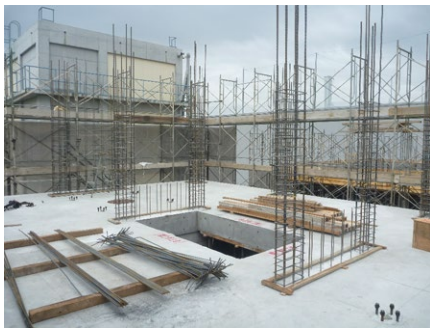
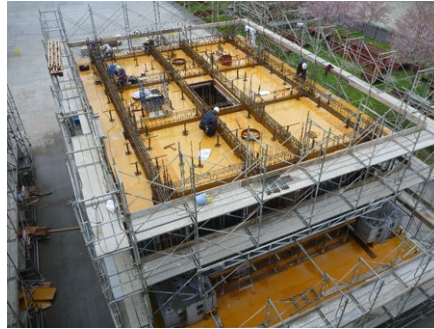
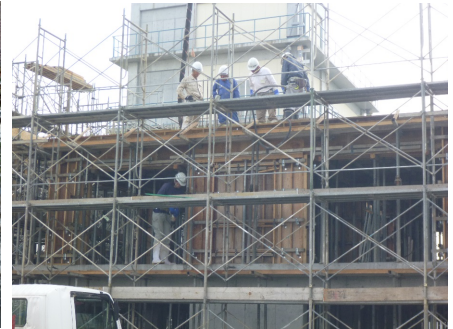
Fig. 1: Specimen construction

(a) Wall and column rebar

(b) Beam rebar

(c) Concrete placing

The concrete quality was confirmed by the air content tests, slump tests, and chloride ions densitometry. Figs. 1(a) to (c) show the placement of concrete form, rebar arrangement, and concrete placing at the site. In principle, the supervision of works for the rebar arrangement and concrete placing followed the Japanese Architectural Standard Specification for Reinforced Concrete Work JASS5 [6]. Figs. 2(a) to (c) show the cast iron bearing surface and its setting at the site. The cast iron bearing surfaces were polished to provide a smooth level surface and the peripheries of the cast iron bearings were chamfered. Studs were placed at the backside of the bearing in order to integrate it with the footing beam.

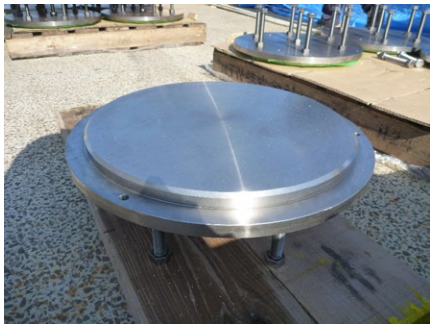
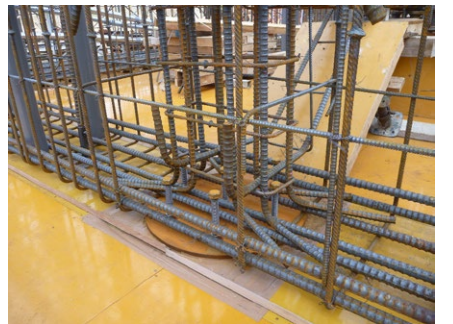
Fig. 2: Cast iron bearings

(a) Surface

(b) Setting

(c) Cast iron and footing beam rebar

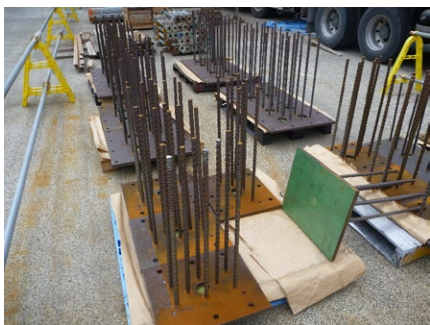
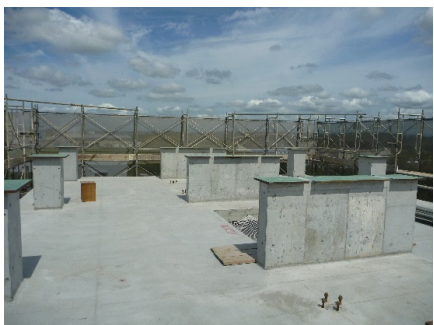
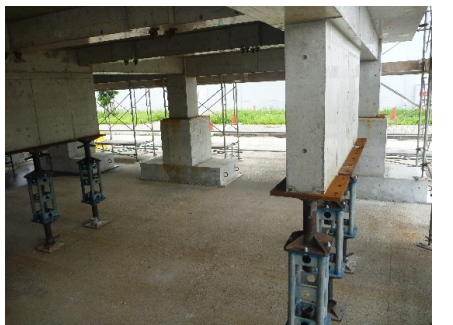
Fig. 3: Specimen joints

(a) Joint steel plates

(b) Bottom part of 6th floor

(c) Upper part of 6th floor

Because of constraints in lifting and transport of the specimen, the 10-story building specimen was fabricated in two separate parts: from the footing beam to the middle of the 6th floor (hereinafter referred to as the lower specimen) and from the middle of the 6th floor to the rooftop (hereinafter referred to as the upper specimen). The lower and upper specimens were joined at the middle section of the 6th floor columns and walls. Steel plates with 200 mm larger than cross-sectional dimensions of column and wall members were attached at the column and wall connecting surfaces of both specimens (Fig. 3,  $t = 19$  mm at walls,  $t = 25$  mm at columns), which overhang each side of the members by 100 mm.

The overhanging parts of the steel plates were provided with 28 mm-diameter holes, and the lower and upper specimens were connected by tightening a total of 184 M20 high strength bolts, thereby joining the steel plates to each other. Blasting was performed at the steel plate connecting surfaces to provide frictional force, and rebar for embedment to the reinforced concrete main frame were stud welded at the backside of the steel plates. The embedment lengths are  $L = 760$  mm at the columns and  $L = 520$  mm at the walls.

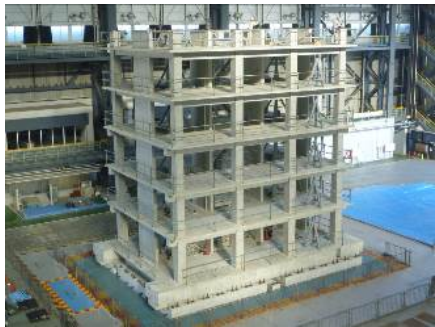
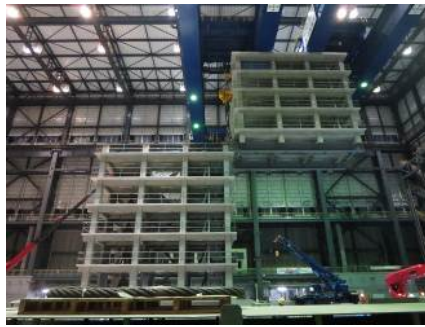
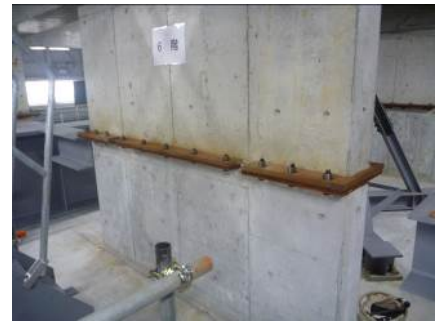
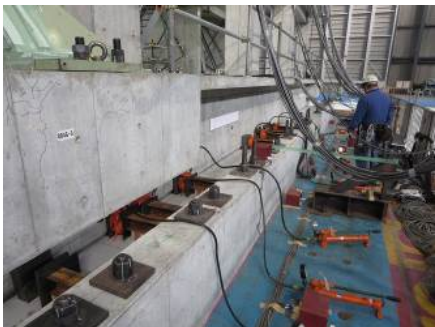
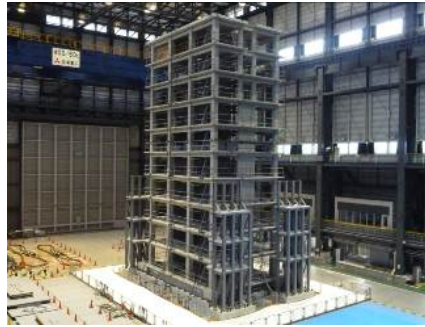
Fig. 4: Shaking test procedure

(d) (2) Lower specimen

(e) (3) Upper specimen

(f) (3) Specimen joint

(g) (5) Specimen return (h)

(6) Base fixed specimen

- (1) Bind the base concrete to the shaking table using prestressing rods.
- (2) Mount the lower specimen on top of the base concrete.
- (3) Mount the upper specimen on top of the lower specimen, and connect the specimen joint plates to each other by tightening the high-strength bolts.
- (4) Perform the excitation test on the base slip construction.
- (5) Restore the drift in specimen position due to base slip construction testing to its initial position using hydraulic jacks.
- (6) Bind the specimen foundation to the shaking table using prestressing rods and install the collapse protection frame on the specimen exterior.
- (7) Perform the excitation test on the fixed base condition.

The specimen was fabricated outdoors and photos for procedures (1), (2), (3), (5), and (6) above are shown in Fig. 4. Fig. 5 shows the base fixing condition for both the base slip and fixed base tests. For the base slip test, only the base concrete was bound to the shaking table, whereas the specimen was merely placed directly on top of the base concrete. In contrast, for the fixed base test, the specimen's footing beam was also bound to the shaking table together with the base concrete, thereby integrating the specimen foundation and shaking table into a single body.

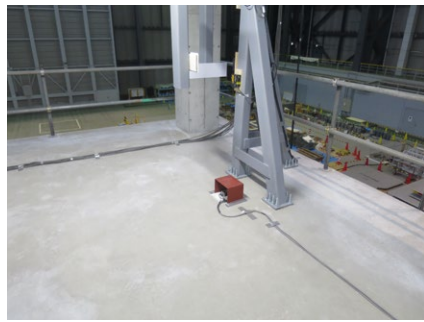
(a) Acceleration

To determine the response behavior of the specimen and its damage process, the floor acceleration and story drift at each story, deformation of members, reinforcement strains, and so on were measured. Each floor acceleration at each story was measured by triaxial accelerometers installed on the floor slab at two locations on each floor (Fig. 7(a)).

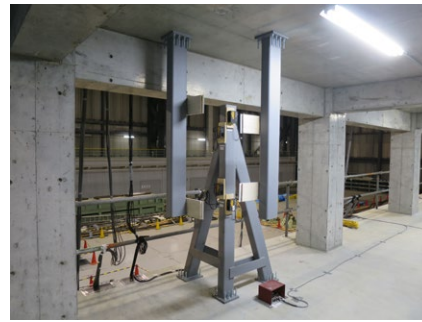
(b) Story drift angle

Inter-story drifts were measured as the relative displacement between the steel frame fixed on top of the floor slab at each floor and the rectangular steel pipe fixed to the bottom of the upper floor slab (Fig. 7(b)). Base slip displacements were measured by laser displacement sensors installed on top of the base concrete bound to the shaking table and in the steel frame bound directly to the shaking table. Displacement sensors for measuring base slip were installed at two locations on each of the four sides of the specimen's outer circumference, for a total of eight locations.

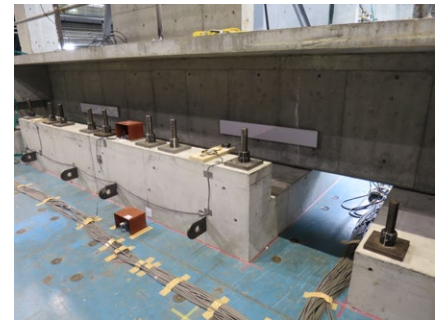
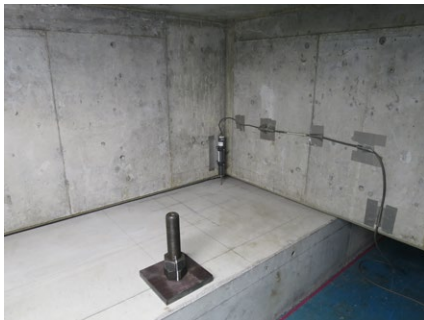
(c) Base slip

(d) Base liftup

In addition, displacement sensors were installed at 10 locations on the sides of the footing beam to measure base uplift as well (Figs. 7(c) and (d)). Bending and shear deformations were measured at shear walls on lower floors, where deformations are expected to become large (Fig. 7(e)). Furthermore, shear deformations on cross-shaped beam-column joints were also measured from the lower through middle floor levels, where the margin of shear strength is relatively small (Fig. 7(f)). As a result, there were 654 measurement points. The data sampling frequency was 1,000 Hz. In addition, videos were taken at 52 locations to record the overall behavior of the specimen and the damage process at members, beam-column joints, and other areas.

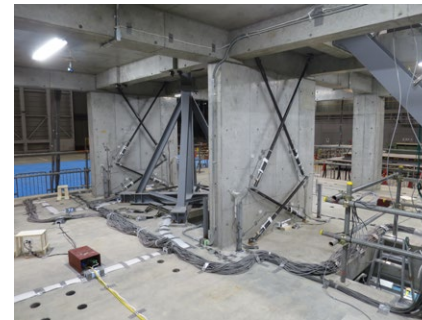
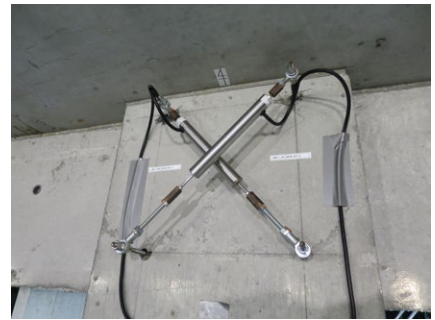
Fig. 7: Instrumentation

(e) Wall deformation

(f) Beam-column joint deformation
