## SEISMIC RETROFIT OF B'NAI ZION HOSPITAL USING AN INNOVATIVE DAMPED ROCKING-MASS SYSTEM

This paper presents the seismic retrofit design of the first major hospital to be retrofitted in Israel. This is the first out of four projects initiated and supported by the Israeli Ministry of Health, in accordance with a decision made by the Government of the State of Israel in 2010 to retrofit thousands of public buildings, assigning a \$1,000,000,000 budget over a time period of 25 years.

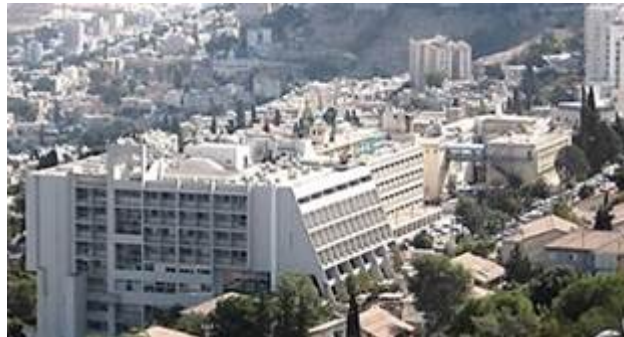
Fig. 1 – Hospital compound aerial overview

The hospital, built on a slope of Mount Carmel (see Fig. 1), is considered to be located in a seismically active area, being only a few kilometers away from the Yagur fault. The Central Building is a seven-story tall rectangular structure, enclosing nearly 9,000 m<sup>2</sup> of built space. The main structural elements are "Debesh" walls made of low strength concrete characterized by a small amounts of cement paste, almost no steel reinforcement and impurities such as seashells. This brittle concrete was a popular construction material in past decades and can be found in many Israeli structures (Fig. 3). The structural system includes a concrete elevator and stair shafts, walls, columns and ribbed slabs, all supported on a shallow foundation.

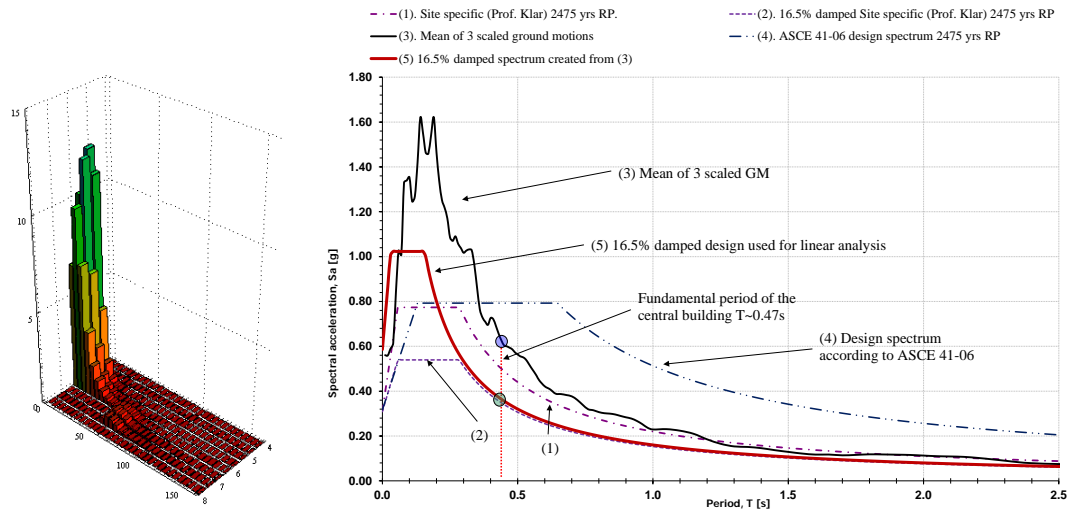
Fig. 2 - Disaggregation results obtained from site-specific survey for a period of 0.5s (left) and design spectra comparison (right) [1].

The earthquakes generated at two main faults contribute most significantly to the seismic hazard of design: a weaker M5.8 near fault (0-10km) ground motion generated by the adjacent Yagur fault and a stronger M7.5 motion produced by the African-Syrian fault located further away at a distance of 60-100 km. The disaggregation plot showed in Fig. 2 clearly shows that the nearby sources, up to 20 km are dominant and therefore govern for design.

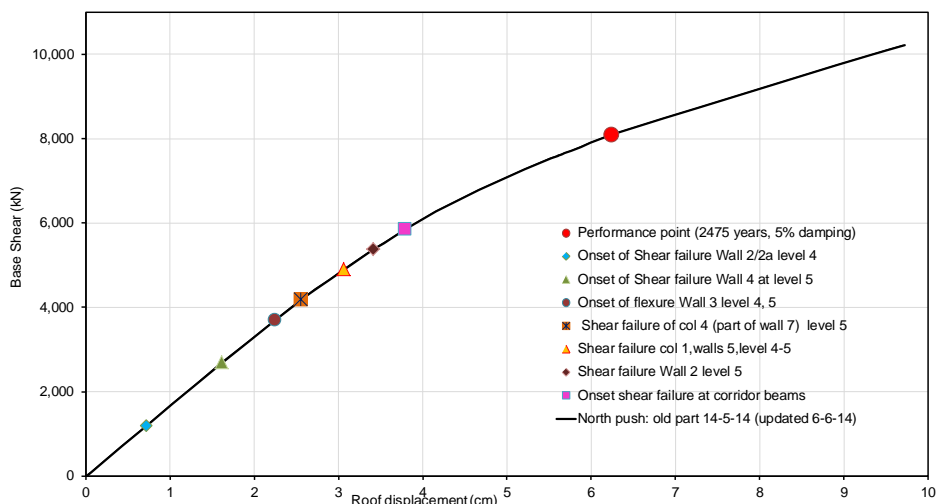
Fig. 4 – Pushover curves for the transverse direction of the existing central building structure showing the failure mechanism prior to the performance point (6.2cm).

Results from the pushover analyses performed using two dimensional models indicate that major yielding in important structural elements, mainly walls, is reached prior to the expected design performance point. Therefore, as shown in Fig. 4 the structure does not satisfy the target design criteria of immediate occupancy in a strong event.

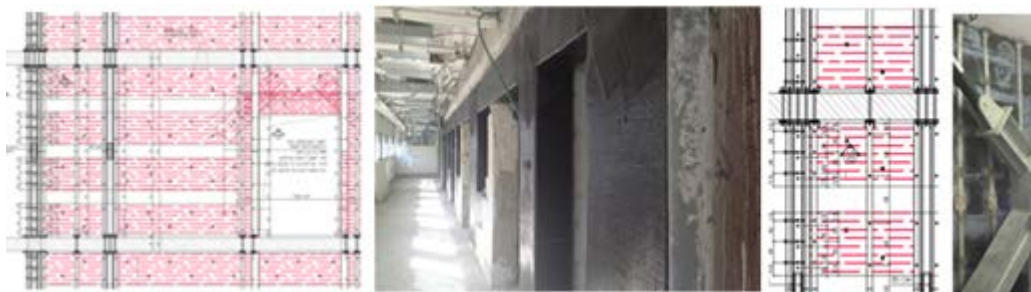
Fig. 13 - FRP and steel plate concrete wall strengthening and its implementation on site

The failure mechanism of the existing Debesh concrete walls is shear-controlled, mainly due to the lack to transverse reinforcement in the elements. This virtually inexistent steel cause non-ductile behavior after cracking is initiated, leading to a dangerous, sudden drop in stiffness and strength of the concrete walls. In order to avoid this undesired phenomenon, the strength and ductility of the existing concrete walls was enhanced using externally bonded fiber carbon reinforced sheets, FRP and postensioned thin steel plates. The FRP sheets increased the confinement of the element and increased its shear strength, thus resulting in a ductile response. The inclusion of longitudinal postensioned steel plates increased the flexural capacity of the concrete walls. Fig. 13 shows images of design and site implementation.
