## PRELIMINARY RESULTS OF EXPERIMENTAL INVESTIGATION AND MODELLING OF STRENGTHENED BARRELL VAULTS

*Keywords: Masonry vaults, Seismic performance, Shaking table test, Strengthening, Textile Reinforced Mortar*

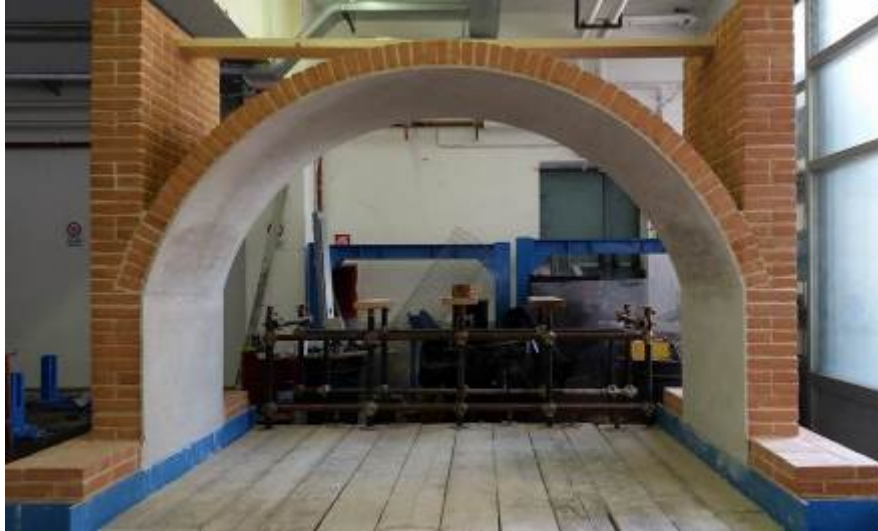
The specimen is a full scale masonry vault that has the following characteristics. The masonry material is made of solid facing clay bricks ( $25 \times 5.5 \times 12$ ) cm<sup>3</sup> and pozzolanic mortar joints, 1 cm thick. The geometry of the specimen is representative of a masonry vaulted roof commonly found in historical religious buildings (i.e. without any filling). The geometry of the vault is characterised by a segmental arch profile which is less than a semicircle. Span and rise of the masonry vault are 298 cm and 114 cm, respectively. The depth of the specimen is different for the base and arch elements, which are 220 cm and 116 cm, respectively (Fig. 1).

The curved element is built over two masonry walls. By means of these panels the vault's imposts are at a height of 114 cm with respect to the bases (Fig. 1). Moreover the masonry lateral walls have been raised up to 234 cm height.

Figure 1 - Geometrical characteristics of the tested unreinforced specimen (dimensions in cm)

The global geometric characteristics of the strengthened vault compared to the unreinforced specimen are similar.

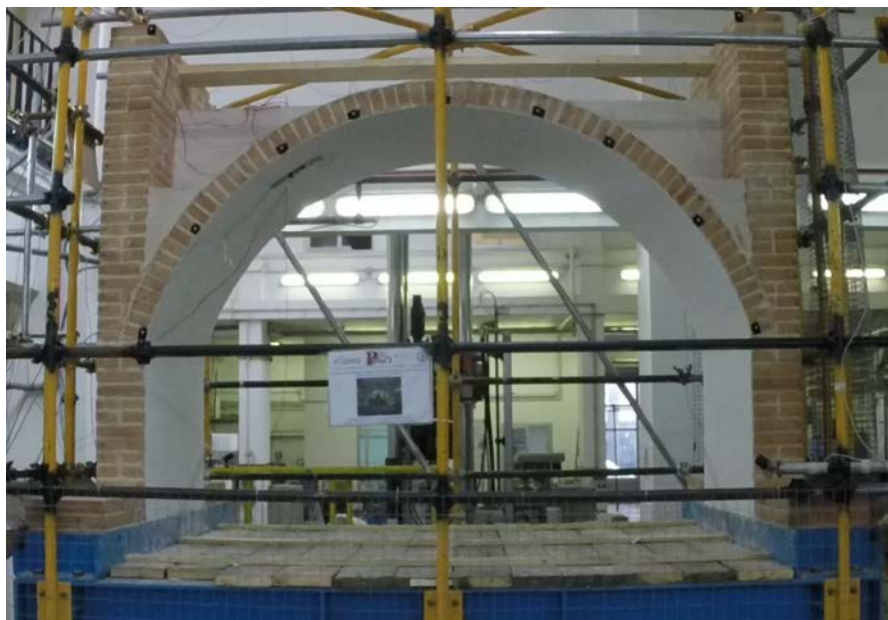
The specimen, failed after first test phase, has been partially rebuilt with same material and workmanship; hence it can be assumed that vault recovered the undamaged condition. The strengthening technique is based on Textile Reinforced Mortar (TRM) coupled with traditional techniques to improve the seismic performance of the masonry curved elements. The strengthening involves different innovative and traditional techniques merged together in a system. Indeed, this strengthening system has been applied at the extrados of the curved element. The TRM was made by a first mortar layer 0.5 cm thick applied to the masonry substrate (extrados of the curved element). Over the mortar layer an alkali-resistant primed fibre grid has been placed. Finally, a second mortar layer, entirely covering the basalt grid was built. The installation of the grid has been performed according to the manufacturer and covering the entire depth of the arch element.

A masonry rib was built over the extrados, in the middle of the curved element. The masonry was made of clay hollow bricks ( $25 \times 25 \times 25$ ) cm<sup>3</sup> and pozzolana-based mortar joints with a thickness of 1 cm. Finally, an innovative stainless steel tie was built over the masonry rib. This last strengthening system was made of unidirectional steel fibres generally characterized by very low prestress. The steel tie is located at a height approximately corresponding to the crown of the masonry vault. The steel tie crossed the walls through a removed brick and it was perfectly bonded to the lateral masonry abutments by means of two lateral steel devices. Each end of the tie element was constrained by using two coupled steel angles. In order to avoid a detachment between the masonry rib and the extrados of the vault, an additional TRM layer has been applied over the rib. Then, the strengthened specimen has been tested again by means of a new set of seismic signals.

Figure 2 - Geometrical characteristics of the tested strengthened specimen (dimensions in cm)
