AMBIENT VIBRATION ANALYSIS OF HERITAGE UNREINFORCED MASONRY BUILDINGS IN BANGLADESH

Abstract

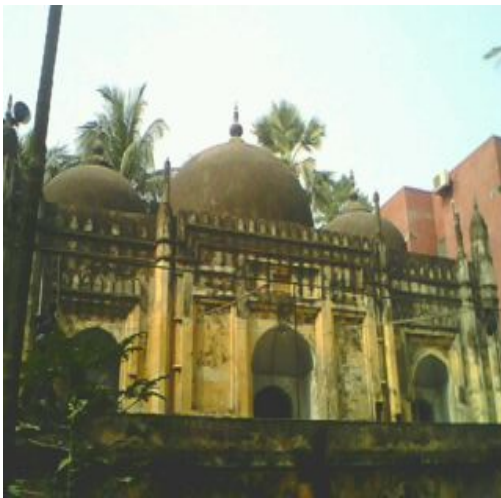
Figure 2: Musa Khan Mosque

This mosque is located at Curzon hall in Dhaka University at latitude $23^{\circ}43'38.5''N$ and longitude $90^{\circ}24'06.9''E$. The Musa Khan mosque (Figure 2) belongs to oblong shaped plan measuring 15.17 m by 7.54 m externally with a 1.52 m thick surrounding brick wall. The prayer hall is entered from the eastern side by three archways and the other two side walls have one pointed-arch openings each. To articulate the main mihrab niche from outside, the kibla wall is projected in the centre towards the west. The whole length of the rectangular hall is divided into three unequal bays by means of two 1.06 m wide arches springing from the east and west walls. The side bays are rectangular in shape and smaller in width, but the central one is bigger and square. With the help of brick pendentives the square central bay is transformed into an octagonal area. By introducing a series of sequences the octagonal area is transformed into a circular supporting area, upon which the dome supports. The two smaller rectangular side bays are converted into square supporting areas for the dome by using two half domed vault springing from the eastern and western walls. Plan and front elevation of the mosque are shown in Figure 3 and Figure 4 respectively.

The predominant frequency of the building of the Curzon Hall Musa Khan Mosque has found 3.6 Hz which is different from the predominant frequency of the site soil (1.8 Hz). So there's no possibility of soil structure interaction during any severe earthquake. It is also similar in case of the Aambour Shah Shahi Mosque. But the predominant frequency of building of the Old Academic Building of BUET is in the range of the peak frequency of the soil. This value is close to the range of the higher modes of vibration for the buildings measured as shown in the figure 16 and figure 17. This raises the possibility of soil-structure interaction.

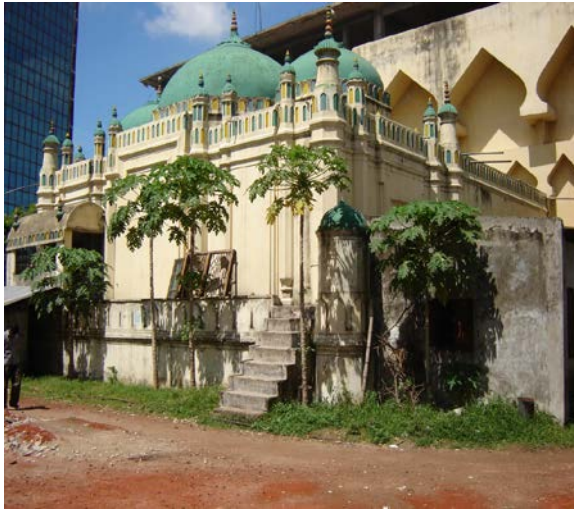
Figure 5: Aambour Shah Shahi Mosque

One of the most well preserved mosque complex of Dhaka city belonging to the 17th century is the Aambour Shah Shahi Mosque (Figure 5). It is located at Karwrnan bazaar in Dhaka City at latitude $23^{\circ}45'11.6''N$ and longitude $90^{\circ}23'35.0''E$. The mosque proper has the usual oblong shaped plan measuring 13.41m by 7.30m externally with a 1.2m thick along east-west direction and 1.6m thick along north-south direction brick wall. The prayer hall is entered from the eastern side by three archways and the other two side walls have also one arch opening each. Corresponding to the three frontal openings, the kibla wall is niched with three mihrabs. The rectangular shaped prayer room is divided into three square bays by two wide transverse corbelled cusped arches supported by twin brick pilasters embedded in the east and west walls. With the help of half domed squinch at each corner, each square area is transformed into a circular supporting area, upon which the dome supports. All the three domes, with a very low shouldered dome on a cylindrical drum, are crowned with lotus and kalasa

final. The central one is slightly higher than the flanking ones. Plan and front elevation of the mosque are shown in Figure 6 and Figure 7 respectively.

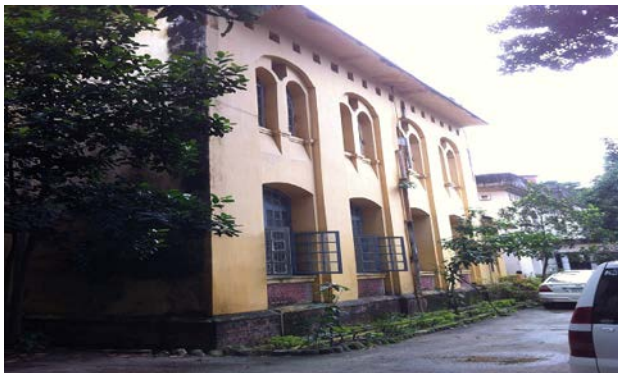
Figure 8: Old Academic Building of BUET

The Old Academic Building of Bangladesh University of Engineering and Technology (BUET) at latitude 23°43'39.0"N and longitude 90°23'34.2"E was built on the early 1900's (Figure 8). Some parts of the building is two stories and some parts is three storied. The OAB building has a mixed used of office cum academic. The OAB's proper has plan measuring 70.5m by 48m externally with a 1.1m thick brick wall every direction. It is Unreinforced Masonry Bearing Walls with Stiff Diaphragms (Building Type 15 according to ASCE/SEI 31-03)^[13]. First floor (2nd story) is slab supported on masonry wall, Ground floor (1st story) is slab on grade. It is mainly unreinforced burnt clay brick masonry with lime mortar. Plan of the OAB is shown in Figure 9.

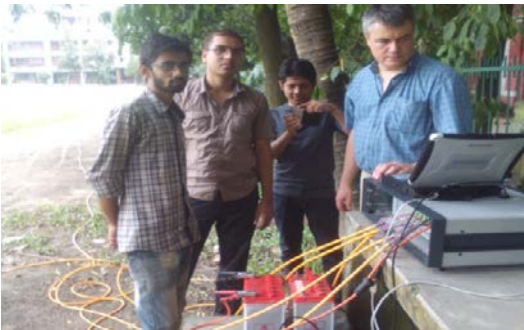
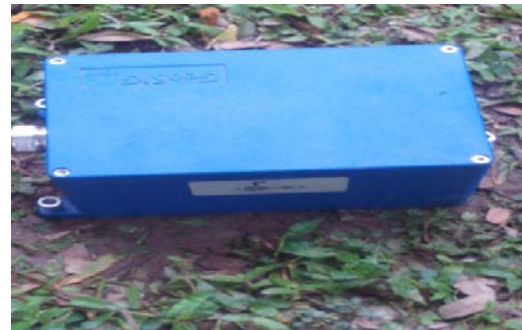
Figure 10: Microtremor Equipment

The equipment used for the microtremor testing system consists of five velocity transducers; two horizontal and one vertical, an amplifier and a laptop computer used for data acquisition. For the selection of the test location, care is taken to avoid heavy traffic, manholes, foundation sand other underground structures. The sensors are placed so that the two horizontal sensors are orthogonal, preferably facing North and East. The analysis is carried out using Nakamura's method, plotting the H/V spectral ratios that are the result of taking the RMS of the east and North spectral ratios. The most significant peak of the H/V spectral ratio is taken to be the dominant frequency of the site.

Methods to get geophysical information from the microtremor measurement were 1) obtaining the phase velocity by array observation of microtremor and 2) obtaining H/V spectrum by using 3 component sensors. After obtaining the phase velocity or H/V spectrum, S-wave velocity profiles should be interpreted by applying an inverse analysis. All 5 sensors were placed in a single row with the distance of 15m and 30 min data was taken.

Soil characteristics can be assessed by Microtremor measurement. Hard soil gives high frequency and soft soil gives low frequency. A structure may experience a vibration period at which it oscillates in the earthquake vibration motion and will tend to respond that. Natural frequency is obtained based on the spectral ratio of horizontal component of the structure to that of ground. Wave propagation mechanism of Microtremor and its relation with ground vibration characteristics were studied from the beginning of Microtremor studies^[11]. Figure 10 shows the microtremor testing equipment.

Equipment arrangement

Microtremor Sensor

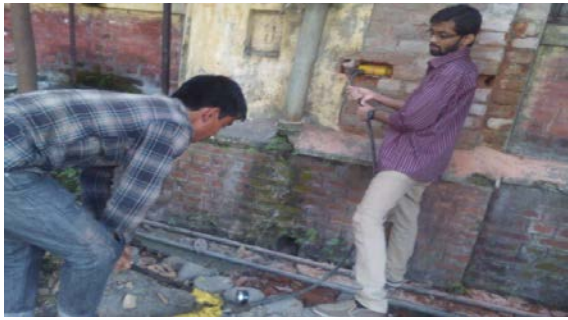
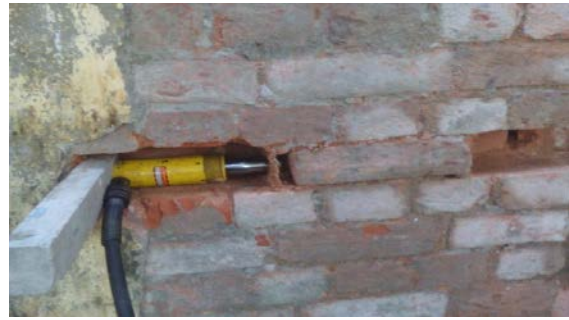
Figure 11: Direct Shear Test

The direct shear test to measure the shear stress due of mortar bond of Old Academic Building of BUET has been performed by using Hi-Force Hydraulic Jack. Figure 11 shows the testing activity of direct shear test.

A calculation on direct shear test of lime mortar as bonding material of Old Academic building has been made. The calculation is given below-

Direct Shear Test of Old Academic Building of BUET	
Jack diameter	35 mm
Area	962.12 mm ²
Brick Size	254 mm (Length); 114.3 mm (Width)
Contact Area	77419.2 mm ²
Dial Gauge Reading	650(Kg/cm ²); 89846.22 (N)
Shear Strength of the Sample, τ	1.161 N/mm ²
Nos. of bricks above testing brick	100 Nos.
Height of wall above testing brick	9.15 m
Unit weight of wall	19 KN/m ³

Vertical Pre-stress on testing brick, σ	173.85 KN/mm ²
$\sigma^* \mu$	0.174 N/mm ²
Shear Stress due to mortar bond only	$\tau - \sigma^* \mu = 0.987$ N/mm ²

The direct shear test was done to find the mortar strength. From the analysis the shear stress due to mortar bond only was found about 0.987 N/mm² which is below the standard value. The direct shear test result suggested that as the mortar bond was not strong enough, the OAB building will be unable to resist lateral forces due to an strong earthquake. A detailed assessment has been done by following the guidelines of Arya (1986)^[18]. Retrofitting of the masonry wall is mandatory. Currently, the OAB is being retrofitted.

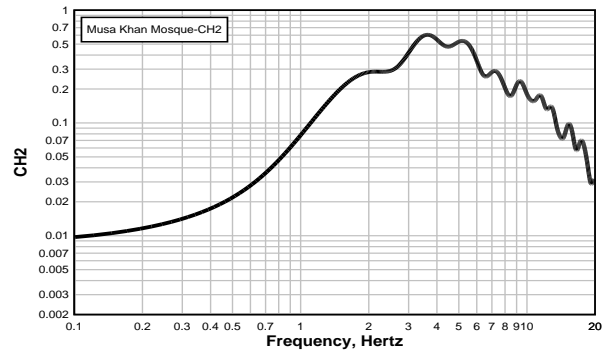
Figure 12: The corresponding FFT of recorded time series of the Curzon Hall Musa Khan Mosque

The intention of the tests described in this research was to provide some preliminary information about the dynamic behavior. The Microtremor analysis of Curzon Hall Musa Khan Mosque has been illustrated as below in figure 12 and figure 13.

Test points	Predominant Frequency of Soil (HVR)	Structural Predominant Frequency	Remarks
Curzon Hall Musa Khan Mosque	1.8 Hz	3.6 Hz	Possibility of no seismic resonance
Aambour Shah Shahi Mosque	1.2 Hz	2.6 Hz	Possibility of no seismic resonance
Old Academic Building of BUET	1.6 Hz	1.9 Hz	Possibility of seismic resonance
