STUDY ON MORTAR FINISHING EXTERNAL WALL WITH VENTILATION SPACE FOR SEISMIC RETROFITTING

Abstract

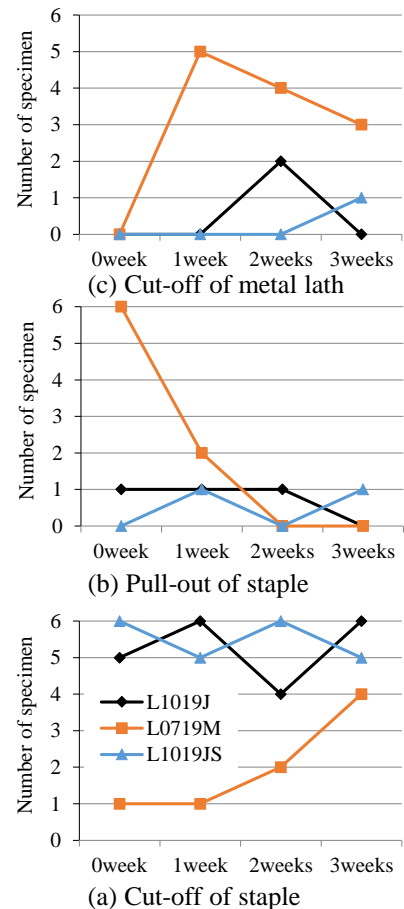
Fig. 5 - Number of specimen corresponding to each failure mode

Typical relationships between shear force and displacement were shown in Fig. 4. Due to the repeated displacement, it is found that stiffness declined and cut-off or pull-out of the staple occurred. The failure mode of No.1 and No.3 is cut-off of staple while the one of No.2 is pull-out of a staple when there is no degradation. After degradation, the failure mode of No.2 transfers to cut-off of metal lath and cut-off of staple because the pull-out strength of staple increased due to appearance of rust on staple. Pic. 3 shows these failure modes. Fig. 5 shows the number of specimens corresponding to each failure mode.

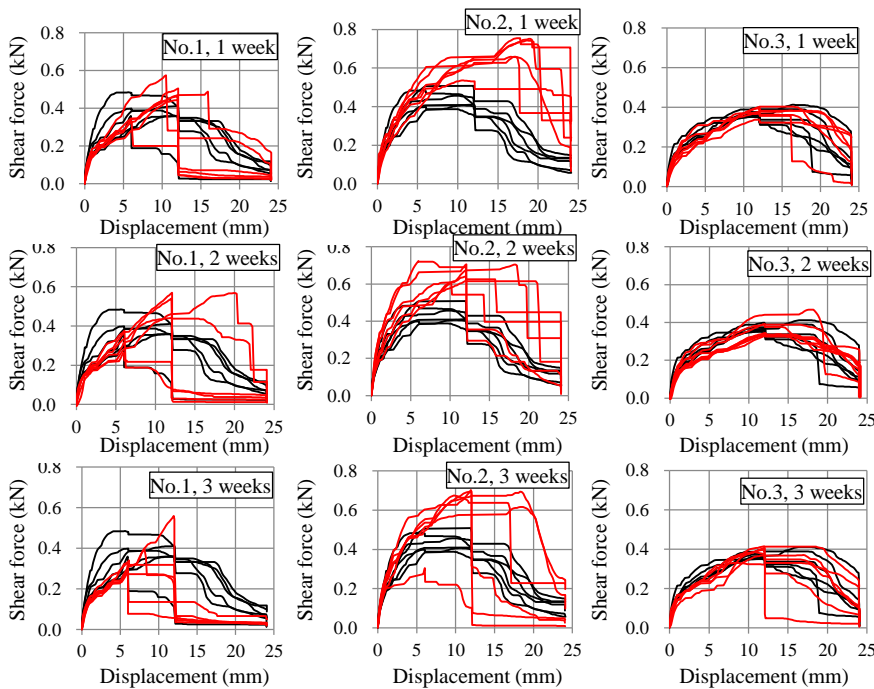
Fig. 6 - Shear force-displacement relationship of staple
(Red line: After degradation, black line: Before degradation)

Fig. 6 shows skeleton curves of all specimens. It is found that degradation decreases ultimate displacement on No.1 and increases the maximum shear force on No.2 while no change was detected on No.3. From the result of No.3 specimens, it was confirmed that there is no degradation on stainless even under high temperature and high humidity atmosphere. Moreover, it was also confirmed that even once wood absorbs water under high humidity atmosphere, the mechanical characteristic recovers after drying.

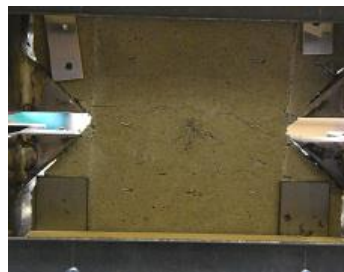
Pic 6 - Crack at 1.5mm of displacement

When the tensile load was applied on the vertical direction, lateral crack appeared on the front and back surfaces at 0.2mm as shown in Pic. 5. When the displacement was less than 1mm, the displacement was restored to approximately zero after unloading. Residual deformation remained over 1mm as shown in Pic. 6. The reason is considered that the glass fiber net yields around at 1mm. Pic. 7 shows tension test of glass fiber net only. Fig. 9 shows relationship between the tensile force and displacement of the glass fiber net. It is found that the tensile force declined over around 1mm. Finally, width of the crack was expanded as shown in Pic. 8. Tensile force-displacement relationship is shown in Fig. 10. Effect of glass fiber net on tensile force was relatively large. To examine the tensile force carried by glass fiber net, glass fiber net was cut before the test on some specimens. In the case of vertical direction of No.1 specimen, maximum tensile forces were approximately 2.5kN with net. When the net was cut before the test, maximum force was about 1kN. It is found that metal lath carries 1kN and the net carries 1.5kN. There was not any remarkable difference between types of metal lath on maximum force. However, as for No.2, the initial force where the displacement begins to increase is higher than other types of specimen. The reason is considered that the weight of the metal lath used in No.2 specimens is 1.5 times compared to the one of No.1.

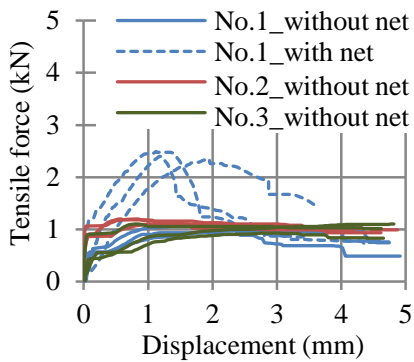
Fig. 10 - Tensile force-displacement relationship on vertical direction

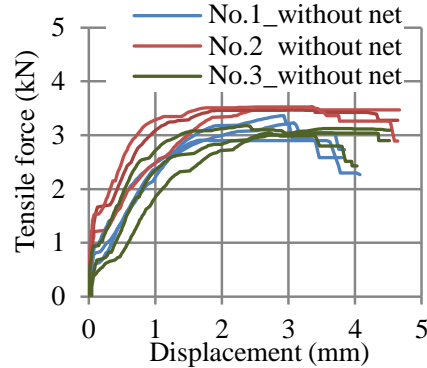
Fig. 11 - Tensile force-displacement relationship on lateral direction

For lateral direction, tests were conducted using the specimen with cut glass fiber net. The failure mode of the specimen with a glass fiber net was shear failure at the notch instead of tensile failure because tensile strength of lateral direction of metal lath was much higher than the one of vertical direction. Fig. 11 shows the tensile force-displacement relationship on lateral direction. It is found that metal lath carries a tensile force approximately three times as much as the one in the case of vertical tensile force.
