EXPERIMENTAL STUDY ON THE SEISMIC PERFORMANCE OF TYPICAL EXISTING REINFORCED CONCRETE BRIDGE PIERS WITH HOLLOW RECTANGULAR SECTIONS

P. Cassese⁽¹⁾, P. Ricci⁽²⁾, G. M. Verderame⁽³⁾, G. Manfredi⁽⁴⁾

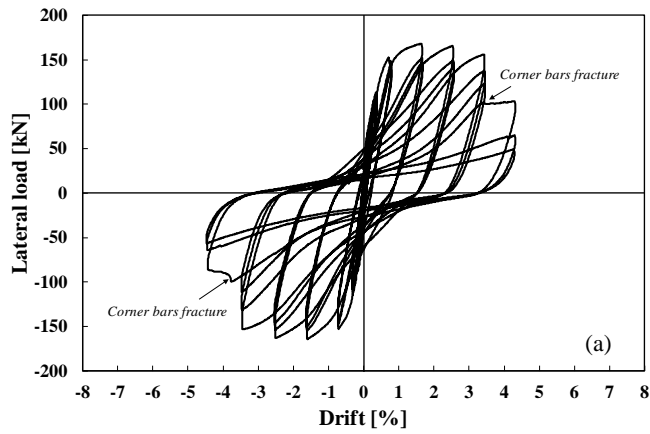
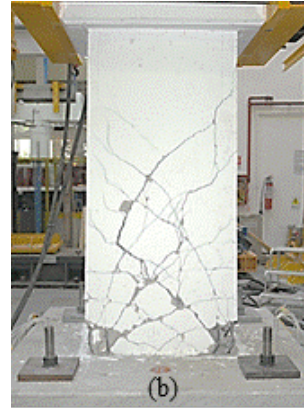
Fig. 4 – Lateral load versus drift cyclic response and final damage state, P1 (a,b), P2 (c,d), P3 (e,f), P2 (g,h)

The results in terms of lateral load versus drift response and final damage state for Test P1 are reported in Fig 4a and Fig 4b respectively. Experimental response appears quite symmetric during the push-pull cycles. A first reduction of the initial stiffness was already observed during the first three cycles set, for a drift equal to 0.08%. Stiffness decreased gradually for a drift range between 0.21% and 0.34%, at which slight cracks appeared on the lower half of the element, initially as flexural horizontal cracks, later evolving along diagonal directions. A considerable stiffness reduction was observed during the fourth set of cycles, for a drift value of 0.76% and a force equal to about 153 kN. Specimen reached yielding condition, as confirmed by longitudinal bars strain measures provided by strain gauges located at the base of the test unit. Existing cracks increased their width, new flexural cracks formed up to a height of about 1000mm from the column base. Further shear cracks formed as extensions of flexural cracks on the upper part of the specimen. Peak load was reached for a drift equal to +1.68% for positive loading direction (push) and -1.63% for negative loading direction (pull). The corresponding peak values of top lateral load were +164 kN and -168 kN, respectively. During the cycles corresponding to peak load, the existing cracks extended and considerably increased their width. Damage at the base of the column developed quickly: vertical cracks appeared in concrete cover corners due to longitudinal bars buckling. The post-peak response was governed by flexure. In fact, it was characterized by a gradual degradation with a softening stiffness (calculated on the envelope of first cycles) equal to -7.3% and -6.7% of the initial stiffness, in positive and negative loading direction respectively. Experimental response was symmetric also in inelastic cycles. The inter-cycle strength drop developed from 10% to 24% from fourth to seventh loading step. During sixth cycles set, for a drift of 2.55%, flexural cracks at column base considerably widened and concrete cover corners completely spalled off. The subsequent cycles set (drift = 3.47%) was characterized by a significant concrete spalling together with significant buckling of longitudinal rebars within the distance between the base and the first layer of transverse reinforcement. During the last cycles set (drift = 4.40%), concrete of the compressed flanges was completely crashed and spalled. Longitudinal corner rebars failed in tension due to oligo-cyclic fatigue caused by buckling/tension cycles. In particular, this phenomenon occurred when the imposed drift overcame the maximum drift attained during the previous cycles set (see Fig 4a), and the associated increase in tension demand on longitudinal buckled bars led to their fracture, thus leading to a sudden intra-cycle strength drop/stiffness decrease in negative/positive direction.

- Tests P1 and P2, characterized by a higher aspect ratio ($L_v/H \geq 2.5$), showed flexural failure modes, with a cyclic response governed by ductile mechanisms. Damage states evolutions were typical of ductile members, with most of damage in non-linear phase located at base (concrete crushing, longitudinal rebars buckling).

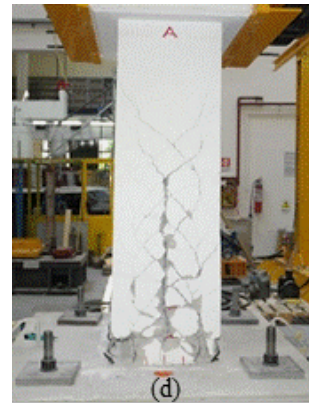
The results in terms of lateral load versus drift response and final damage state for Test P2 are reported in Fig 4c and Fig 4d respectively. Experimental response appears quite symmetric during the push-pull cycles only up to peak load, while post-peak phase is characterized by different evolutions in positive and negative load direction. Also in test unit P2, a first reduction of the initial stiffness was observed during the first three cycles set (drift = 0.23%). Hairline cracks were observed along the East and West specimen surfaces, at the first stirrups levels. Stiffness decreased gradually for a drift range between 0.50% and 0.79%, at which slight cracks appeared on the upper half of the element and the existing flexural cracks evolved along diagonal directions. Longitudinal rebars reached yielding strain value during the third loading step, as confirmed by the strain gauges located at the base of the test unit. A substantial stiffness reduction was observed during the fourth set of cycles (drift = 1.69%). Specimen reached yielding condition and damage state developed quickly: existing cracks increased their width, new flexural cracks formed and further shear cracks appeared as extensions of flexural in the central zone. Peak load was reached for a drift equal to 3.50% for both positive and negative loading direction, with a corresponding strength peak of 116 kN. During the cycles corresponding to peak load, existing cracks increased their width suddenly, diagonal ones in particular, which intersected themselves in correspondence of the central longitudinal bar, causing a concrete cover spalling along a vertical center line. Damage at the base of the column developed quickly: vertical cracks appeared on cover corners due to longitudinal bars buckling and concrete spalled off. Hysteretic curves were characterized by a considerable pinching effect. The post-peak response was asymmetric and governed by flexure. In fact, during sixth cycles set (drift = 5.25%) different load values were reached in positive and negative direction, equal to +91 kN and -111 kN respectively. Such an asymmetry was due to first longitudinal corner rebar failure in tension (because of oligo-cyclic fatigue). This phenomenon implicated a drop in strength (45% in push direction and 60% in pull). Softening stiffness values (calculated on the envelope of first cycles) were equal to -6% and -3% of the initial stiffness, in positive and negative loading

direction respectively. During the last cycles set, for a drift of 7.08%, compressed concrete between the base and the first stirrups layer completely crushed and spalled. Remaining longitudinal corner rebars failed in tension. Corresponding hysteresis loops were very narrow.

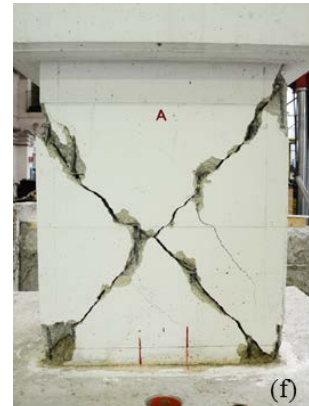
The results in terms of lateral load versus drift response and final damage state for Test P3 are reported in Fig 4e and Fig 4f respectively. Experimental response appears slightly non-symmetric during the push-pull cycles. This effect, more evident with increasing drift, is associated with the shear cracking extension and reversal process. Once a set of cracks is open for a given loading direction, the reversal into the opposite direction is partially characterized by closing of the previously opened shear cracks. Therefore, for a given imposed horizontal displacement, a stiffness decrease is observed. Also in test P3, a first reduction of the initial stiffness was observed during the first three cycles set (drift = 0.06%). No cracks were observed along the specimen surfaces, but only at the base section. Stiffness decreased gradually for a drifts range between 0.17% and 0.41%, at which slight cracks appeared on the East and West specimen surfaces along first four stirrups layers and evolved quickly along diagonal directions toward compressed zone. In particular, two diagonal cracks formed from top to down opposite corners with an inclination angle of about 45 degrees. A substantial stiffness reduction was observed during the fourth set of cycles (drift = 0.93%). Longitudinal rebars reached yielding strain value, as confirmed by the strain gages located at the base of the test unit. Specimen reached yielding condition and damage state developed quickly: existing shear cracks increased their width and length, no flexural cracks formed and new slight shear cracks appeared as extensions of flexural ones in the central zone. It is noteworthy highlighting that, unlike test P1 and test P2, no considerable damage was observed on the base zone. Fifth cycles set (drift = 2.23%) was characterized by a single push/pull cycle. During pushing phase, for a drift value of +1.48%, drop in strength equal to 58% was observed, from +278 kN to +118 kN, at a drift value of +2.23%. Main shear crack opened suddenly up to a width of about 10 mm, along an ideal concrete strut with a medium inclination of about 42 degrees. A sliding between the upper and the lower part of the specimen was observed, with buckling of longitudinal rebars crossing the main diagonal crack. Shear sliding also caused buckling of the longitudinal rebars next to the base section with resulting concrete cover spalling. Pull phase was characterized by a lower stiffness. For a drift equal to -1.27% another drop in strength was observed (from -228 kN to -92 kN). Shear crack with a medium inclination of about 47 degrees opened suddenly, causing buckling in longitudinal rebars and concrete cover spalling.

- Test P3, characterized by an aspect ratio $L_v/H=1.5$, showed shear failure after flexural yielding. The cyclic response was typical of squat columns, governed by shear mechanisms. In fact, damage evolution was characterized by significant diagonal cracks since linear phase. Shear failure mode was characterized by a large drop in strength (of about 60% respect to maximum reached value) related to evident diagonal cracks opening, inclined of about 45 degrees.

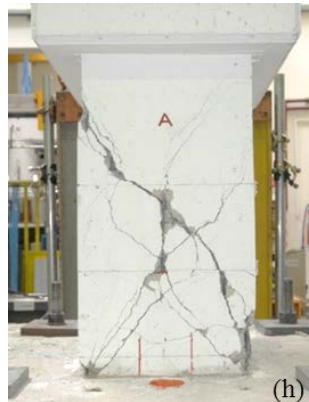
The results in terms of lateral load versus drift response and final damage state for Test P1 are reported in Fig 4g and Fig 4h respectively. Experimental response appears quite symmetric during the push-pull cycles. Also in test unit P4, a first reduction of the initial stiffness was observed during the first three cycles set (drift = 0.06%). No cracks were observed along the specimen surfaces, but only at the base section. Stiffness decreased gradually during second and third cycles sets, for a drift range between 0.17% and 0.43%. In fact, the second set was characterized by slight cracks on the East and West specimen surfaces along second and third stirrups layers, evolving quickly along diagonal directions toward compressed zone. Existing cracks increased their width during the third set, some flexural hairline cracks appeared next to the base and two wider diagonal cracks formed from top to down opposite corners with an inclination angle of about 38 degrees. A substantial stiffness reduction was observed during the fourth set of cycles (drift = 0.99%). Longitudinal rebars reached yielding strain value, as confirmed by the strain gages located at the base of the test unit. Specimen reached yielding condition and damage state developed quickly: existing shear cracks increase their width and length and new slight shear cracks appeared in the central zone, next to principal ones. Peak load values were reached, +193 kN and -188 kN, in positive and negative loading direction respectively. The inter-cycle strength drop developed from 5% to 19% passing from fourth to fifth loading step. Damage state evolved quickly: new shear cracks formed in the upper part, existing main diagonal cracks increased their width and extended reaching the base corners, causing concrete cover cracking. A clear fixed-end rotation was observed. Sixth loading step (drift = 3.40%) was characterized by one push/pull cycle. During pushing phase, for a drift value of +2.80%, response curve evolved along a horizontal slope, maintaining an about constant force value equal to +155 kN (equal to 80% of peak load) up to a drift of +3.40%. East-West principal diagonal crack opened suddenly. During the

following pull phase, for a drift value of -2.49%, a sudden strength drop was observed (from -137 kN to -87 kN). The loss in strength respect to global peak load was equal to 54%. Corresponding to this drop, West-East main shear crack, along an ideal concrete strut with a medium inclination of about 38 degrees, opened suddenly up to a width of about 10 mm. A sliding between the upper and the lower part of the specimen was observed, with buckling of longitudinal rebars crossing the shear crack. Shear sliding caused buckling of the longitudinal rebars next base section with resulting concrete cover spalling.

- Test P4, characterized by an aspect ratio $L_v/H=2.25$, showed shear failure after flexural yielding. The cyclic response was characterized by flexure-shear interaction. In fact, during non-linear phase damage evolution was characterized initially by flexural cracks at the base, for drift values higher than test P3, and later by significant diagonal cracks, up to shear failure.
