SEISMIC VULNERABILITY OF TIMBER ROOF STRUCTURES: AN ASSESSMENT PROCEDURE

Abstract

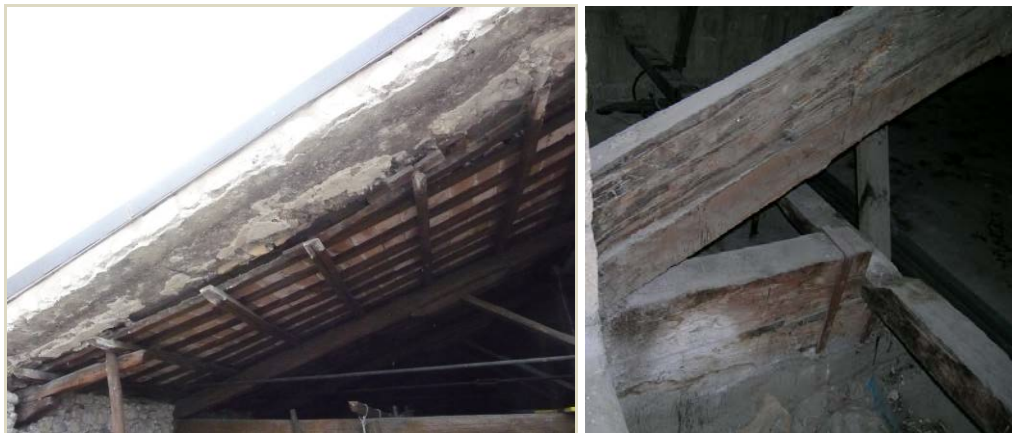
Figure 3. Results of interventions; a massive intervention over a roof truss (left) [5]; the chord of a truss was cut for unknown reasons jeopardizing safety (right)

for a variety of non structural reasons, often with negative effects on safety. In fig. 3, at right, cutting the truss chord and blocking the stump at the floor with a probably ineffective metal hoop is highly questionable.

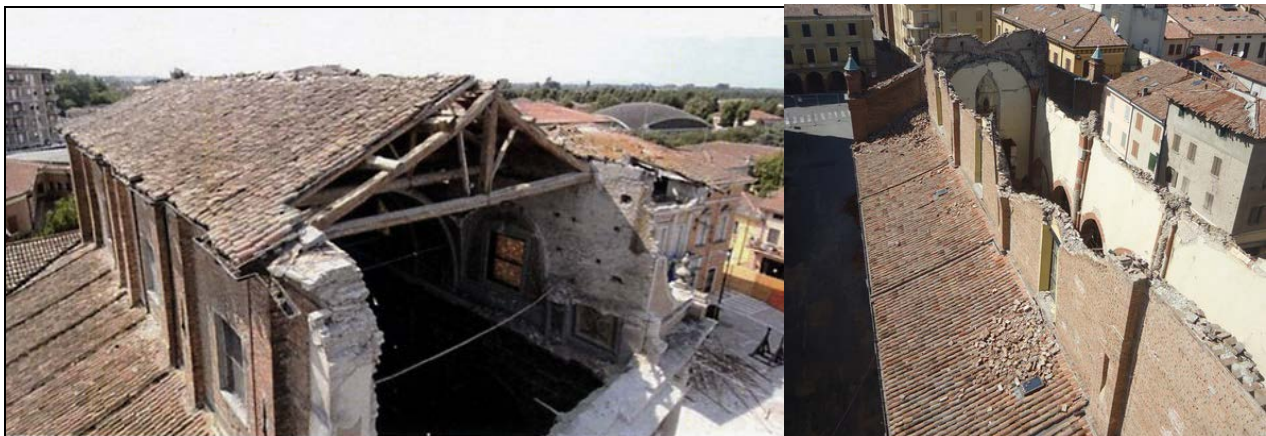
Figure 4. Partial or total collapse of roof structures in churches during the 2012 earthquake in Emilia, Italy [7].

Because failures of this type have been very frequent in nave walls of church buildings during recent earthquakes in Italy, fig. 4, the study has been performed on this kind of structures. Results may then be extended to other truss-wall situations in similar geometric conditions.

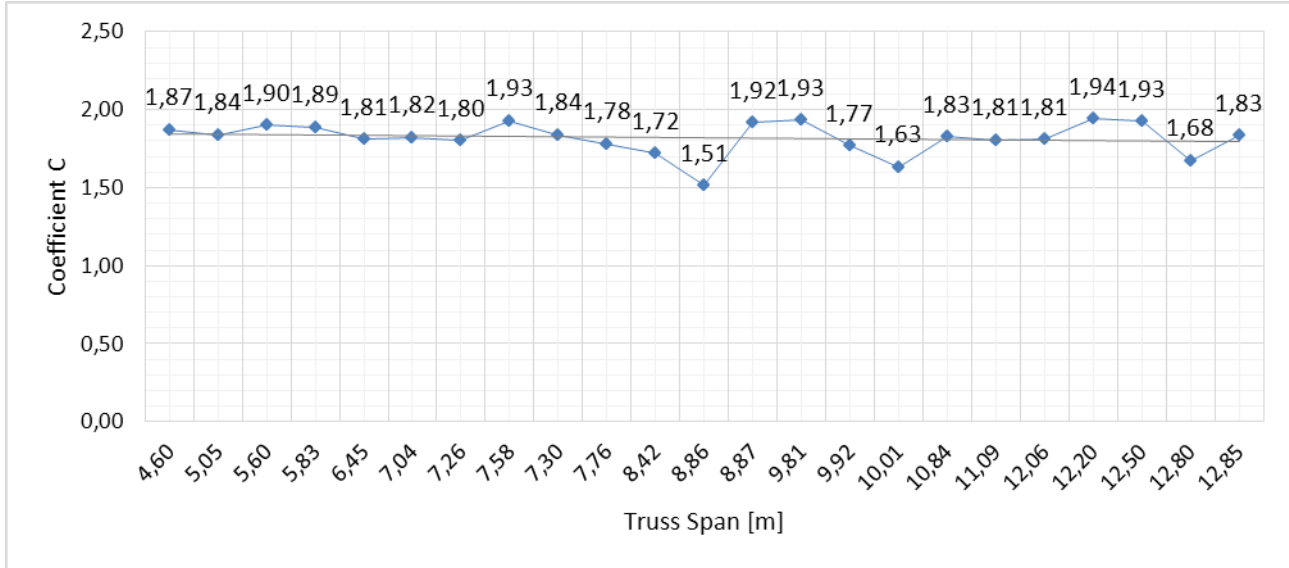
Figure 6. Coefficient c values obtained from a series of case studies.

Expression (2) promises to be very useful for fast, synthetic estimations, as long as a simple way of expressing coefficient c may be found. Loads depend on wall geometry and material, type of roof cover over the truss, span length, etc. Coefficient c , consequently, ranges between 1 and 2 depending on whether the weight of the roof or that of the masonry dominates. Roof loads are, however, basically of two types: regular loads amount to about 2 kN/m^2 , while heavy roofs like those that were strengthened as in fig. 3 weight about 5 kN/m^2 . With this reference, a series of cases has been examined. Results from the lighter, and more common, roofs, yielded a coefficient c with an average value of 1.83 and very low variability, as in fig. 6; heavier roofs were clustered around $c = 1.33$ with equally low variability. Therefore, as a first approximation and for the case of church roofs,
