SEISMIC BEHAVIOUR OF RAMMED EARTH DWELLINGS REINFORCED WITH WOOD ELEMENTS AND A UPPER CONCRETE BEAM

Abstract

Keywords: Rammed earth buildings; reinforcement solutions; seismic reinforcement; wood reinforcement

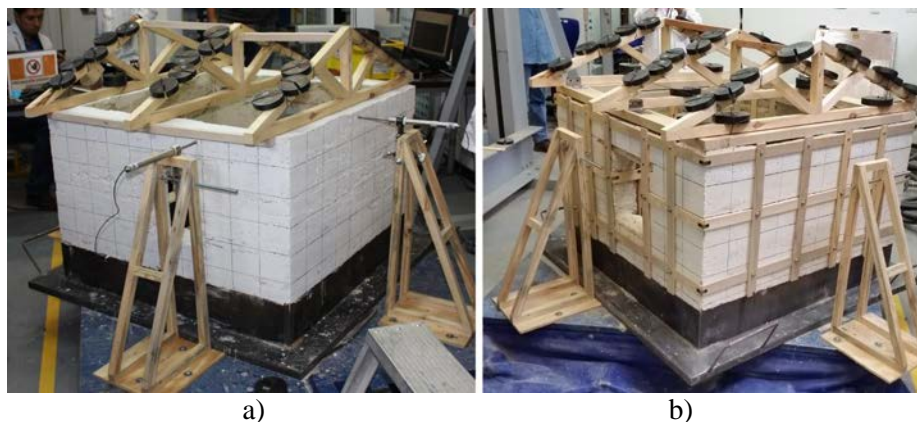
In order to test the proposed strategy, two reduced scale models were built: one without reinforcement or upper beam, and the other with the mentioned transition to the upper beam and wood reinforcement. Both were on a 1:6 scale from a representative dwelling house of one story and 36 m² plan area, which is the minimum plan size for a low income housing in Colombia. The plan dimensions of each model were 1m x 1m and the height was of 57 cm. The model had 4 walls with a thickness of 8 cm: one complete and the other three with openings for windows and a door. In order to analyze the effect of the location of openings, one wall had its window at the center and the other on the edge section of the wall, near the corner. Finally, the left wall had a central door. The roof was designed as a truss wooden roof where several metal pieces were attached to simulate the mass of the roof. The foundation was built over a metal framework with a mix of stone, sand and clay, with the same thickness of the walls, see Fig. 3a.

The wood reinforcement was composed of vertical and horizontal elements of 35 mm wide and 5 mm thick, separated 250 mm in both directions, according to the recommendations of the AIS manual [14]. They were connected to one another by 6.35 mm rods that also pierce the wall to connect the system on both sides of the wall. At the corners the elements were connected by bolted steel angles. The transition between the wall and the upper beam was of 10 cm wide with 4 layers of 2.5 cm each, see Fig. 2 b) and Fig. 3b.

Fig. 3 – Reduced scale models: a) unreinforced model and b) reinforced model

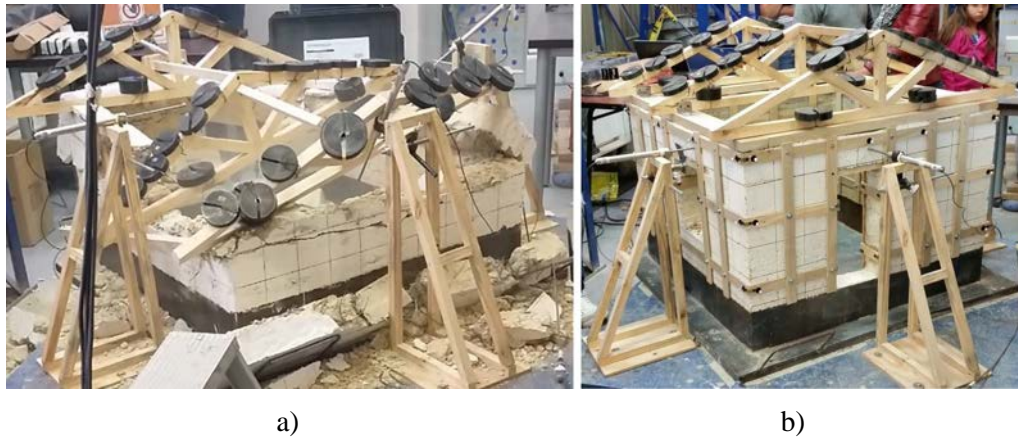
Regarding the building models, the global behaviour of both structures was quite different as expected. The unreinforced model did not resist the whole signal since at 16 seconds all walls presented local failures and partial collapse and at approximately 20 seconds the whole structure collapsed, see Fig. 7a. The reinforced model on the contrary withstood the complete ground motion with only a few cracks in the lower regions, near the corners and the foundation, and also near the first horizontal element, see Fig. 7b and Fig. 8.

Fig. 7 – Global behaviour of: a) unreinforced model after the test, and b) reinforced model after the test

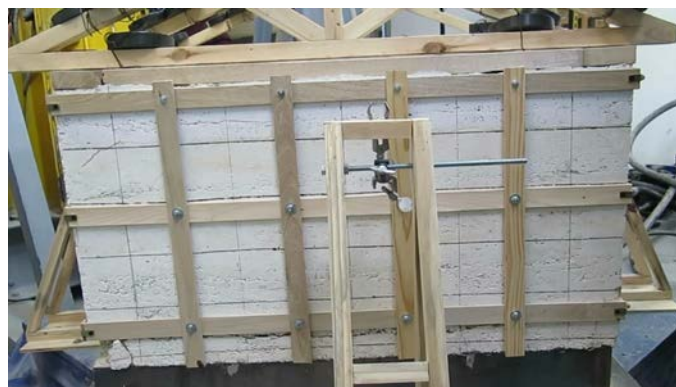
Fig. 8 – Complete wall view of the reinforced model after the test

Concerning the reinforced model, there was no collapse after it was subjected to the same strong motion. The most fragile region seems to be the one between the foundation and the first line of horizontal reinforcement. Horizontal cracks were observed right above the foundation and right below the first line of horizontal reinforcement. As a consequence the bottom section of one corner, wedge shaped, splits away from the model, see Fig. 8. Despite of these localised cracks, the soundness of the model was well preserved.

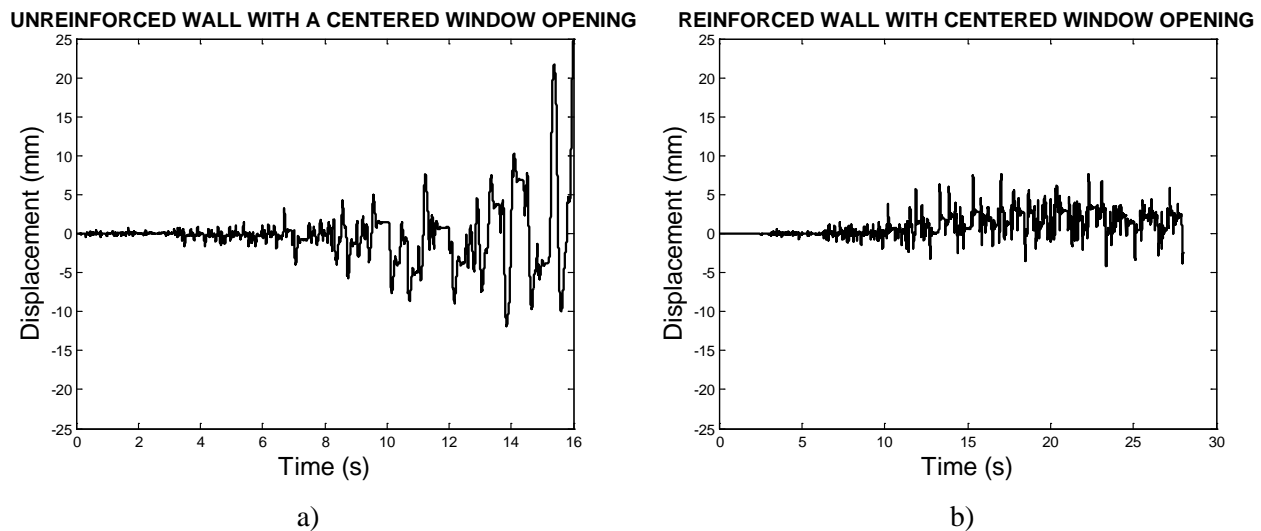
As an example, Fig. 9 shows the case of the wall with a central window opening. A stiffness increasing represented by a reduction in the maximum out of plane displacement (from 24.6 mm to 7.67 mm) and a reduction of the response period from 0.42 to 0.14 seconds. Finally, there was no permanent displacement after the application of the whole strong motion signal. The other three walls behaved equally well.

Fig. 9 – History of displacements of the wall with centered opening for: a) the unreinforced model and b) the reinforced model
