## **EXPERIMENTAL BEHAVIOR OF ELASTOMERIC BEARINGS AND SEISMIC BARS OF SIMPLY SUPPORTED CHILEAN BRIDGES**

### ***Abstract***

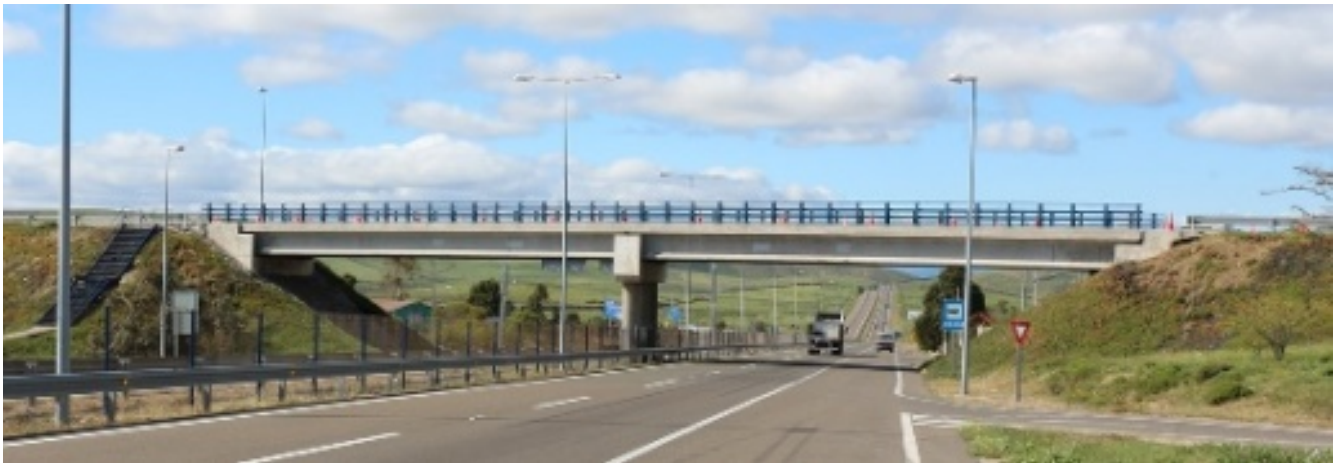
Fig. 1 – Typical Chilean overpass

Typical highway bridges in Chile consist on two span simply supported structures with prestressed concrete girders connected by a continuous reinforced concrete slab. The girders are supported by elastomeric bearings which are not bolted and allow sliding between the bearing and the heel of the beams, and between the bearing and the bearing table. The lateral displacement of the superstructure in some bridges is also restricted by lateral reinforced concrete or steel stoppers. According to the Chilean seismic design code [1], bridges are designed with seismic bars, which are vertical steel rods that connect the superstructure with the bearing table. These seismic bars are intended to prevent uplift of the superstructure and they are designed to resist certain vertical force. However, when the superstructure of a bridge is subjected to large lateral displacements, these seismic bars also provide lateral restraint. A typical overpass in Chile is shown in Fig. 1.

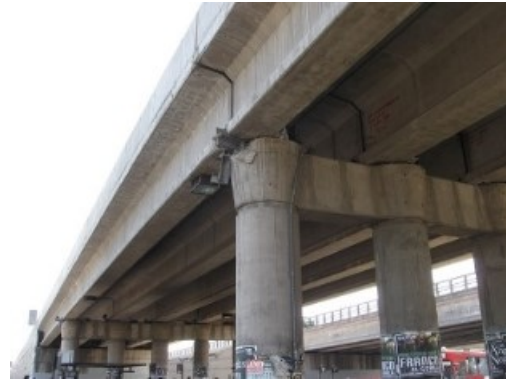
b) Transverse displacement of superstructure, Independencia overpass, 2010 Maule earthquake

Damage has been recently observed in Chilean bridges after 2010 Maule earthquake, and 2015 Illapel earthquake. Approximately 300 bridges were damaged, including 20 with collapsed spans, due to the Maule earthquake. Observed failure modes in this earthquake were: damage to connection between superstructure and substructure, unseating of spans in skewed and straight bridges due to transverse displacement and rotation of the superstructure, scour and pier damage due to tsunami action, among others [2]. More information of damaged bridges due to Maule earthquake is available elsewhere ([2], [3], [4] and [5]). After 2015 Illapel earthquake, minor damage was observed, and only eight bridges suffered damaged but without losing its functionality [6]. The observed damage was displacement of the superstructure due to sliding of elastomeric bearings, settlement of bridge approaches or damage to connection between superstructure and substructure. Examples of the observed damage in recent earthquakes are shown in Fig. 2. A collapsed bridge due to unseating of spans is shown in Fig. 2a). Permanent lateral displacement of the superstructure of Independencia overpass with damaged steel stoppers is shown in Fig. 2b). Las Mercedes underpass with significant lateral displacement is shown in Fig 2c). For such displacement, the seismic bars were expected to provide lateral restraint to the superstructure. Finally, Fig. 2d) shows sliding of elastomeric bearing in Talinay underpass after 2015 Illapel earthquake.

The objective of this paper is to summarize two experimental campaigns that were conducted at Pontificia Universidad Católica de Chile to characterize the seismic behavior of Chilean bridges. Two components of the bridge were tested under cyclic lateral loads: elastomeric bearings and seismic bars. Test of steel stoppers, as those observed in Fig. 2b), are summarized in Hube and Rubilar [7].

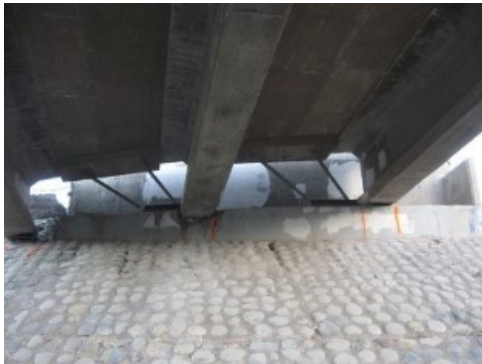
c) Transverse displacement of superstructure and deformed seismic bars, Las Mercedes underpass, 2010 Maule earthquake

characteristics of the seismic bars of Chilean bridges were obtained from a survey of 13 bridges [10]. Two seismic bars are typically installed between prestressed concrete girders at each side of the span, as observed in Fig. 2c). The average diameter of these bars is 22 mm and the specified yield strength of the steel is usually 280 MPa.

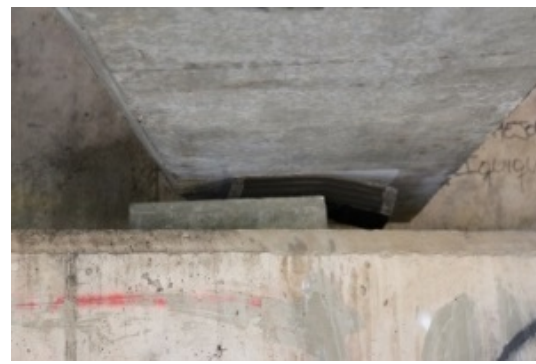
d) Sliding of elastomeric bearing, Talinay underpass, 2015 Illapel earthquake

For the monotonic test, the lateral displacement was applied with a constant velocity of 2 mm/s. The bearings suffered shear deformation until sliding started to occur, as expected, at the contact of the bearings with the top reinforced concrete block. For the case of Talinay Bridge damaged after 2015 earthquake, sliding occurred between the bearing and the heels of the beam as observed in Fig. 2d). In such bridge, the coefficient of friction of the leveling mortar of the cap beam was smaller than that of the heel of the reinforced concrete beam. Fig. 4a) shows a deformed bearing when subjected to small lateral deformation and Fig. 4b) shows a bearing that is sliding at the top surface. The failure mode observed in all tests was sliding of the elastomeric bearing with respect to the top reinforced concrete block. The observed sliding failure mode is equivalent to that observed in the elastomeric bearings tested by Steelman et al. [9]. Delamination of internal shims, nor stability failure modes were observed in the tested bearings. Also, similar to the bearings tested by Steelman et al. [9], the structural integrity of the bearings was not compromised after the tests. Fig. 4c) shows the top worn surface of an elastomeric bearing after the six tests (Table 1) where the structural integrity is not compromised. Fig. 4d) shows the top reinforced concrete block after the tests with traces of rubber.

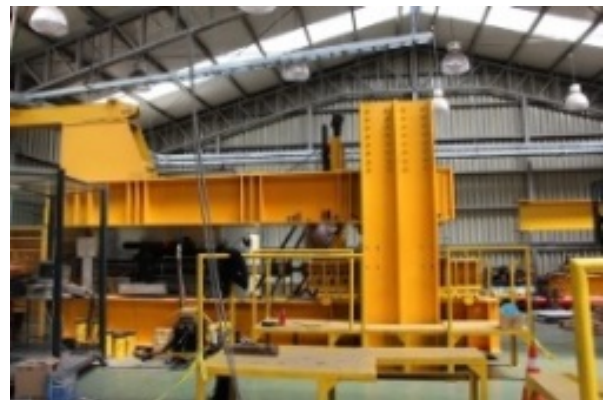
b) Photograph of the test setup

Fig. 3 – Test setup, elastomeric bearings

The test setup of elastomeric bearings is shown in Fig. 3. The elastomeric bearings were placed between a top and bottom reinforced concrete blocks. The short side of the bearing (400 mm) was oriented in the direction of the applied load. The dimensions of the reinforced blocks were 1200 x1200 x100 mm and were constructed for these tests. The surface of the bottom reinforced concrete block was relatively rough to simulate the actual condition of the leveling mortar in cap beams under the bearings (Fig. 2d). The surface of the top reinforced concrete block was smooth, to simulate the surface of the bottom web of a prestressed reinforced concrete beam. This smooth surface was achieved by casting the block concrete on top of a wooden form. For the test setup, the smooth surface of the top concrete block was installed pointing down to simulate actual conditions.

The top and bottom reinforced concrete blocks were bolted to a steel loading frame that is used to test full-scale elastomeric bearings isolators at the laboratory of Pontificia Universidad Católica de Chile. The lateral load was applied with a 1,000 kN dynamic MTS actuator. The vertical load was applied to the bearings using five hydraulic jacks with a total loading capacity of 5,000 kN. The loads of these jack was transferred to the horizontal loading frame with a vertical steel frame, which can be observed in Fig. 3b).

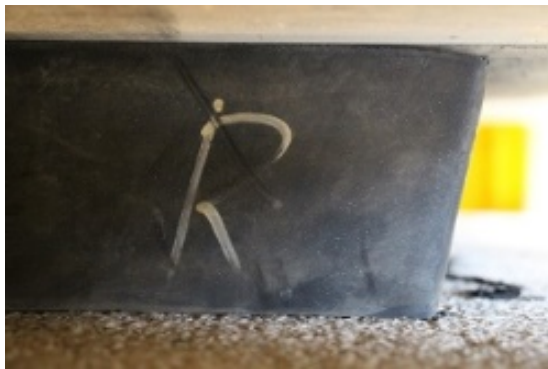
a) Bearing with lateral deformation

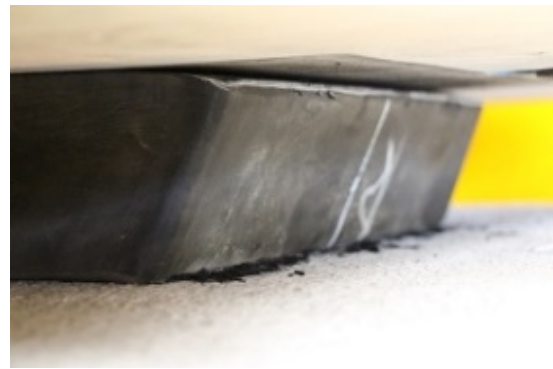
b) Bearing sliding

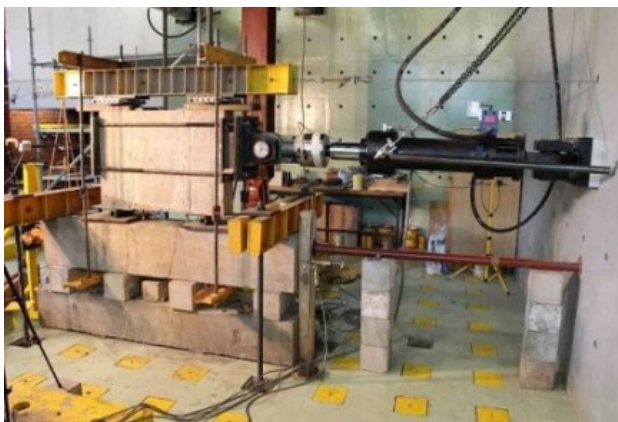
a) Specimens with diaphragms

Fig. 8 – Test setup, seismic bars

The proposed seismic bars specimens represent a portion of the bridge with two seismic bars between a pair of consecutive girders. Each specimen consist on a bottom reinforced concrete block representing the bearing table of the substructure, and a top reinforced concrete wall or beam representing the reinforced concrete diaphragm or slab, depending on the case. Additionally, each specimen comprised two vertical seismic bars connecting the bottom and top reinforced concrete blocks. The specimens were constructed using 1/2-scale with and the diameter of the seismic bars was 16 mm. Fig. 7 shows the test regions of a bridge and the constructed specimens for cases WD and WOD. The clear distance of the seismic bars  $h_l$  (refer to Fig. 8) was 100 mm and 720 mm for specimens WD and WOD, respectively. Fig. 8 shows pictures of the test setup for both cases. More information of these tests is available elsewhere [12].

The lateral load was applied with an actuator with a capacity of 610 kN in compression and 340 kN in tension. The actuator was bolted to the reinforced concrete slab or diaphragms of the specimens using two steel plates. The bottom reinforced concrete block was attached to the strong floor with two transverse steel beams that were bolted to the strong floor. For both type of specimens, the vertical displacement of the diaphragm or slab was restricted with two rollers at the top and two rollers at the bottom. The bottom rollers simulate the vertical restraint provided by the elastomeric bearings, and the top rollers prevented the uplift of the diaphragm or slab. In real bridges, the uplift of the superstructure is prevented by its own weight. For the specimens WOD, the reinforced concrete slab was placed on top of two parallel steel beams to provide additional flexural stiffness and strength to the slab, but allowed the free displacement of the seismic bars between them.

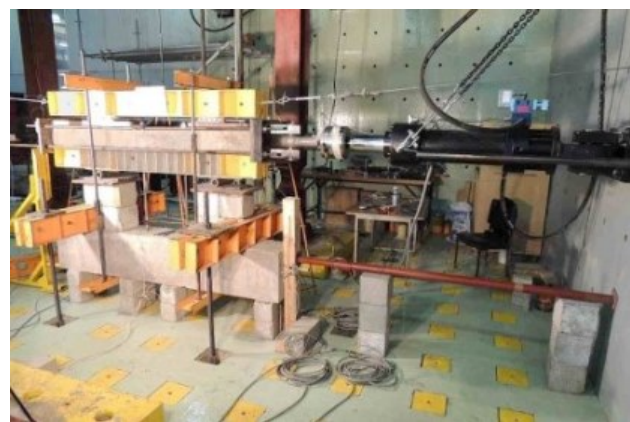
b) Specimens without diaphragms

For the specimens WOD it was not possible to observe the exact moment in which the seismic bars touched the PVC tubes embedded in the slabs because of the presence of the steel beams of the test setup (Fig. 8b). For cycles with displacement amplitude larger than 144 mm, the nuts of the seismic bars lifted, implying that the prestress force of the seismic bars was lost. The failure of the specimens WO1 and WOD2 was not achieved at the end cycles, where the largest amplitude of 190 mm was restricted by the actuator stroke. Therefore, specimen WOD3 was loaded only with positive displacement to achieve larger displacements. The failure of specimen WOD3 occurred during a cycle with displacement amplitude of 320 mm. The failure mode of specimen WOD was fracture of both seismic bars at the threads location above the slab. The north bar fracture 15 seconds earlier than the south bar. Finally, the damage observed in the concrete of the slab of specimens WOD was less than that on the diaphragms of specimens WD. This reduced damage is explained by the larger clear distance of seismic bars in specimens WOD.

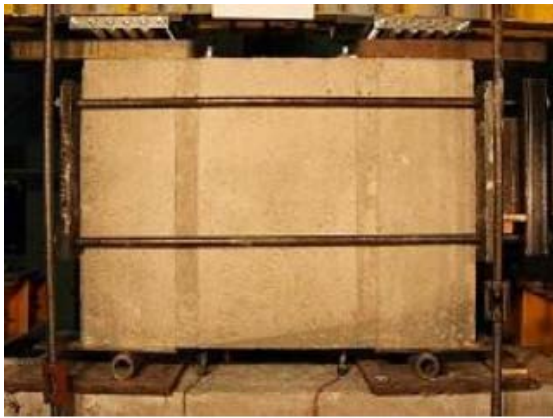
a) Seismic bars touching the PVC tubes of the diaphragm, specimen WD2

For the specimens WD, which were characterized by a clear distance of 100 mm, contact of the seismic bars with the embedded PVC tubes of the diaphragm was first observed at the cycle with displacement amplitude of 20 mm. This instant is shown in Fig. 9a) for specimen WD2. For cycles with displacement amplitude larger than 50 mm, the nuts of the seismic bars lifted when the specimens were passing through zero displacement, as can be observed for specimen WD2 in Fig 9b). Both specimens WD failed due to fracture of the seismic bars at the beginning of the first cycle with displacement amplitude of 150 mm, and were not able to reach such displacement amplitude. The fracture of the seismic bars occurred at the contact with the bent cap, possibly due to stress concentration and fatigue experienced by the seismic bars. The forces generated by the contact between the seismic bars and the PVC tubes in the diaphragm caused damage to the PVC and concrete at the bottom of the diaphragm.

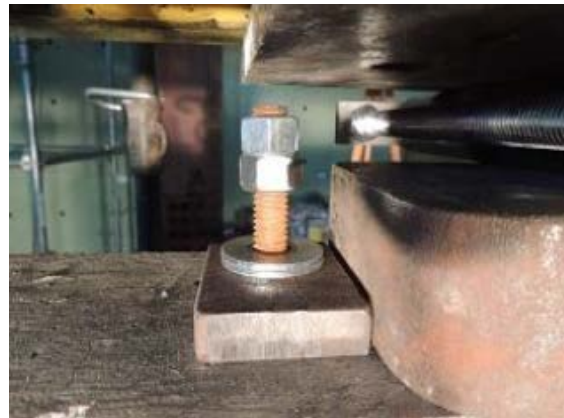
a) Uplift of the seismic bar nuts, specimen WD2
