## STRUCTURAL PERFORMANCE OF WELD JOINTS WITH LACK-OF-FUSION DEFECT AT 35° GROOVE FACE

### **Abstract**

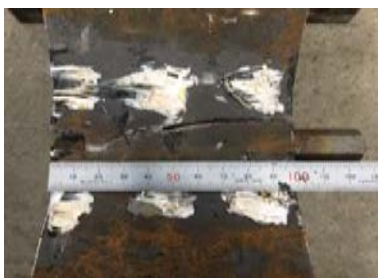
No.14 (Surface, Edge, 35°)

Photo. 1 – Fracture condition

The experimental results are shown in Table 1. Figs. 4 and 5 present the load–displacement relations and skeleton curves, respectively. Specimen No. 1–No. 7 had a center defect, whereas No. 8–No. 13 had an edge defect for Series 1. Photos of some fractured specimens are shown in Photo 1.

Specimen of No. 2, No. 9, No. 10 and No. 11 showed a rapidly decreased load and a brittle fracture. The other specimens had a slowly reduced load and a ductile fracture. The largest defect rate was found in specimen No. 6, which was fractured in five cycles with early crack progress. Specimen of No. 3, No. 8 and No. 9 with a small defect rate in the center and edge defects did not fracture in  $\pm 45.2$  mm. Therefore, these specimens were fractured with the push-over. Specimen No. 2 did not fracture in 45.2 mm after the second time. The specimen was rapidly fractured by increasing the load on the positive side of the push-over. Specimen No. 16 with an edge defect in Series 2 also did not fracture in  $\pm 48$  mm. The specimen showed a ductile fracture by increasing the load on the positive side of the push-over.

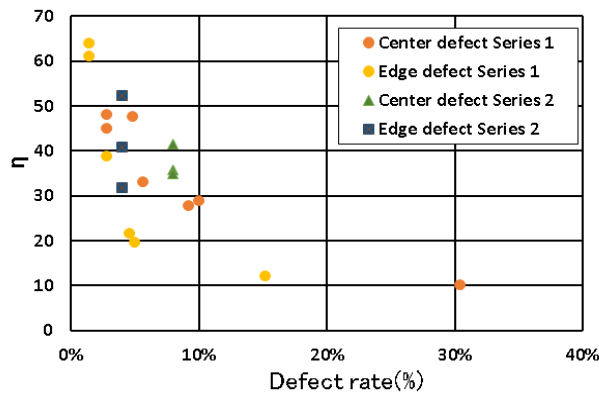
Fig. 6 – Comparison of η

The cumulative plastic deformation was also determined by the skeleton curve line ( $\eta_s$ ). Fig. 6 shows the relation between the cumulative plastic deformation and the defect rate, and Fig. 7 shows also the relation in the case of skeleton curves. The performance decreases when the defect rate is large. The higher the defect rate, the easier the specimen might fracture. The edge defect is easily fractured even with the same defect rate, which is more than that in the center defect.

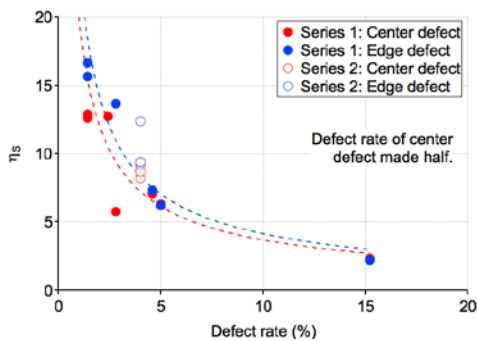
Fig. 8 – Defect rate – ηs

Fig. 8 is plotted with the defect rate as half values of the center defects. It appears that the results of the edge defect correspond with half the size of the center defect. From a point of view of fracture mechanics, the stress intensity factor of a edge defect of length  $a$  and that of a center defect of double length  $2a$  are known to be equivalent [4]. The diagram of the stress intensity factor is shown in Fig. 9. It is considered that the allowable size of the edge defect is half the size of the center defect. Fig. 10 presents the comparison between different angles and between different positions of defects. Notably,  $\eta$  of the bottom side defect corresponding to the

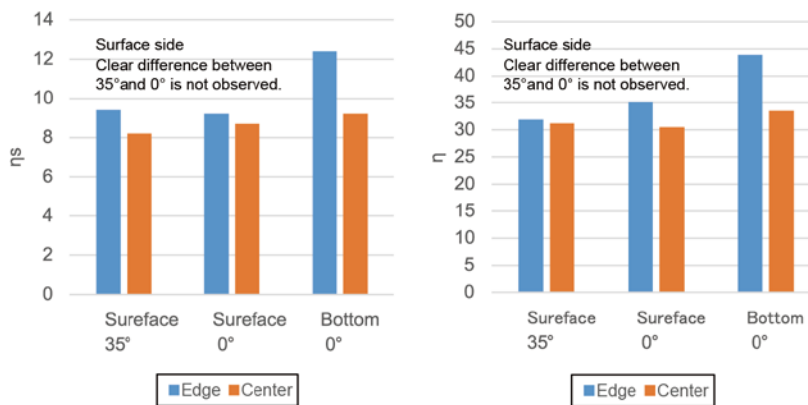
Fig. 10 – Comparison with defect angles (Series 2)

initial layer defect is larger than the surface side defect even with the same defect size. The clear difference in the angles for the defects in the surface side is not observed.
