# DIAGONAL TENSION TESTING OF AS-BUILT AND FABRIC REINFORCED CEMENTITIOUS MATRIX STRENGTHENED MASONRY PANELS

N. Ismail<sup>(1)</sup>, T. El-Maaddawy<sup>(2)</sup>, A. Najmal<sup>(3)</sup> and N. Khattak<sup>(4)</sup>

*Keywords: diagonal tension; fabric; masonry; infill; strengthening; earthquake.*

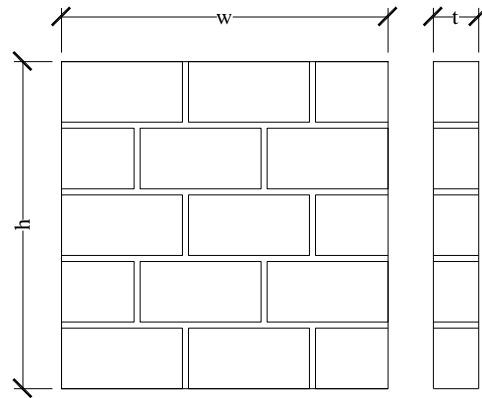
Fig. 1 - Test panel geometry and bond patterns

Test panels were given the notation WAN or WSN, where M refers to wall, A refers to as-built specimens, S refers to fabric type used to strengthen the test panel (G, B, or C), and N denotes the test number. Actual measured test panel dimensions and applied FRCM strengthening details are shown in Table 4, while the masonry bond pattern used is shown in Fig. 1. All test panels were left for 28 days and FRCM were left for at least 14 days for curing prior to testing.

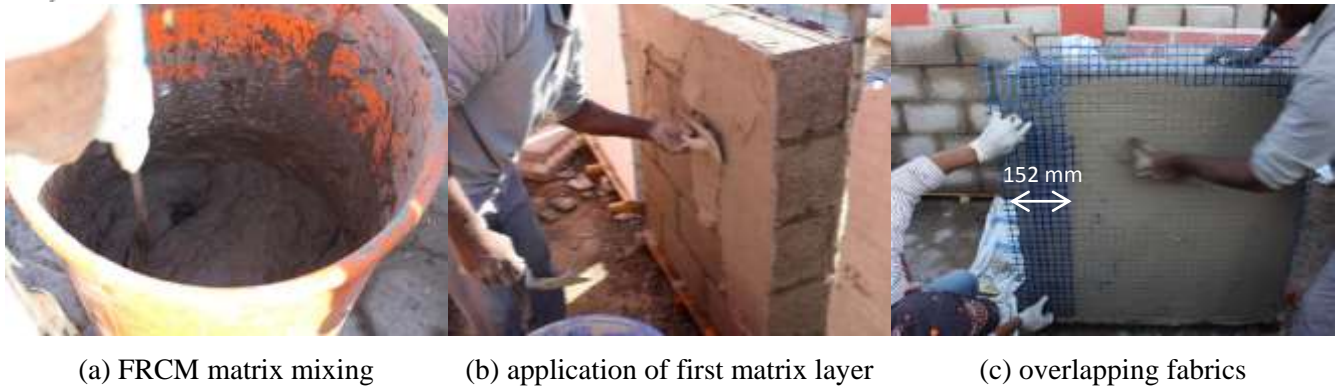
Fig. 2 – Photos of FRCM strengthening application

The FRCM application was started by cleaning the substrate masonry surface thoroughly by removing dust and fragments, which was then brought to saturated surface dry condition by sprinkling water onto it. The FRCM matrix was prepared using manufacturer instructions by thoroughly mixing the pre-weighed and packed solids and liquid components in a bucket using a mixing attachment with an electric drill machine set to rotary action only (see Fig. 2a). This prepared matrix was applied onto the full face of test panels receiving FRCM strengthening in a thin layer of roughly 3 mm using moderate pressure on levelling trowel (Fig. 2b).

Once the first layer of FRCM matrix has been applied onto the substrate masonry surface, later polymer/basalt mesh cut to exact sizes were placed onto still fresh first layer of FRCM matrix and pressed into the mortar layer using a hand trowel (Fig. 2c). The horizontal rovings of polymer fabric/grid were placed parallel to bed joints and were overlain by a second 3-4 mm thick layer of FRCM matrix hand applied using a trowel. The total thickness of the applied FRCM overlay was kept to approximately 10 mm for all FRCM strengthened test panels. The reinforcement fabric used herein were supplied in rolls, with fabric being 1 m wide and 10 m long. Therefore, an overlap of roughly 152 mm was used to cover the full surface of the test panels (Fig. 2c). The selected overlap length of 152 mm was based on recommendations given in ACI 549-13 [8] and on the basis of manufacturer recommendations.

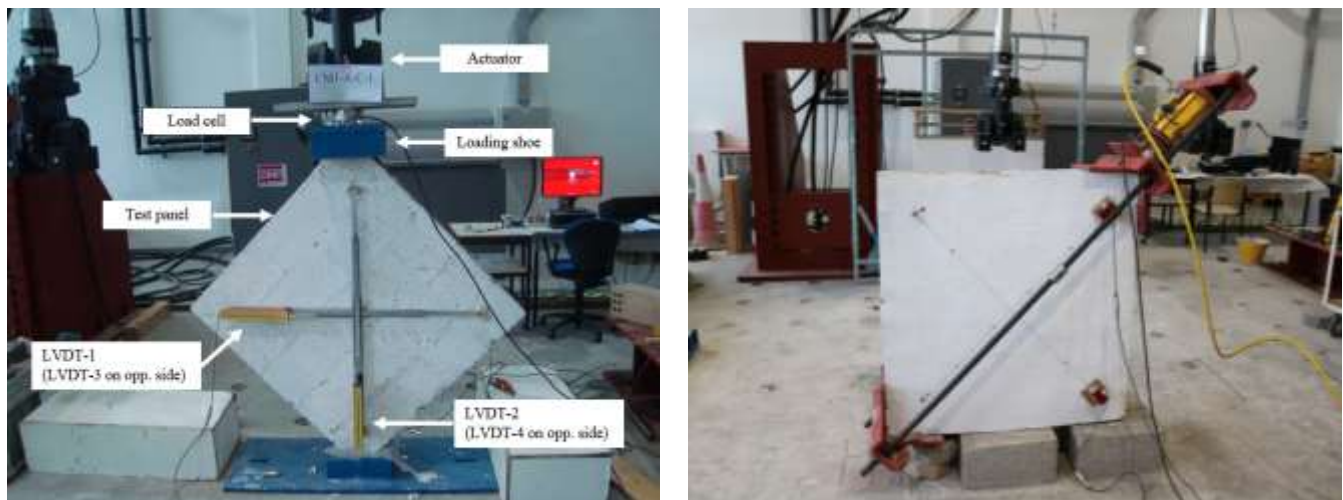
(a) Test setup for As-built specimen

(b) Test setup for strengthened specimens

Fig. 3 – Diagonal tensile test setup details

Two different types of test setup were used to investigate the in plane diagonal shear strength in accordance with ASTM E519-15 standard test guidelines [36]. The test procedure allows inducing a diagonal shear cracking and/or bed joint sliding failure mode. The test panel was subjected to a gradually increasing monotonic loading under a displacement rate of 0.01 mm/s along the diagonal joining the opposite ends of the test panels using a 500 kN automated actuator. Applied diagonal force was measure using a 500 kN load cell and corresponding displacements along both the diagonals of the test panel were recorded using four linear variable displacement transducers (LVDTs) mounted onto specially manufactured sliding guides with a gauge length of about 1200 mm. The LVDTs were attached along both diagonals on both faces of the test panel. The test setup used is shown in Fig. 3a. The FRCM strengthened specimens tilted out of plan at large loading magnitudes when tested in diagonal orientation and moved the hydraulic actuator outwards, which was owing to the localised crushing at loading shoes. Therefore, to achieve the ultimate failure load, the test setup was modified to test the FRCM strengthened specimens. In the modified test setup, load was applied manually using a hydraulic jack coupled with a 500 kN load cell. The applied loading rate was manually controlled to a displacement rate of more or less 0.01 mm/s. The modified test setup adopted is shown in Fig. 3b. The applied diagonal force was measure using the load cell coupled with the hydraulic jack and the resulting deformations along both the diagonals of the test panel were recorded using four draw-wire type linear displacement transducers (LDTs) mounted directly onto the specimen along both the diagonal with a gauge length of 1200 mm.

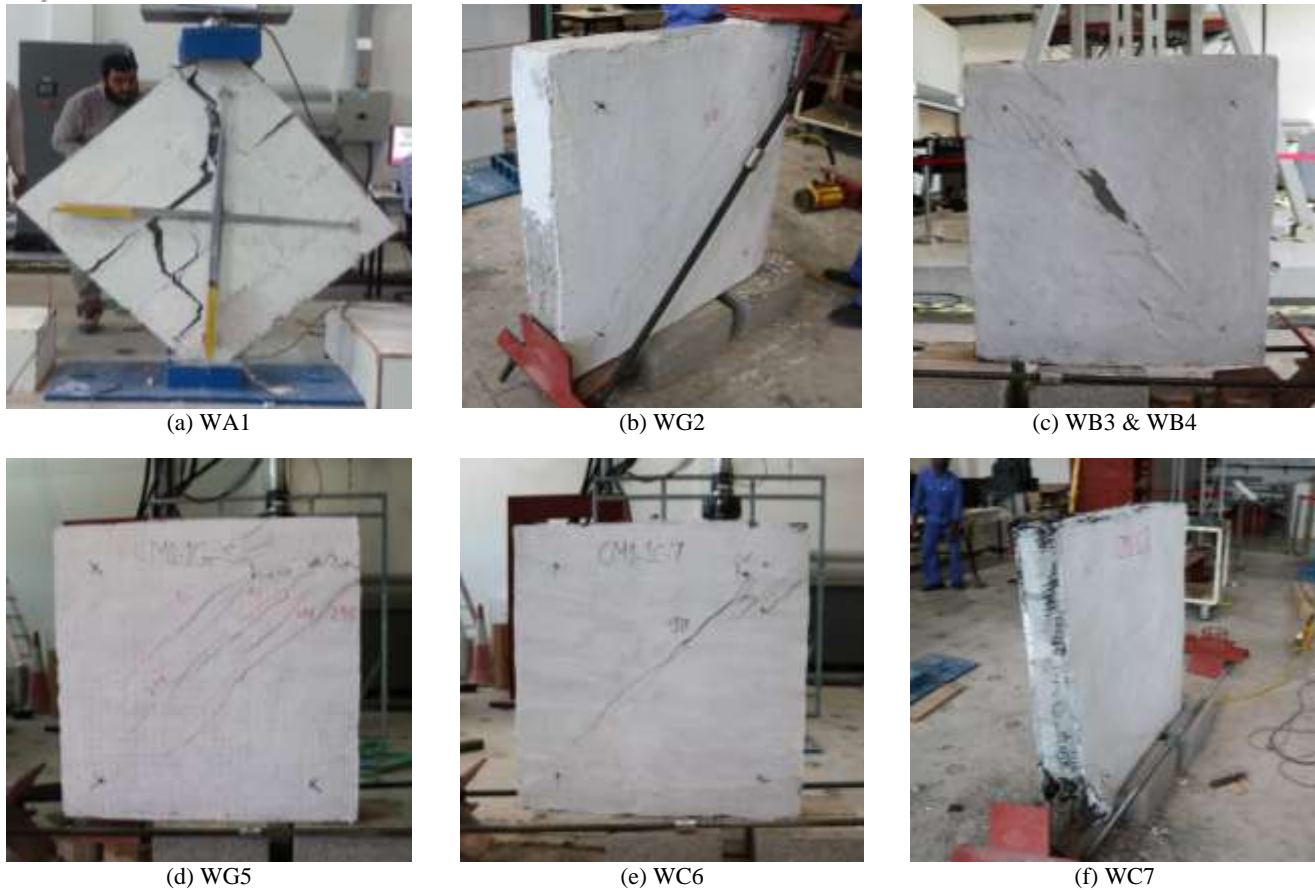
Fig. 4 – Observed crack patterns at the conclusion of tests

The observed failure mode during the testing of as-built panel are shown in Fig. 4a. The as-built tested panel (WA1) performed with an approximately linear behaviour up to first cracking and then failed suddenly in a brittle manner, exhibiting bed joint sliding failure mode. As the applied tensile stresses reached the tensile strength of mortar-brick interface, which was mainly derived from cohesion in this case cracks propagated through the interface that lead to sudden collapse in a brittle manner.

On the contrary, a more ductile and gradual failure was exhibited by the FRCM strengthened specimens. First diagonal crack appeared at a load of 300 kN in specimen WG2, where diagonal cracking initiated along the line of action of applied force. The cracked initiated from the loaded corners and propagated towards the middle region of the test panel, followed by localised toe crushing and splitting of concrete masonry near the loading corners as shown in Fig. 4b. Test panel WB3 exhibited similar failure mode, with first diagonal crack appeared at a load of 309 kN that was followed toe crushing and concrete masonry splitting near the loaded corners. In specimen WB4 (see Fig. 4c) failure initiated with localised toe crushing at a load of 191 kN, whereas the diagonal crack appeared at 345 KN load. Localised damage in outer layer of the FRCM matrix was observed after diagonal cracking but the splitting of masonry was not observed. In specimen WG5, toe crushing started at a load of 296 kN and first crack appeared at 311 kN (see Fig. 4d), followed by vertical splitting of masonry units.

In specimen WC6 (see Fig. 4e), toe crushing started at a load of 170 kN and the diagonal first crack was noted at a load of 317 kN. The diagonal crack penetrating throughout the thickness of the FRCM matrix were observed, whereas the carbon fibre was not ruptured. Diagonal cracking was not observed in specimen WC7 because of the early toe crushing at one of the loaded ends at a load magnitude of 215 kN, which initiated masonry splitting (see Fig. 4f).

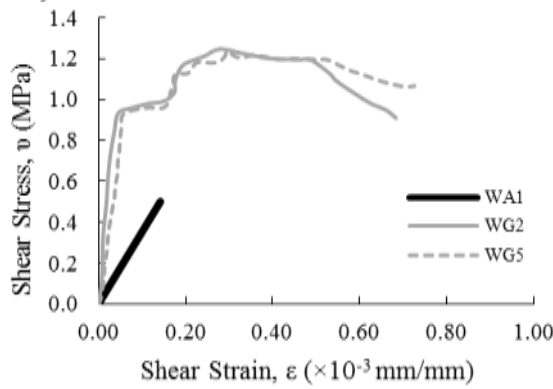
(a) WG2 and WG5

Fig. 6 – Experimental shear stress-strain response

Figs. 6a to 6c show the shear stress-strain ( $v$ - $\epsilon$ ) curves of tested wall panels, whereas Fig 6d shown the definition of reported parameters. In general, the  $v$ - $\epsilon$  curve of the as-built tested panel consisted of a linear initial portion until it suddenly collapsed/failed, with a sudden vertical drop in stress magnitude. FRCM strengthened test panels exhibited a linear-elastic behaviour up to cracking (characterised by the initial linear portion of the  $v$ - $\epsilon$  curves) and then a ductile failure mode with gradual decrease in the post-peak strength (characterised by flattened horizontal portion of the  $v$ - $\epsilon$  curves). Specimens retrofitted by glass and basalt FRCM have shown the same behaviour, whereas the specimens strengthened with carbon FRCM did not show same stress-strain curve because of the pre-mature localised corner crushing observed in wall panel WC7.

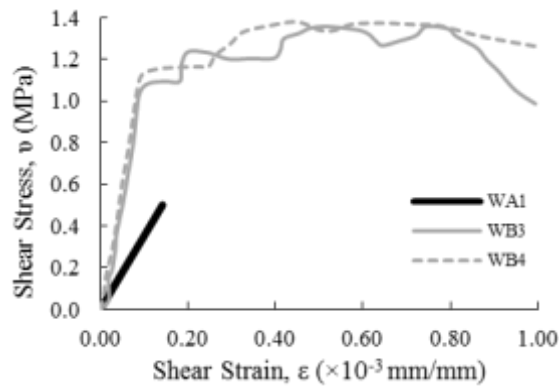
(b) WB3 and WB4

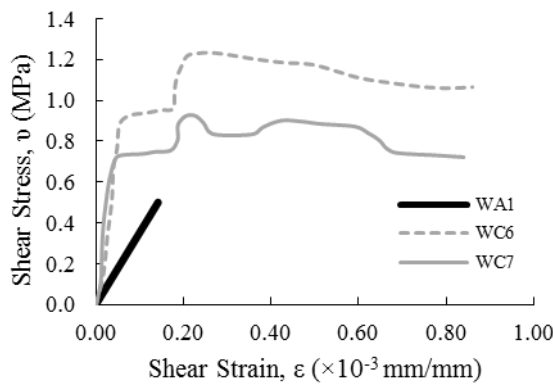
(c) WC6 and WC7

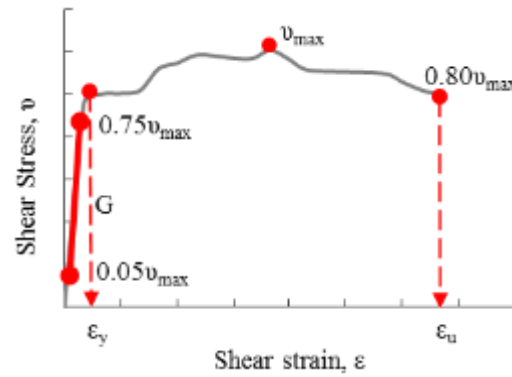
(d) Typical stress-strain behaviour
