## Two-way cavity clay brick walls tested in-situ

H. Derakhshan<sup>(1)</sup>, W. Lucas<sup>(2)</sup>, M.C. Griffith<sup>(3)</sup>

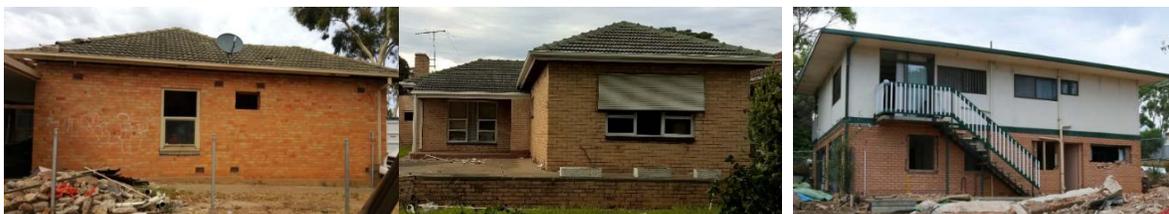
Figure 1: Case study buildings

Two of the buildings were single-storey suburban houses (Figure 1a and b) estimated to have been built in early 1960s and closely resembling each other in general aspects, e.g. wall thickness, finishes, cavity wall construction details, wall ties, and roof type. The roof of these buildings was mildly pitched, made of timber rafters and sheathing, and overlaid with masonry tiles. Its weight was supported by the outer leaf of the external walls resulting in the inner leaf to be without applied pre-compression. Some of the weight of the roof was carried by internal walls via struts connected to wall top. The structural foundation consisted of concrete strip footings with a wooden flooring. The 3<sup>rd</sup> building was an early 1980s two-storey house with a URM ground storey and a fibrous cement/steel frame on the top-storey (Figure 1c). The floor was 120 mm concrete slab that distributed the gravity loads over both masonry leaves. The roof had a light-weight metal construction.

The walls generally had no openings except for small penetrations for ventilation in some walls, an electricity box in one wall, and a small window in another wall as described herein. Wall A-1 had 4 small (250 x 180 mm) ventilation cavities close to the corners of the walls similar to those visible in Figure 1a. Wall A-2 had similar ventilation openings in addition to a 1.1 x 0.4 m cut-out in the external leaf that had previously housed the mains electricity breaker box. Wall B1 included a single window opening measuring 970 x 610 mm that was framed with a 90 x 45mm pine frame with 19 mm thick plywood panel before testing.

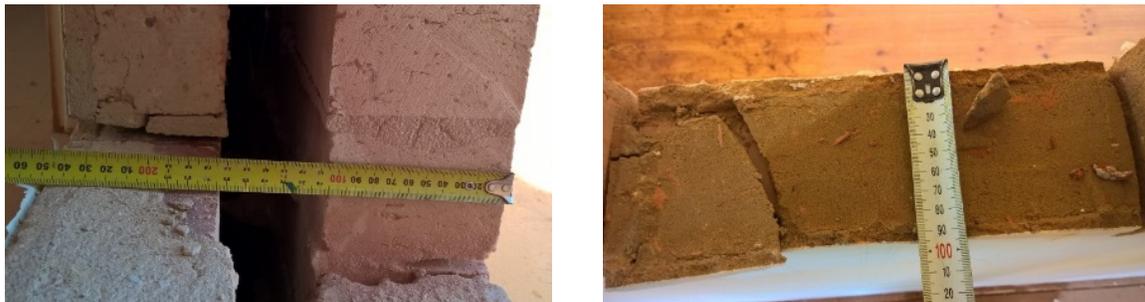
Figure 3: Details of wall construction (Buildings A and B)

The inner leaf of the external cavity walls and all the internal walls in Buildings A and B had been built with bricks laid on their depth, producing 76 mm leaf thickness, as opposed to the outer leaf and all walls in Building C that had been constructed with bricks laid on their width resulting in 110 mm wall thickness (Figure 3).

The inner face of the internal leaf of cavity walls (i.e. A-1, A-2, B-2, and B-4; typical out-to-out thickness of  $110+55(\text{gap})+76+10=250$  mm; see Figure 3a) and both faces of the internal single-leaf walls (i.e. A-3, B-3, and B-5; typical thickness of  $76+20$  mm; see Figure 3b) had a 10-mm low-strength cement plaster finish. The walls in Building C had the original brick surface without rendering.

(a) Wall B-2 (typical external wall in Buildings A and B)      (b) Wall A-3 (typical internal wall in Buildings A and B)

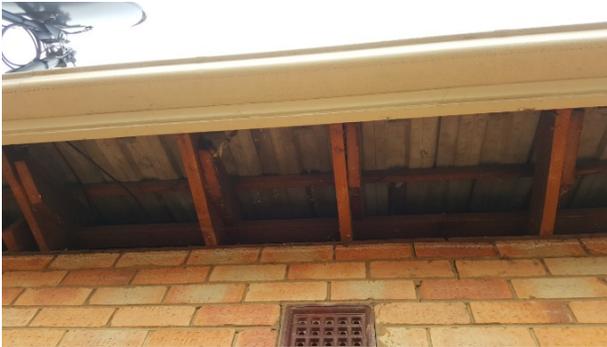
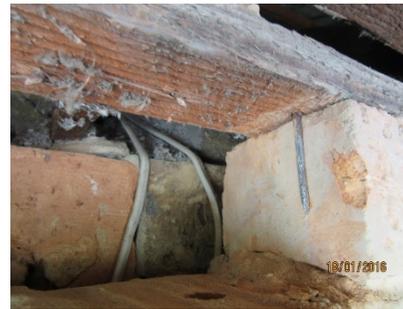
Figure 4: Details of roof rafters sitting on top of the exterior walls (Building A)

In both Buildings A and B, the top of the inner leaf of the external walls (i.e. Walls A-1, A-2, B-2, and B-4) was loosely connected to the ceiling via a cornice, with the connection providing little or no restraint and these wall leaves carrying no axial load. The top of the exterior leaf was supported by roof rafters (*Figure 4a*), with the rafters seating on a top timber bearing plate that was nailed into the top course of the masonry (*Figure 4b*). Hence, the external wall leaf was load-bearing.

(a) Roof rafters sitting on external wall leave

(b) Nailed connection of the timber plate to external wall leaf

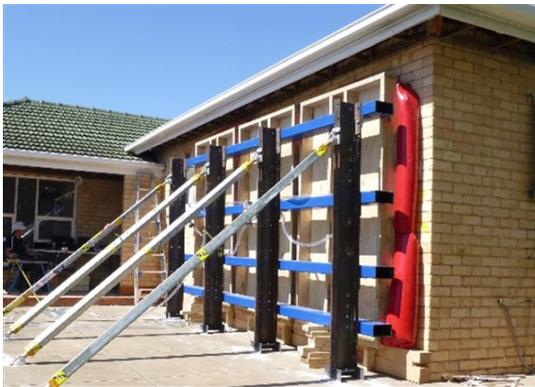
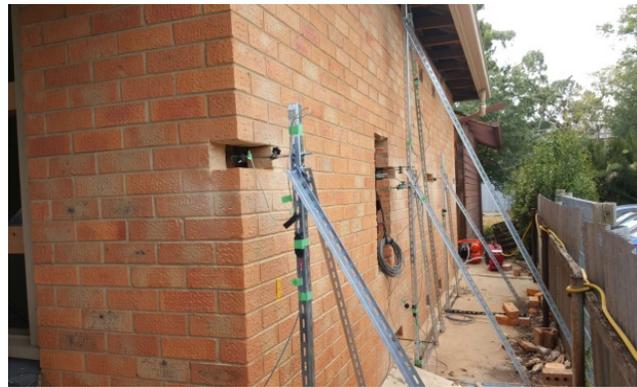
Figure 6: Test setup

A typical in-situ test setup has been shown in Figure 6. Except for wall B-2, the other external walls were tested by applying a uniformly-distributed pressure on the internal leaf by means of a system of airbags. For Wall B-2, airbag pressure was applied from outside the building on the external wall leaf face (Figure 6a).

In all cases timber backing boards were fabricated to the geometry of wall and placed within approximately 100 mm of the wall face being loaded. The backing boards were secured either to the cross walls (where existed) or to the floor. Airbags were placed in the gap between the backing and the wall and inflated to apply pressure on wall surface. The pressure was directly measured using an electronic pressure potentiometer and the data transferred to a data logger.

Wall displacements were recorded using LVDTs setup (Figure 6b) in accordance with the assumed restraint conditions such that the maximum displacement as well as the horizontal and vertical displacement profile could be captured.

(a) Backing frame (Wall B-2)

(b) Typical instrumentation (Wall A-2)

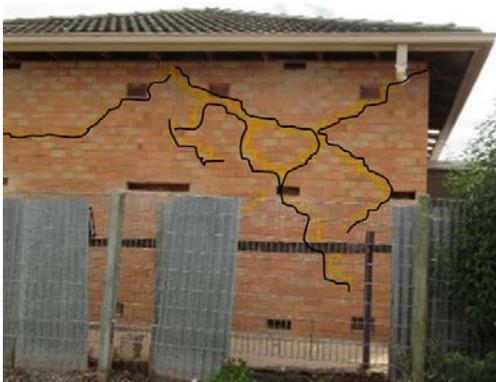
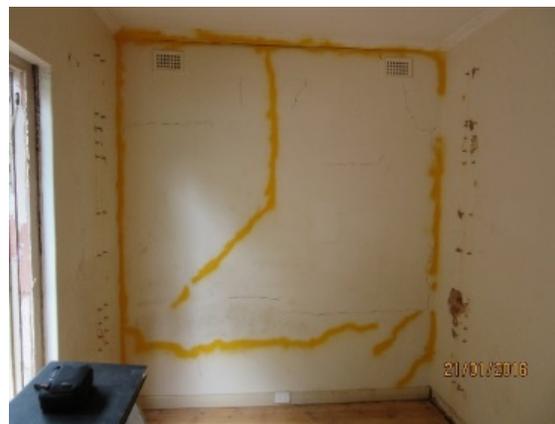
Figure 7: Crack pattern for Wall A-1

(a) External leaf

(b) Internal leaf (loaded)

The cracking pattern for external leaf of Wall A-1 (Figure 7a) is consistent with that for a wall with lateral restraint along 4 edges, where diagonal cracks extend from the wall corners with an angle that is equal to the natural slope of masonry construction, i.e. height to length ratio of masonry units. This cracking pattern suggests that the wall ties transferred significant amount of force to the external leaf. The damage observed for the internal leaf (Figure 7b) is consistent with a wall supported along three edges, with the top edge being free. A the

joint between the top cornice and the wall opened as visible in Figure 7b) due to the little restraint provided by the connection. The observed damage for Wall A-2 was very similar to A-1. The cracking in Wall A-3 confirmed that the roof strut supporting the top of the wall as described earlier herein provided sufficient restraint that prevented deformation at the top boundary. The wall deflected profile will further be discussed in the next sections.

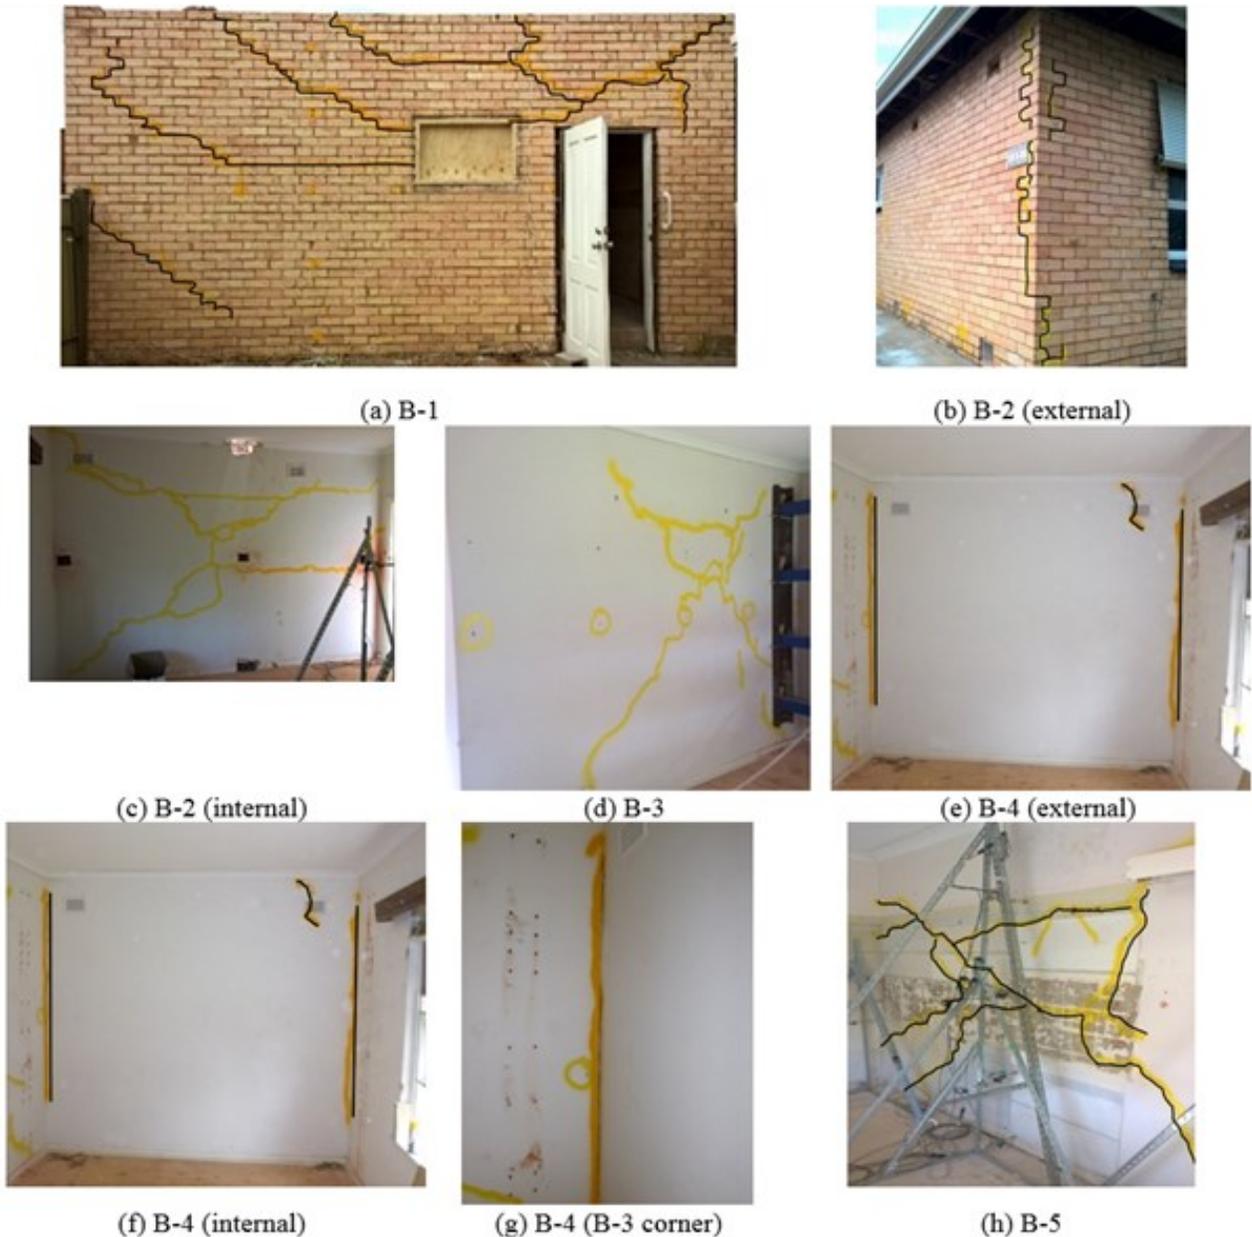
Figure 8: Crack pattern for walls in Building B

The crack patterns for walls in Building B are shown in Figure 8. The damage in Wall B-1 (Figure 8a) was focused on upper half of the wall due to some out-of-plane slip occurring at the wall ties. The damage included re-opening of the pre-existing cracks in the spandrel above the door opening and the deflected profile (as discussed later herein) suggested that the spandrel provided little restraint, with the wall response being consistent with a three-edge supported wall. Post-test observation of loaded wall face revealed vertical joint between the test wall and the masonry piers indicating no positive connection.

The wall that was loaded from external face (B-2, Figure 8b and c) underwent cracking on the internal leaf (Figure 8c) that was slightly shifted upwards from the wall mid-height, similar to the case of Walls A-1 and A-2.

This observation was consistent with the boundary condition at top, which was ceiling cornice with negligible restraint. Some cracking was observed in the adjacent room that suggested the door frame shown in Figure 8c (right vertical edge) did not provide the test wall with substantial restraint. The internal walls B-3 and B-5 (Figure 8d and h) underwent cracking consistent with four-edge supported wall demonstrating the effectiveness of the roof strut connections at top. The crack pattern on the external face of Wall B-4 (Figure 8e) was slightly shifted upwards due to roof flexibility and the lack of rotational restraint along the top edge. The vertical edges of Wall B-4 connection with an external wall and an internal wall (previously tested B-3) showed cracking (Figure 8f) most significantly for the latter (Figure 8g). The larger cracks at this corner with the internal wall was attributed to lack of good interlocking between external and internal walls.
