## IMPLEMENTING A HOLISTIC DUCTILE DESIGN APPROACH TO STAINLESS STEEL WINE STORAGE TANKS

### Abstract

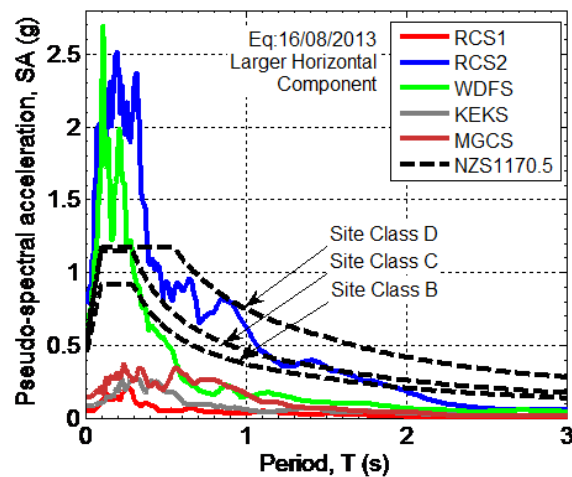
Fig.3 illustrates the larger component response spectra of the observed ground motions in the Marlborough region in comparison to the NZS1170.5:2004 design response spectrum for  $Z=0.4$  (the representative value for Seddon and Ward, while Blenheim has  $Z=0.33$ ) and a Return Period Factor,  $R_u$ , of 1.0. It is the understanding of the authors that the majority of tanks in Marlborough are designed for lower levels of shaking using Importance Level of 1, corresponding to an  $R_u$  of 0.5

Fig.3 - Larger horizontal response spectra recorded at strong motion stations in Marlborough during: (a) the 16 August 2013 Lake Grassmere earthquake. (Source: Morris et al. 2013)

It can be seen that shaking in Seddon (i.e. RCS2) and Ward (i.e. WDFS) significantly exceeded the site class C design spectrum for vibration periods less than 0.3 seconds. For periods greater than  $T=0.3s$  the spectral amplitudes in Ward rapidly reduce (due to very shallow soil overlying rock), while the spectrum in Seddon exceeds the design spectrum for periods beyond  $T=1.0s$ . As previously noted, the ground motion amplitudes in Blenheim and the Wairau Valley can be seen to be significantly smaller than those in Seddon and Ward, and well below design levels.

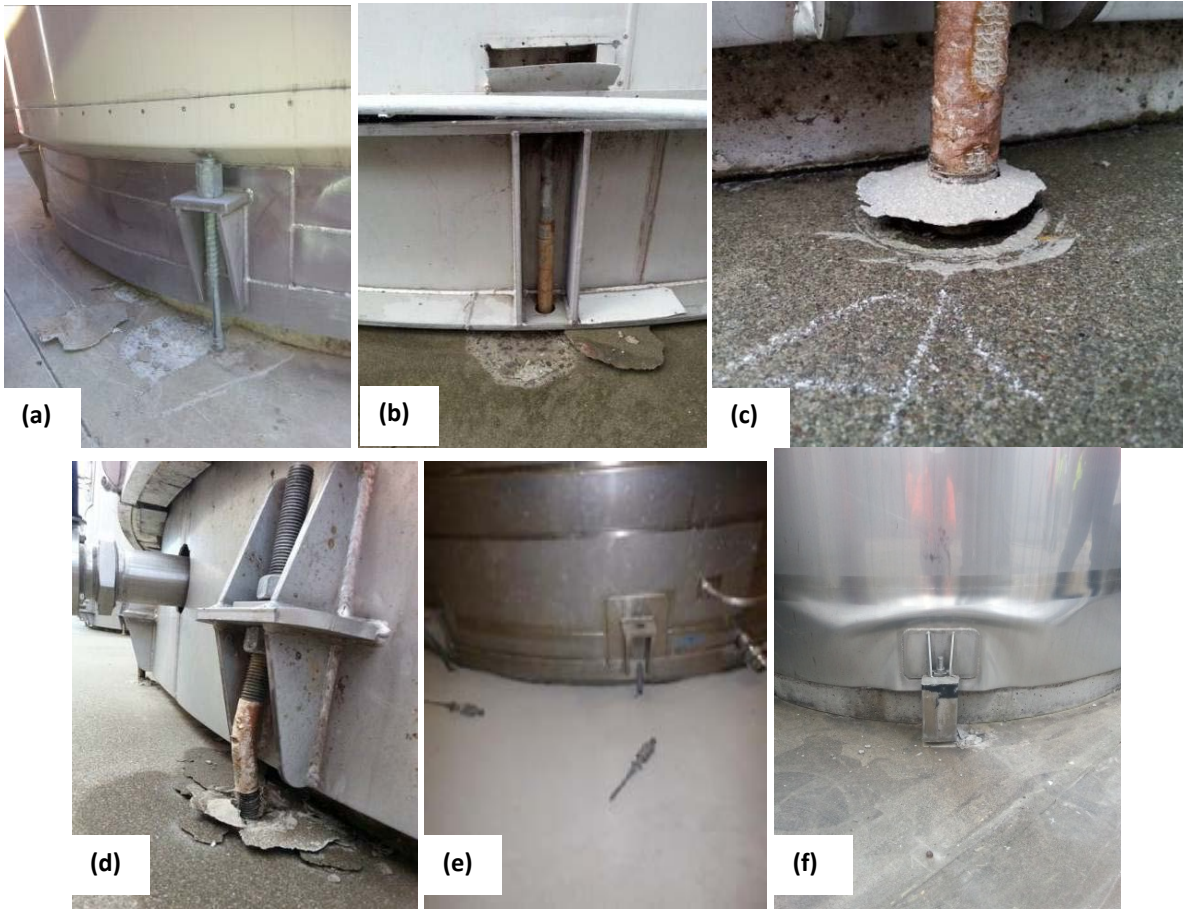
Anchorage failure by pullout, bolt tensile fracture and bolt shear failure

Fig.4 (a-h) -Various damage observations for plinth mounted wine storage tanks.

- Anchor failure in the form of anchor fracture, anchor yielding, pullout through the epoxy, or concrete cone failure as shown in Fig.4 (a)-(e).
- Lateral movement on the plinth, leading to bending of anchors.

- Localized stress to tank skirt associated with poor distribution of anchors around the tank (Fig.4 (f)).
- In extreme cases, buckling of tank walls, both in elephant's foot and diamond shaped buckling modes (reference Fig.4 (g-h)). The elephant's foot buckling appeared to be constrained by the coolant bands. Buckling appears to have occurred when the tank settled so far down the plinth that the skirt makes contact with the slab forcing the tank wall to resist excessive compressive loads.
