PERFORMANCE OF TRANSPORTATIONS SYSTEM IN THE 2016 KUMAMOTO EARTHQUAKE

Abstract

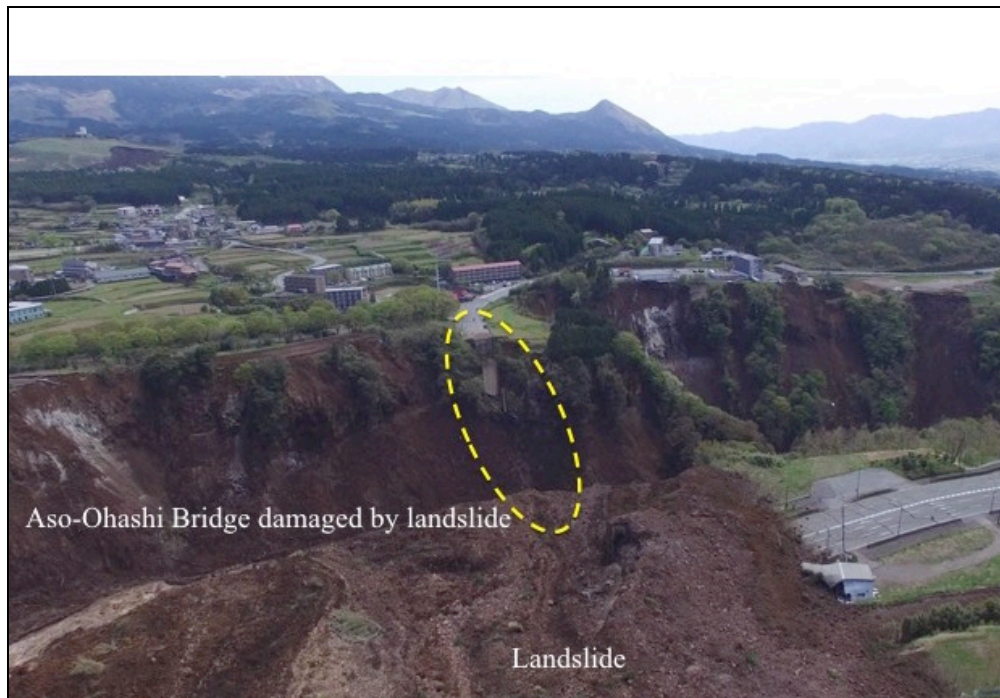
Figure 1. Aso-Ohashi Bridge was damaged by massive landslide

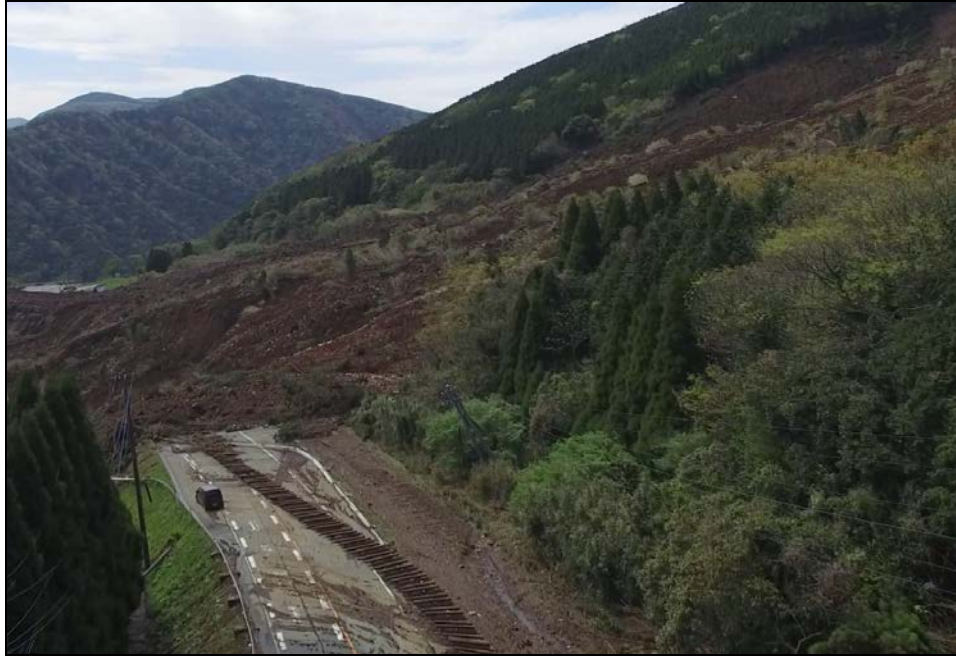
As of the first week of July there are a few railway lines that are not operating yet. The most important one is the tourist train to Aso Volcano. A large part of the train track was dislocated by landslide. For major routes the recovery was quite quick.

Figure 2. Railway track was dislocated by landslide.

The railway system in Kyushu is mainly operated by Kyushu Railway Company (JR Kyushu) and Nishitetsu Railway. Kyushu Island is link to Honshu (main island) by Kanmon Tunnel and Kanmon Bridge. The island has both Shinkansen and non-Shinkansen railway services. Landslides also impacted railway tracks, as shown in Figure 2. There was a deadheading
