GEER-ATC M_w7.8 ECUADOR 4/16/16 EARTHQUAKE RECONNAISSANCE PART II: SELECTED GEOTECHNICAL OBSERVATIONS

Abstract

Keywords: earthquake reconnaissance; geotechnical observations; liquefaction; site amplification; ports; GEER; ATC.

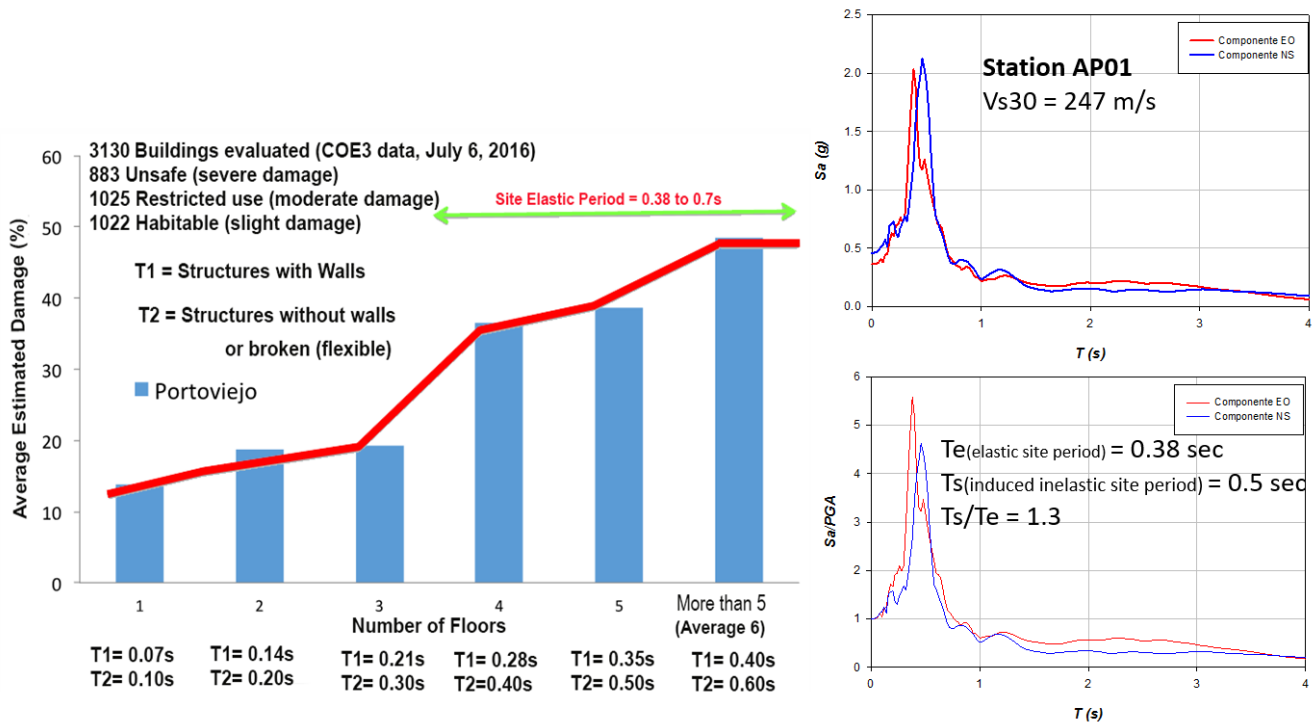
Figure 2. (a) Average estimated damage in Portoviejo based on ATC procedures and (b) acceleration response spectra for 5% structural damping for station APO1 with its normalized acceleration response spectra (modified from [1]).

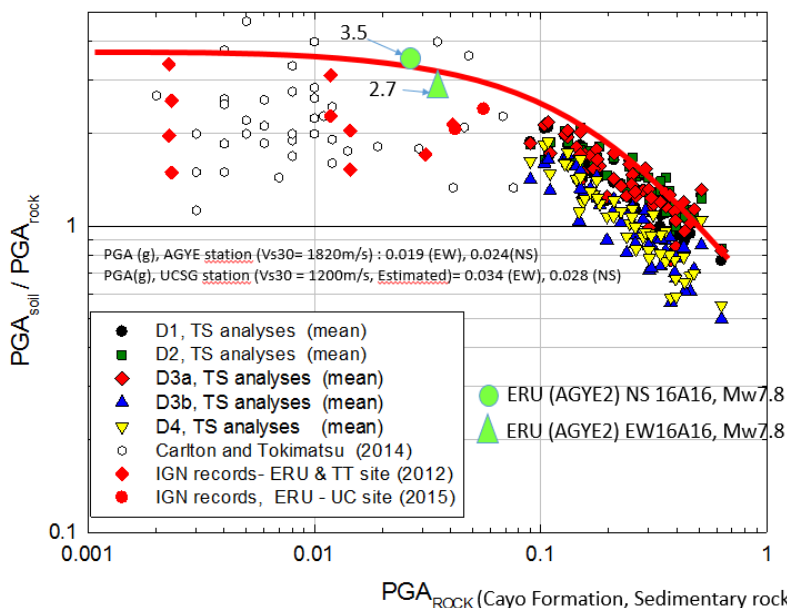
Figure 5. Guayaquil: Peak Ground Accelerations (PGA) relation between soil and rock for the PGA of Cayo Formation, modified from Vera-Grunauer (2014)^[4]

Figure 5 presents the PGA amplification between the soil and rock (PGA_{soil}/PGA_{rock}) for the Cayo formation. Low intensity earthquakes of 2012 and 2015 are included, together with estimations for the deltaic estuarine deposits for high intensity earthquakes. The April 16th main earthquake records in the two components fits well with the average calculated from nonlinear total stress analyses in the different geotechnical zones of Guayaquil. Amplification (PGA_{soil} at AGYE2 station and the estimated PGA_{rock} at UCSG station) of 3.5 and 2.7 were observed for NS and EW component, respectively.

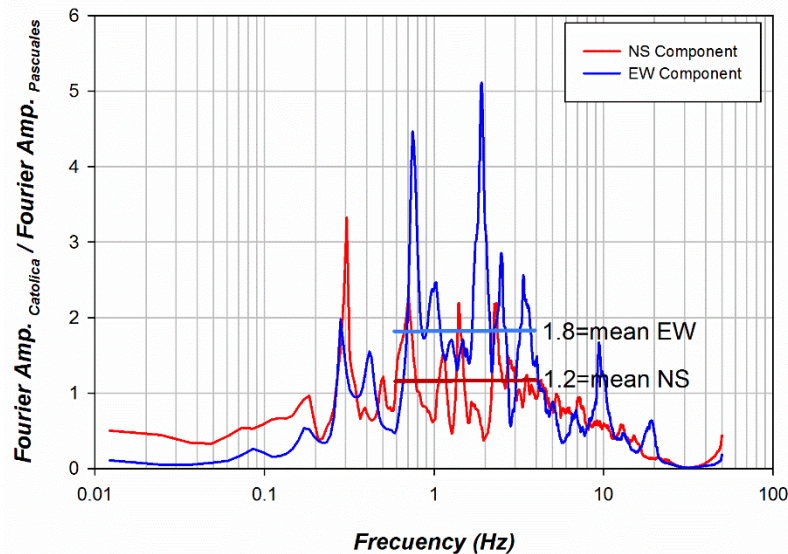
Figure 6. Fourier amplitude spectra ratio between UCSG and AGYE PT stations

Using the adjusted seismic record of Pascuales (AGYE, TP), scaling factors were estimated based on Fourier amplitude spectra ratio between the UCSG (Cayo formation) and AGYE TP (Piñon formation) stations as shown on Figure 6. The period range of 0.7 to 4 s (1.4 to 0.25 Hz) was considered to obtain the scaling factors

which will define the transfer functions (from AGYE TP to UCSG station) for the input motion at outcropping rock in AGYE2 soil column. Scaling factors of 1.8 and 1.2 were obtained for the EW and NS components, respectively. The scaled input seismic records were considered to be characteristic for outcropping motion for Cayo formation (Type B). Then, wave propagation analyses using the software DMOD and SHAKE, were done for the AGYE2 soil column. The comparison between the AGYE2 records and the estimated site response is shown on Figure 7. For the EW component, there is a good agreement between the estimated and measured spectra for all periods, while in NS, the long-period response from 0.9 to 2.5 s was underestimated by using the 1.2 scaling factor. The PGA at both AGYE2 components matched the estimated site response. The difference in the sedimentary rock lithology at UCSG and the igneous rock at AGYE TP, combined with possible topographic effects due to the intrusion of the igneous rock could have influenced the NS component at AGYE TP station. At AGYE2 station, the S_a for this deep soft site was 10 times higher than UCSG at the site's inelastic site period of 1.65 s.

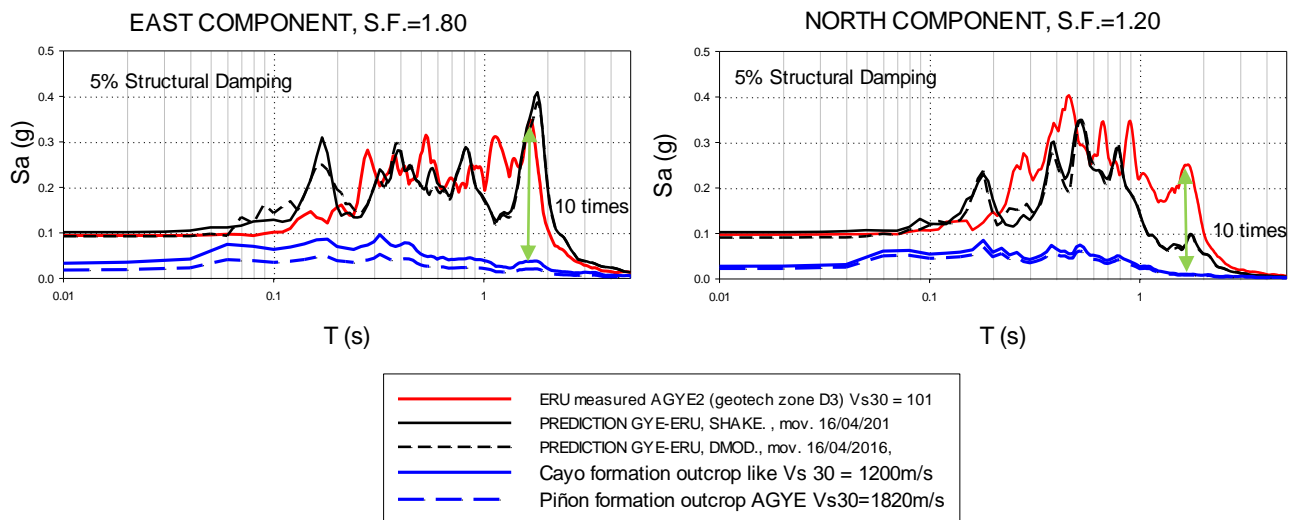
Figure 7. Predicted and measured spectra in AGYE2 station by propagating the scaled AGYE TP record

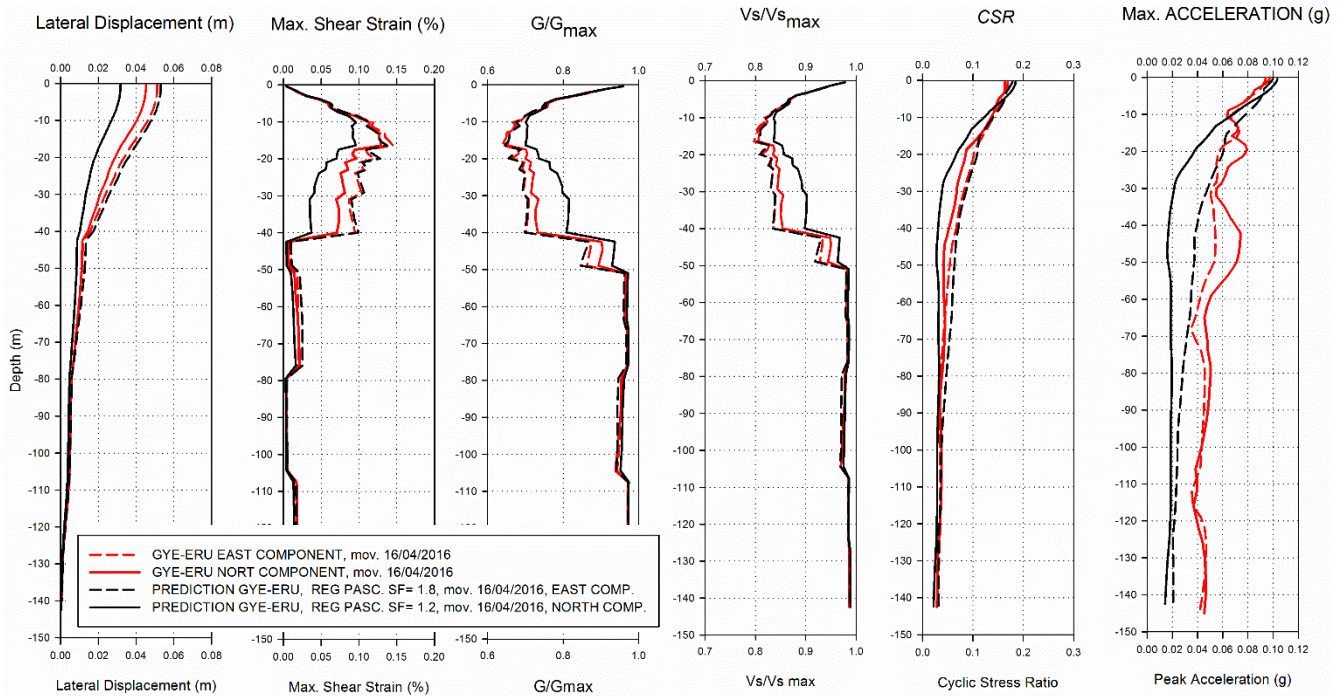
Figure 8. Lateral displacement, max shear strain, G/G_{\max} and $V_s/V_{s\max}$, CSR, and max acceleration comparison between the predictions and measurements at the AGYE2 station.

A deconvolution analysis was performed from the AGYE2 Ramon Unamuno record within Zone D3a with similar response observed in the estimated maximum shear strain, induced G/G_{max} and cyclic stress ratios, CSR

($0.65\tau_{\max}/\sigma'_{v0}$) for the EW and NS components by propagating the scaled AGYE TP record in AGYE2 soil column (Figure 8). The levels of accelerations in the 2016 event were similar to the ones in the 1942 event. In the 2016 earthquake the overall behavior was satisfactory with only few structures collapsing, several buildings with structural damage and some buildings with nonstructural damage.

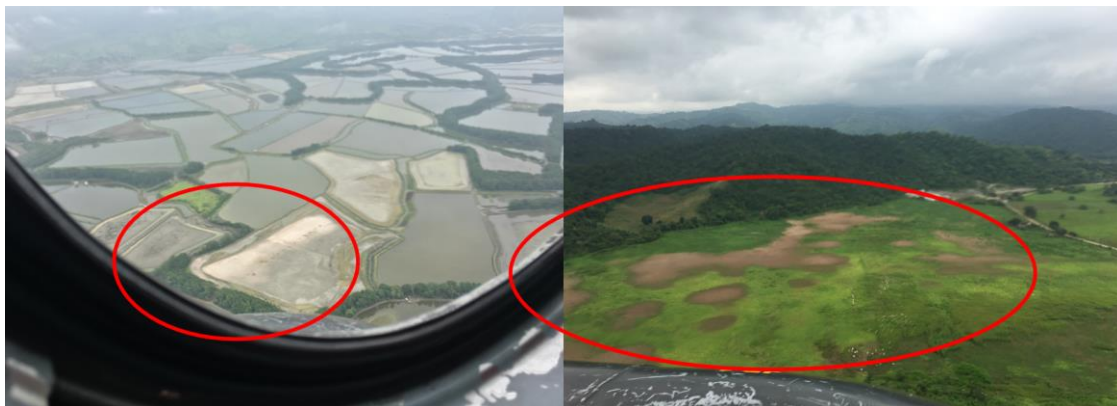
Figure 9. Liquefaction evidence from helicopter flyover of Manabí coast from the GEER-ATC reconnaissance mission ^[1] (GPS, left: $0^{\circ}39'41.8''S$, $80^{\circ}18'46.6''W$; right: $0^{\circ}12'31.7''S$, $80^{\circ}15'22.5''W$)

Liquefaction was observed at the affected coastal areas due to presence of loose granular soils and shallow groundwater, with several cases in the city of Manta and along the Portoviejo River^{[1], [2]}. Two macro-landslides in Manabí were likely triggered by increment in water pressure and loss of soil strength due to possible liquefaction not evident at the surface near the landslides. Evidence of liquefaction with flooding and settlements was detected during the GEER-ATC army helicopter flyover as shown on Figure 9^[1] with potential sand ejecta.

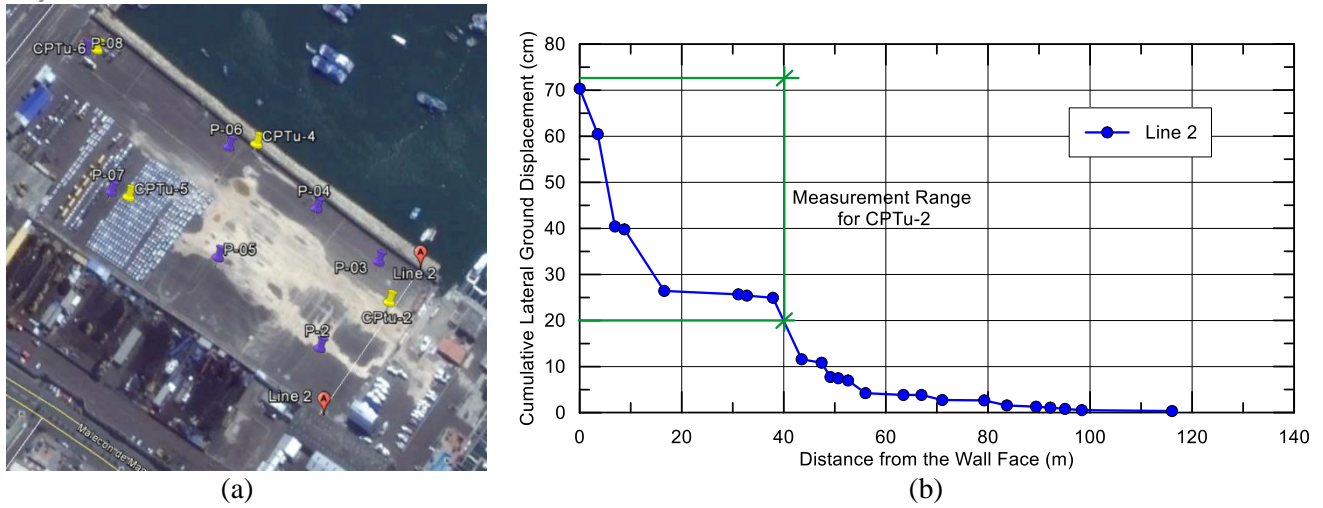
Figure 11. (a) Location of line 2 in Lot 500, (b) Cumulative lateral spread displacements measured along Line 2.

Seven SPT tests were performed in Lot 500 as is shown in Figure 11 and the liquefaction potential and volumetric settlements were evaluated by various authors^{[8] [9] [10] [11] [12] [13] [14]}. In addition, several CPTu tests were performed in the lot area and the liquefaction potential and post-liquefaction effects were evaluated. Figure 11 shows the location of CPTu-2 in the parking lot, while Figure 13 presents the liquefaction potential estimated by the method of Idriss & Boulanger (2008)^[12] and Robertson (2009)^[9], and the volumetric settlement and lateral displacement estimated by the method of Zhang et al. (2002, 2004)^{[11] [13]} and Idriss & Boulanger (2008)^[11]. The method of Idriss and Boulanger (2008)^[12] considers the Fines Content variation, thus this was calibrated with a SPT boring performed close to CPTu-2. It can be seen that the method of Zhang et al. (2002, 2004)^{[11] [13]} yields closer predictions to the measured lateral deformations.

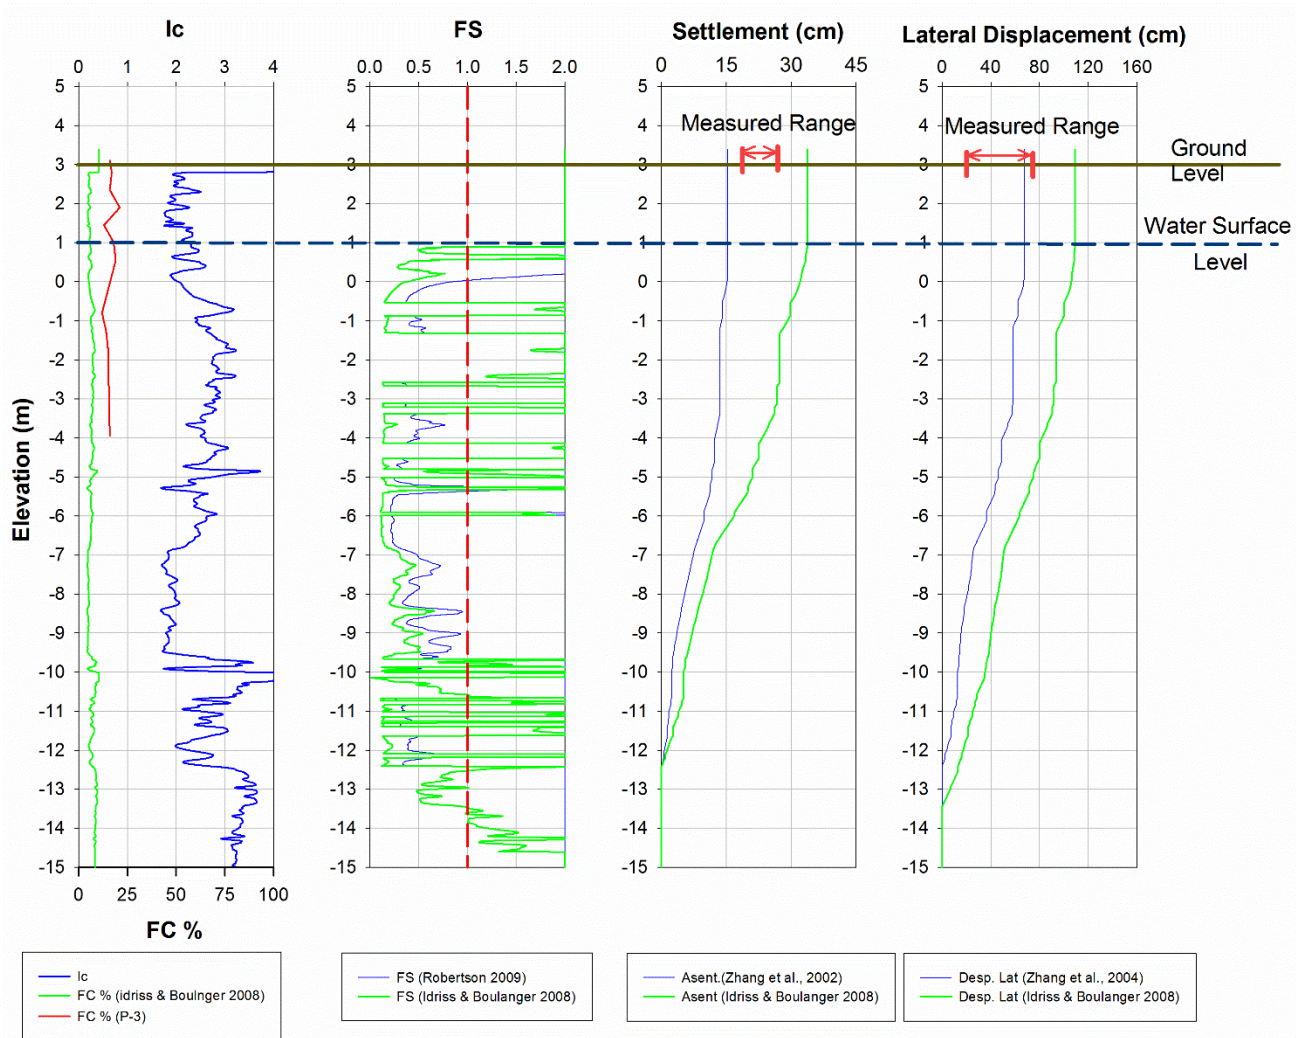
Figure 12. Liquefaction potential and lateral displacement evaluation for CPTu-2 in Lot 500.

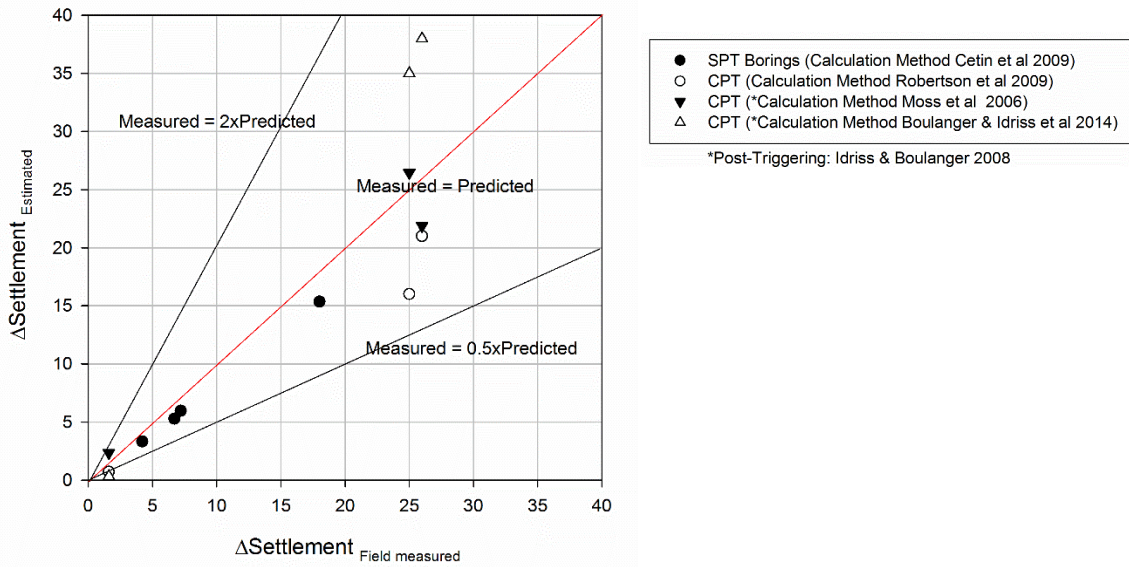
Figure 13. Post-liquefaction volumetric settlement (in cm) calculated and measured at Lot 500 in Manta Port.

A comparison of the estimations and the measurements in each of the SPT locations is shown in Figure 13. It can be observed that Cetin et al. (2009)^[8] and Moss et al. (2006)^[10] yield closer estimations to the observed in field.

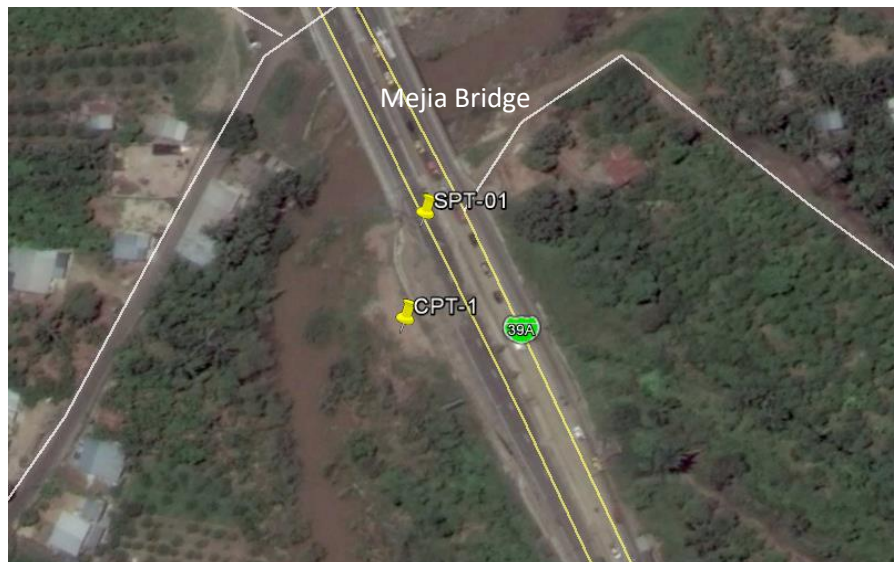
Figure 14. Location of the SPT and CPT tests performed at Mejia Bridge

The location of a SPT and CPTu tests performed after the earthquake are presented on Figure 14. In addition, an aerial view of the failure at the Mejia Bridge site (by COE-3) is shown Figure 15 with sketched markups of the observed movement of the embankment along assumed failure planes. The failure planes appear to be either along the interface between the embankment and the foundation soils (planar surface) or through the foundation soils. The latter, indicative of a more circular surface failure may be due to liquefaction-induced softening that allowed the reduced-strength soil to shear in the earthquake.

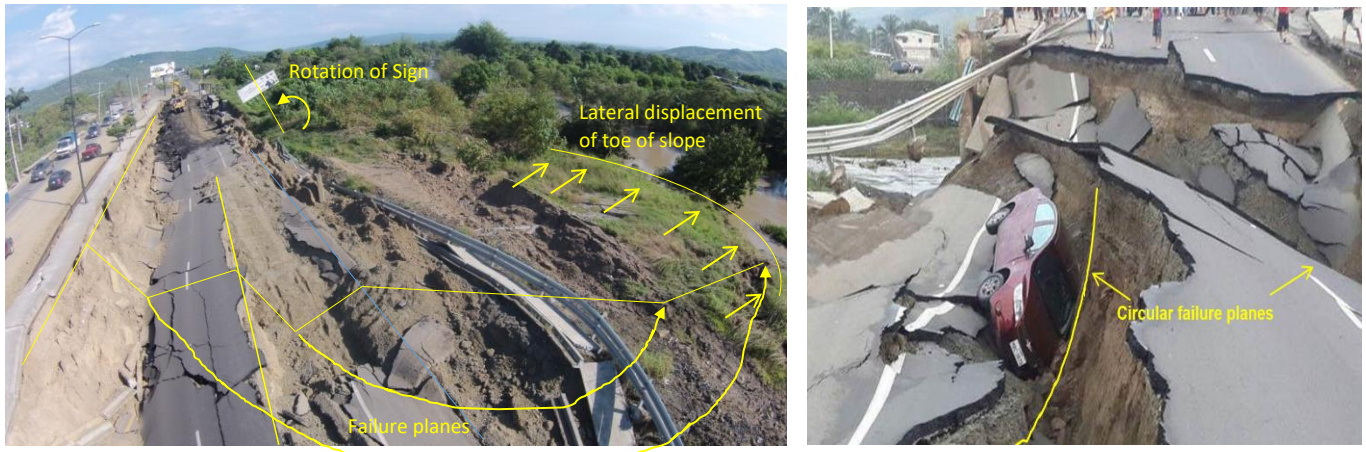
Figure 15. Mejia Bridge. Right: Aerial view of embankment failure with assumed movement and failure modes marked with yellow (after COE-3, GPS: 0°59'24"S, 80°28'11"W). Left: Embankment view after earthquake. For details see [1].

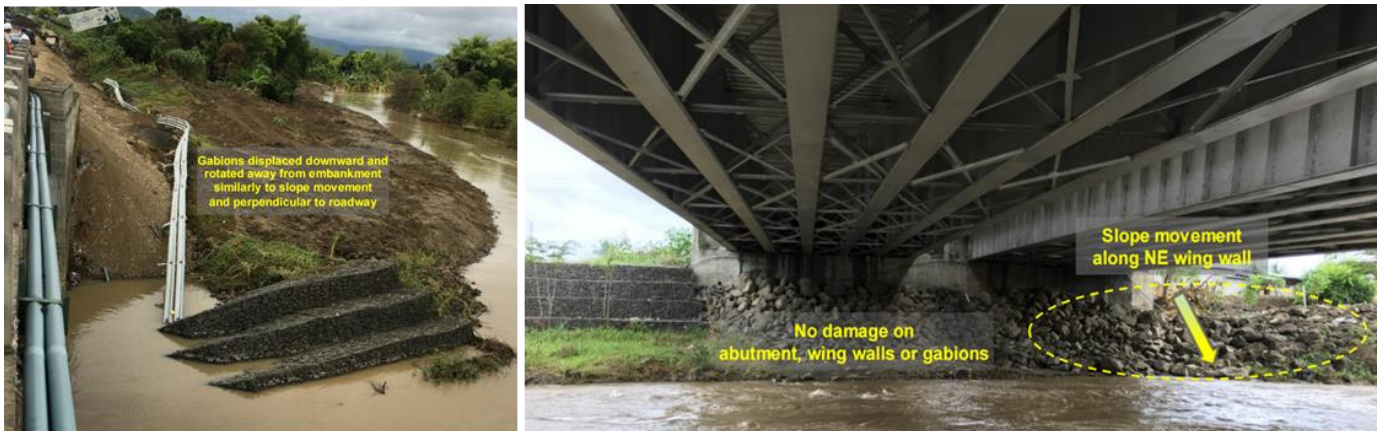
Figure 16. Mejia Bridge. Left: Failures of SW abutment and gabions (GPS: 0°59'23.5"S, 80°28'11.6"W). Right: North abutment performance (GPS: 0°59'24.94"S, 80°28'11.26"W). For details see [1].

The south west abutment and gabions of the Mejia Bridge displaced downward and rotated away from the embankment. The north abutment exhibited little damage to the walls and gabion slope adjacent to the bridge, with some settlement and/or rotation of the slope next to the NE wing wall (Figure 16).

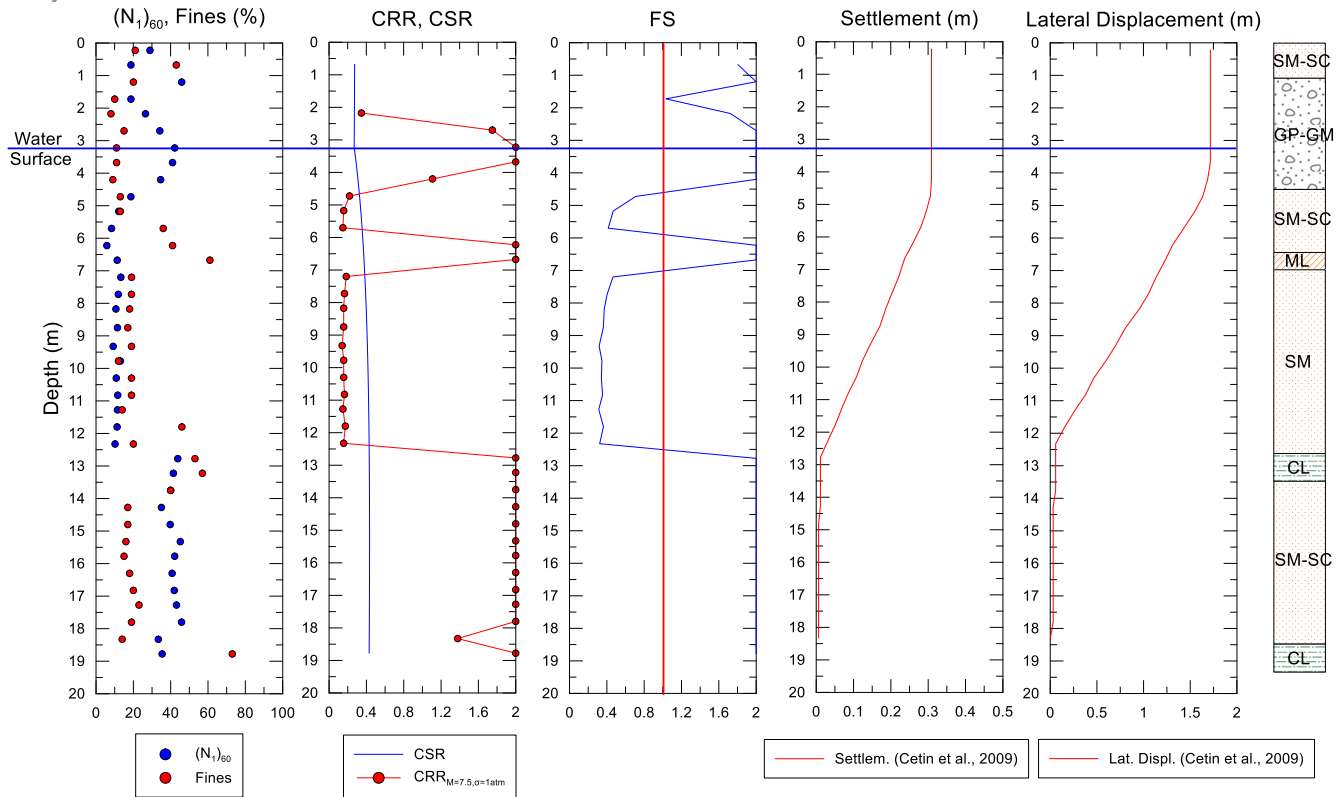
Figure 17. Liquefaction potential and post-liquefaction evaluation for P-01 Mejia Bridge Embankment.

The liquefaction potential and post-liquefaction effects were evaluated for the SPT P-01 located at the top of the embankment and the results are presented in Figure 17. For fine grained soils criteria of Bray and Sancio (2006)^[15], which is based on the PI and w_c/w_L was considered. Consequently, soils that due to its index properties are not susceptible to liquefaction were not evaluated in post liquefaction analysis. Additionally, it is assumed a similar effect on triggering effects of the fines content on the lateral spreading. The large value of displacement estimated of 1.7 m would indicate the failure in the embankment.
