M_w7.8 MUISNE, ECUADOR 4/16/16 EARTHQUAKE OBSERVATIONS: GEOPHYSICAL CLUSTERING, INTENSITY MAPPING, TSUNAMI

Keywords: Earthquake; tsunami; liquefaction; subduction; Ecuador

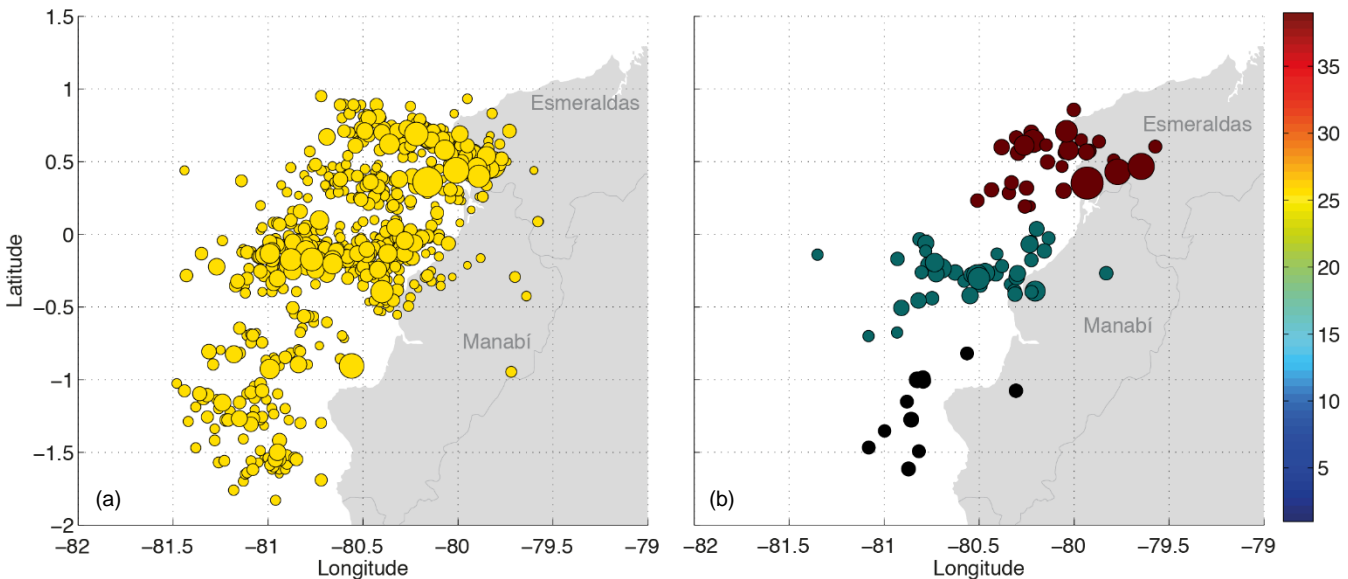
Fig. 4 – (a) IGEPN spatial distribution of 4/16/16 earthquake and aftershocks; (b) geophysical clustering from pre-seismic radiation correlation with spatio-temporal distribution of USGS data [24]. Observations up to 5/20.

The presence of such clusters has been demonstrated [24] by correlating clear pre-seismic radiation with the spatio-temporal distribution of USGS data. The methodology followed allows, with respect to the rupture process: (1) association of seismic events with main points of energy release; (2) geophysical clustering of aftershocks; and (3) identification of geodynamic relationships between clusters since the main shock.

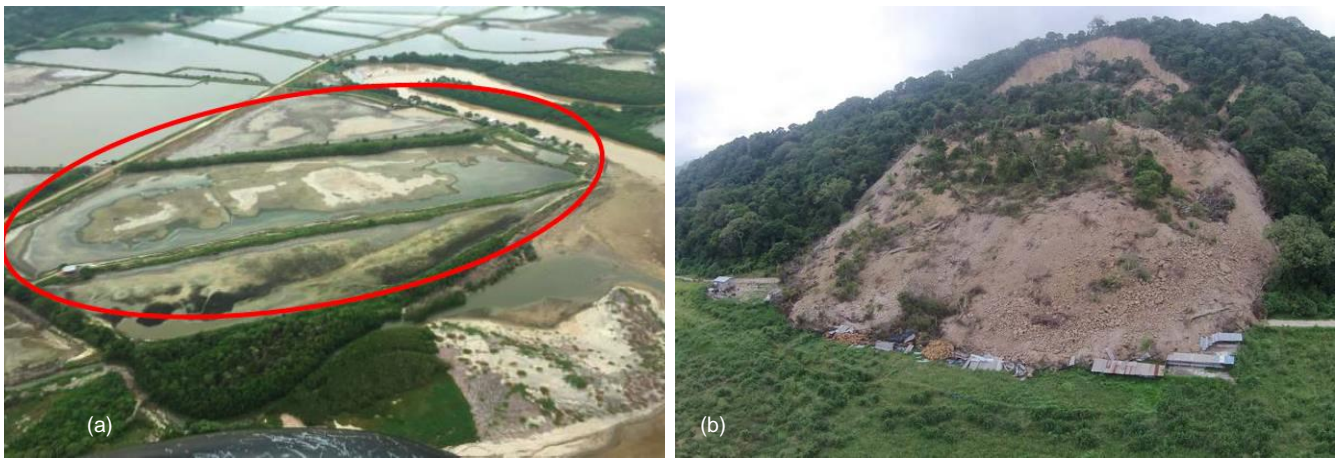
Fig. 5 – (a) Liquefaction evidence from GEER army helicopter flyover of Manabí coast, at Jama; (b) landslide on San Vicente-Canoa road. Source: GEER-ATC Report [1].

A geological survey and collection of field data collection were performed within 3 days from the main event [1], providing 290 data points of earthquake-induced (coseismic) effects for evaluating max macroseismic intensities (evaluated using the ESI 2007 scale [21]) and predominant geomorphological features. The latter are important in evaluating site effects documented in Muisne, Pedernales, Jama, Canoeing, Chone, San Isidro, Manta, Portoviejo and Tosagua. Aftershocks of the same seismogenic structure as the main event generated settlements and sinkholes, soil liquefaction with sand ejecta and landslides in Pedernales and Mompiche.

To understand the isoseismal fields of macroseismic intensities the coseismic geological information was compiled in the field based on: (a) landslides of natural and stabilized slopes, (b) cracks in natural field in the supratidal coastal and flood plains, (c) fractures to the main axis of concrete and paved roads, (d) sinkholes and liquefaction in floodplains and areas of paleo-meander, (e) surface faulting with displacements in hilly areas, (f) natural and anthropic subsidence between hills and floodplains, (g) minor tsunamis with logs of run-up height < 1 m. Field effects were included for local intensity > VI. The GEER-ATC reconnaissance team provided organized information of earthquake-induced failures [1]. For example, the army helicopter flyover of Manabí coast showed evidence of land settlement and liquefaction in flooded areas with sand ejecta in Jama (Fig. 5a), and landslide at the San Vicente-Canoa local road (Fig. 5b).

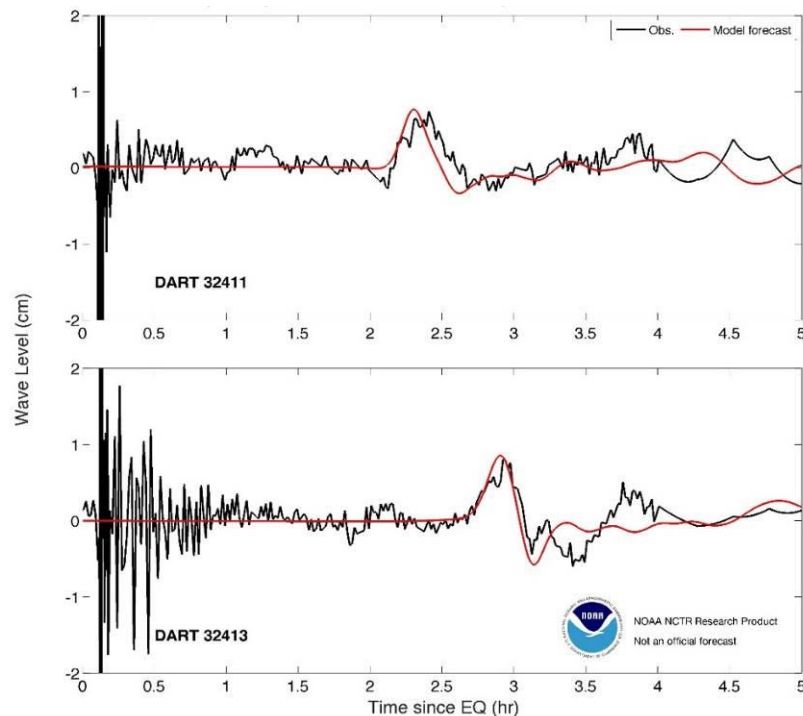
Fig. 7 – Register of oceanic propagation of the tsunami at DART Buoy position. Source: NOAA.

There is no certainty if the April 16th 2016 tsunami was triggered by a massive submarine landslide or seafloor coseismic deformation. According to the Ecuadorian Oceanographic Institute of the Navy, INOCAR, the tsunami crest arrived at Esmeraldas 6 min after the earthquake. This is a very short travel time from the tsunami landslide scars [32], and for the fault plane of the similar 1942 event [9]. Numerical simulation shows that the tsunami should have travelled > 20 min from its generation zones. When the focal mechanism is well defined, we would update the numerical simulation for seismically-induced tsunami. Nevertheless, a tsunami was triggered, as registered 2 and 3 hours after the earthquake by 32411 and 32413 DART NOAA buoys at the Panama and Peru basins, respectively. Seismic waves propagated over the seabed, affecting the register at the buoys' pressure sensor up to 1 hour after the earthquake (Fig. 7). The tsunami period was approximately 40 min with amplitude of about 1 cm based on observations.

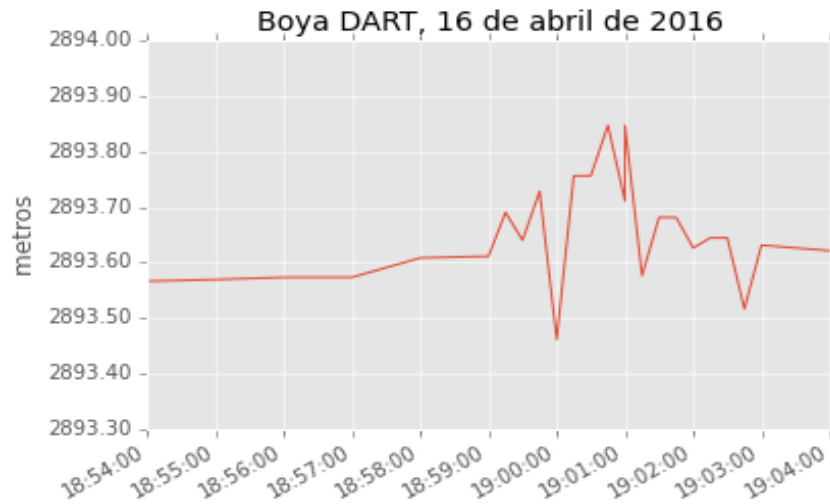
Fig. 8 – Tsunami sea level perturbations. Source: INOCAR.

Locally, the tsunami was registered by the INOCAR-DART buoy, which is close to the epicenter, immediately after the earthquake. It has been difficult to differentiate the tsunami signal from the noise produced by the earthquake. However, the perturbation existed after the earthquake time, changing the initial conditions in the calm water level (Fig. 8). INOCAR issued a Tsunami Warning over the entire Ecuadorian coast based on the data from their buoy, which remained in effect 4 hours after the event, considering a potential threat to the shores of the nearby Galapagos Islands. People at the coastal areas reported remarkable changes in seawater levels and also strong rift currents, although the amplitude of the tsunami did not reach a high water level. Fortunately for the coastal communities, the tsunami impact occurred at low tide. This fact appears to be the reason that no inundation occurred and considerable physical effects at the coastlines were absent, which would not be the case under different tide conditions. Some authorities were not concerned that there was a tsunami threat from this event due to the false perception that a tsunami can only be possible if the epicenter was on the ocean side.

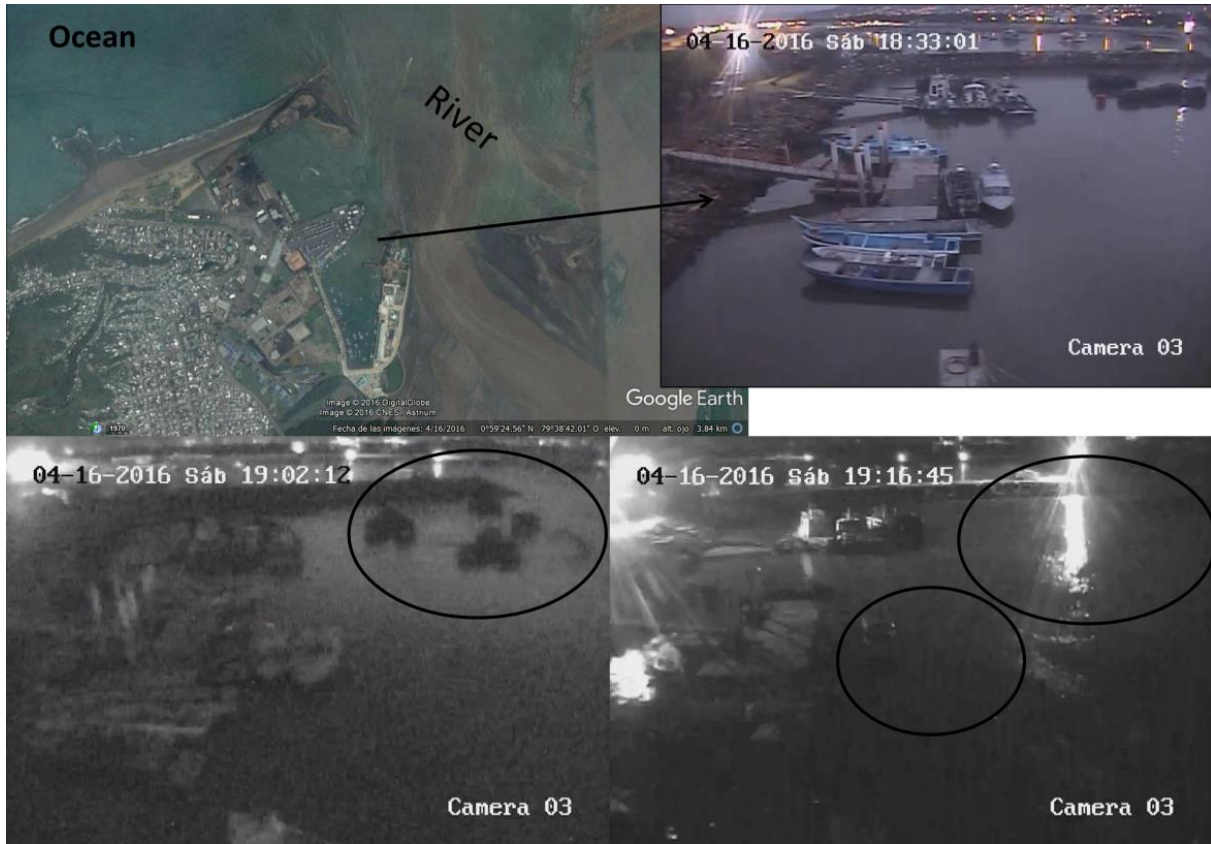
Fig. 10 – Small boat and buoys were moved from their anchors due to the tsunami at Esmeraldas port (ECU911).

The Esmeraldas Port registered the tsunami arrival with the receding of the water, started at 19:00. From 19:06 to 19:09, the tide gauge registered the tsunami crest arrival which gives a rate of change in water level of ~50 cm/min. (Fig. 9). Even with arrival at low arrival, the Esmeraldas Port was exposed to strong residual currents. Some small boats and buoys were moved from these anchorage sites due the strong currents (Fig. 10).
