CHARACTERIZATION OF SEISMIC DEMAND AFTER THE CENTRAL ITALY 2016 EARTHQUAKES

Abstract

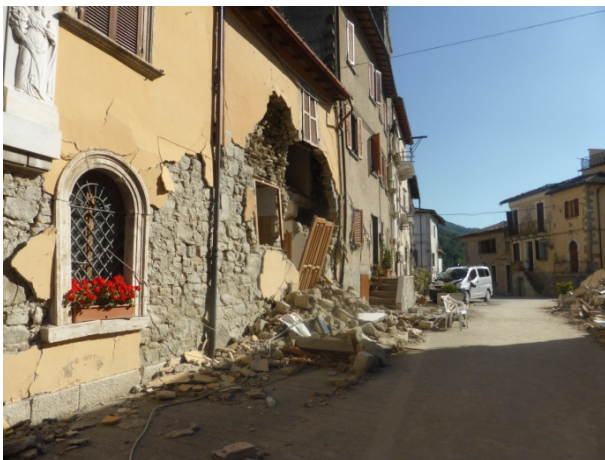
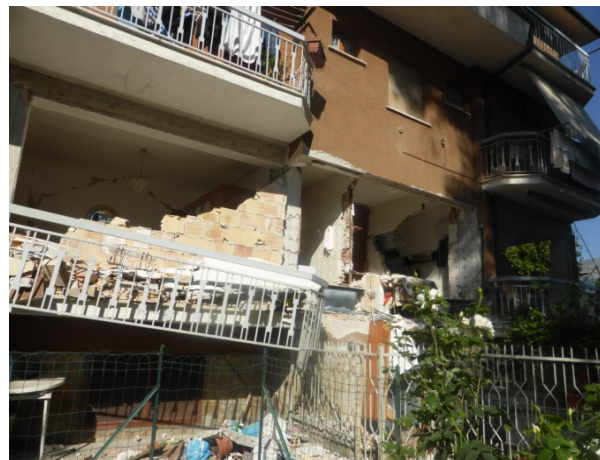
Fig. 1. Damage to masonry (a) and reinforced concrete buildings (b)

A complex sequence of seismic events occurred in central Italy from the end of August to the end of October 2016. The significant magnitudes of the main seismic events resulted in considerable damage in different cities and villages (Fig. 1), as well as architectural heritage.

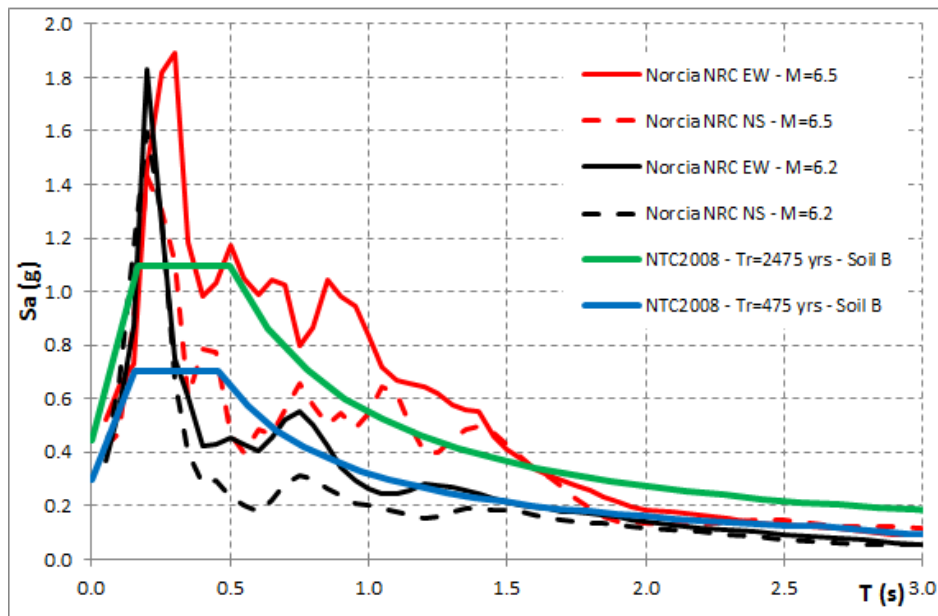
Fig. 2. Comparison between recorded ground motion (Norcia station) spectra and code elastic spectra
