SEISMIC BEHAVIOR OF REINFORCED CONCRETE ROOFS ON MASONRY BUILDINGS

Abstract

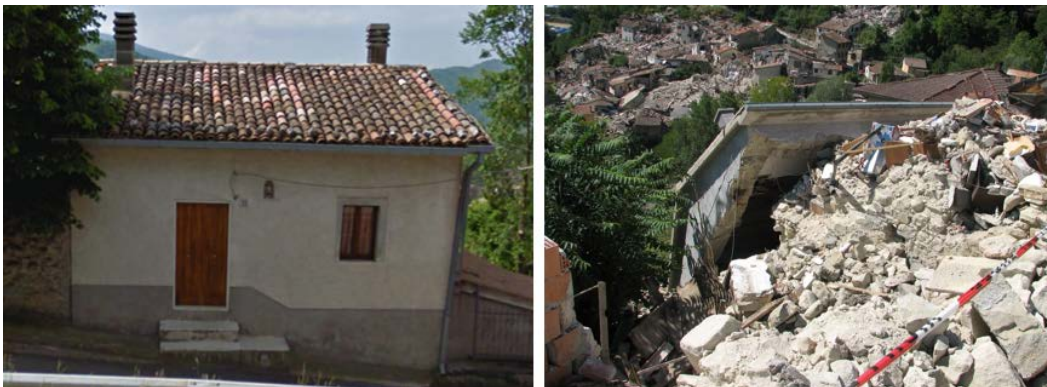
Fig.1 – Masonry building before and after the Central Italy earthquake, Pescara del Tronto.
