HOKKAIDO Eastern Iburi Earthquake 2018 – Telecommunications and Transportations Lifeline Performance

Alex K Tang⁽¹⁾

This paper examines the performance of Telecommunications, and Transportations lifelines in the M_w 7.0 Hokkaido Eastern Iburi Earthquake of September 2018.

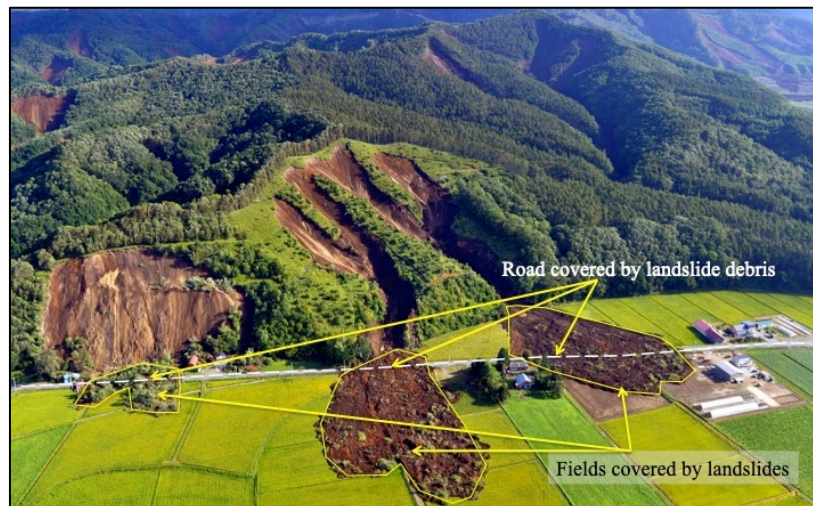
This earthquake is one of the most extensive landslides events in Japan's earthquake record. The landslide covered an estimated 400 sq. km. One of the impacts of many landslides was the spread of the flow that destroyed the rice and vegetable fields. The financial impact to agricultural sector of the prefecture was very significant. Figure 1 shows this special characteristic of one of the many landslides in this earthquake.

Fig. 1 – Spread of debris from the landslides covering the rice fields and other vegetable fields.

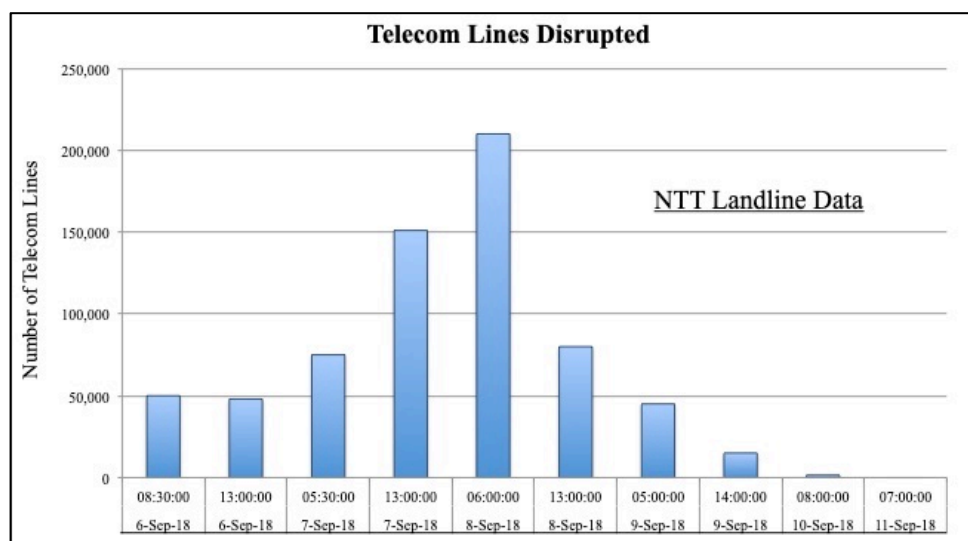
Figure 3 shows NTT landlines disruption due to power outage. On the first date after the main shock the landline disruptions were due to severed lines by landslides. Starting on the 7th of September to peaking on 8th of September disruptions were due to backup power running out in Exchange Offices. As power returning to Hokkaido, the number of landlines affected was greatly reduced by mid-day on the 8th of September. Basically all landlines were back to normal on the 11th of September, six days after the earthquake.

Fig. 3 – NTT landline disruption during the power outage period

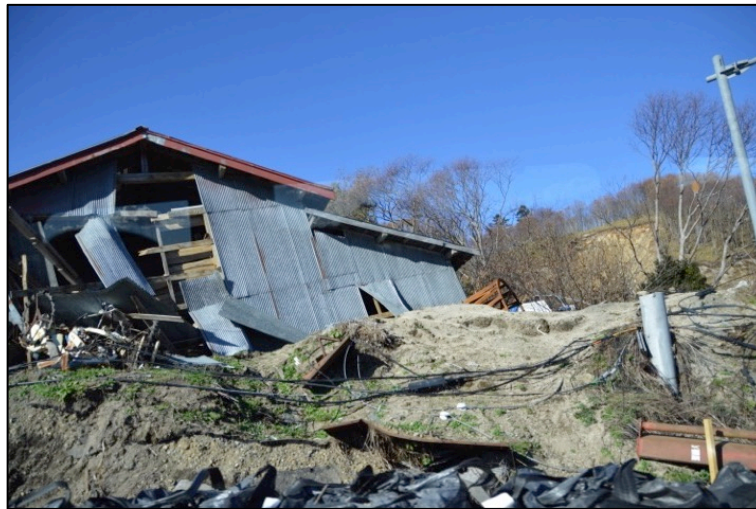
The physical damage experienced by the telecom network was mainly caused by landslides that destroyed transmission and distribution lines. Figure 3 shows one of the many sites with landslides taking out utility poles carrying both telecom lines and power lines. There are many cell sites within the earthquake-impacted area; there was no damage to any cell sites due to landslides as the cell sites are quite far from the foothills. One pair of cell sites (one owned by DoCoMo and one owned by KDDI) is situated between two major landslides, Figure 4. The problems experienced by these cell sites were power outage and severed cable connections to exchange offices. Insert in Figure 4 shows the mobile satellite (the white vehicle with a parabolic antenna on the roof) was used to connect the cell sites to exchange offices and the mobile power generator.

Fig. 3 – Damaged transmission and distribution telecom cables.

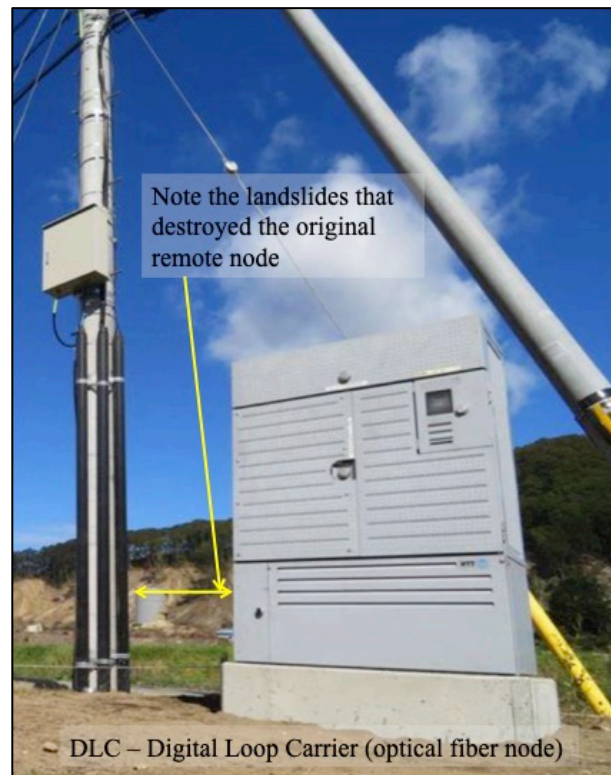
Fig. 7 – New DLC (NTT East)

to install a temporary DLC¹ with optical fiber access, Figure 7. This shows NTT is following a strategic network enhancement process to build a more resilient network.

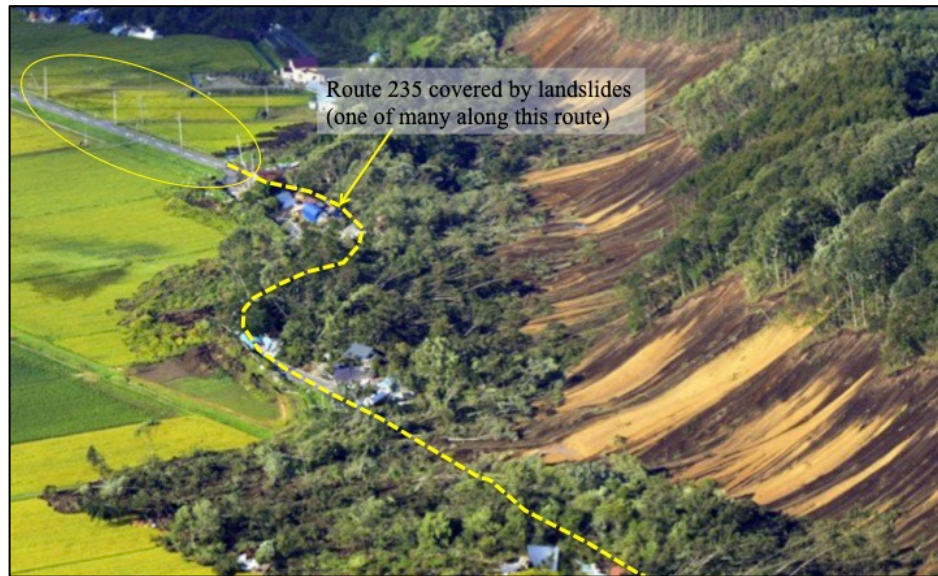
This section will provide information relating to disruption to roads, rail, air and sea transportations. Again landslides covering roads, which resulted in longer recovery time, mainly caused the disruption, Figure 9.

Fig. 9 – Rural roads in the landslides area. (Base photo from Guardian Media Group)

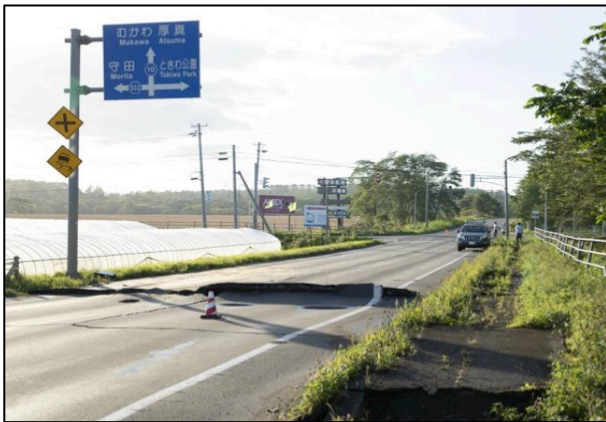
Due to power outage the tollgates were momentarily closed and access to the highway was also closed for damage assessments. The highway was opened after detours were set up. The damage to the high-speed toll way was minor. Figures 10 and 11 showed the damage caused by the earthquake on national roads.

Fig. 10 – Surface compression failure (MLIT)

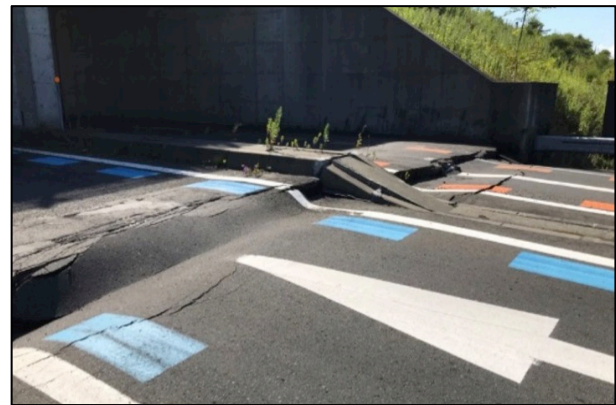
Fig. 11 – Surface compression close to the overpass (MLIT)

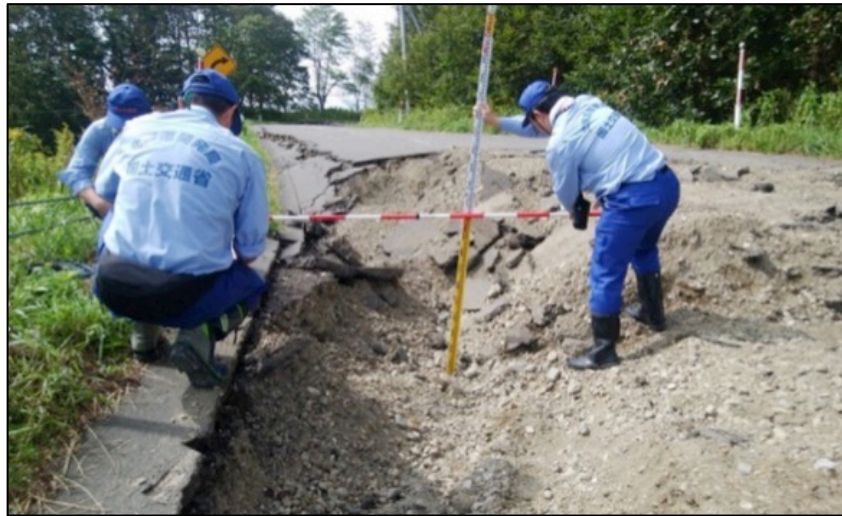
There were several rural roads damaged by lateral spread and surface cracks. MLIT TEC-Force teams were on site putting together plans for recovery. Figure 12 shows a MLIT TEC-Force team working at the road failure site.

Fig. 12 – MLIT TEC-Force preparing details for recovery work. (MLIT)

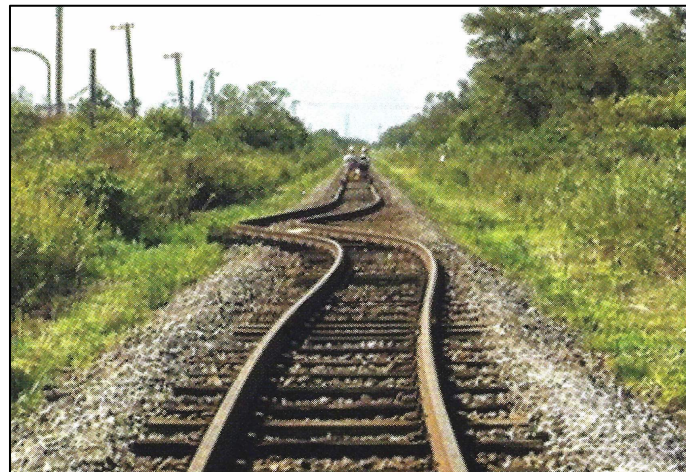
JR (Japan Rail) Hokkaido is the primary operator of the railway network in Hokkaido. A few remote railway lines only operate during tourist seasons. Operation of the rail systems such as light rail and subway were affected by power blackout. There was a twisted railway tracks due to ground deformation on Hidaka (日高) Main Line between Hamataura (浜田浦) Station and Mukawa (鹉川) Station, Figure 13.

Fig. 13 – Twisted railway tracks (JR Hokkaido)

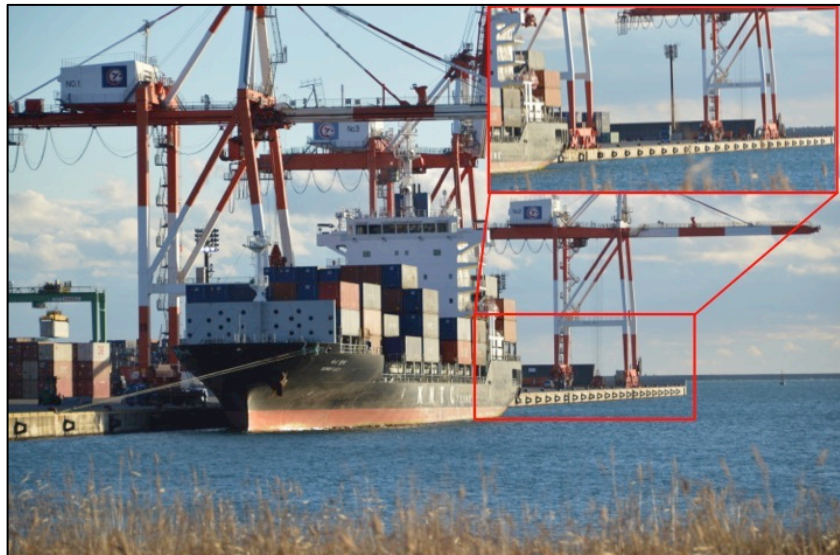
There was no reported pier damage and all ports were open, Figure 14. The ports were critical in supporting local community with necessary supplies, such as water.

Fig. 14 – Container port shows no damage and operating.

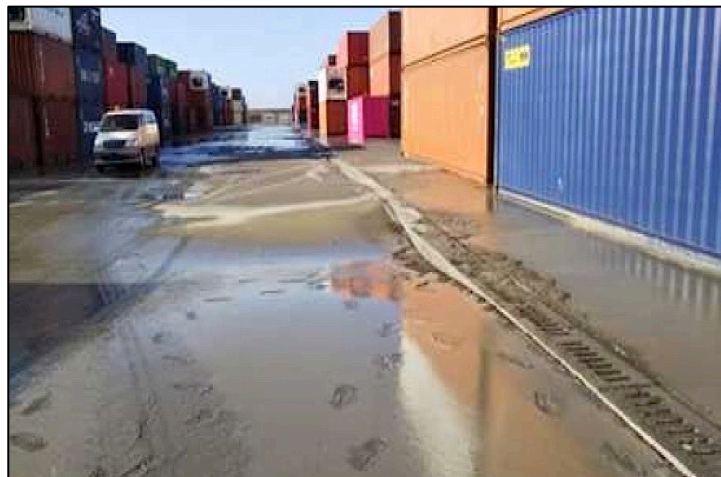
One of the container ports had liquefaction, Figure 15.

Fig. 15 – Liquefaction at a container storage area at the port (MLIT)
