## GEO-SPATIAL ANALYSIS OF REINFORCED CONCRETE BUILDING DAMAGE IN 2017 MEXICO EARTHQUAKE

*Keywords: 2017 Mexico Earthquake; concrete building damage; post-earthquake reconnaissance; geo-spatial mapping*

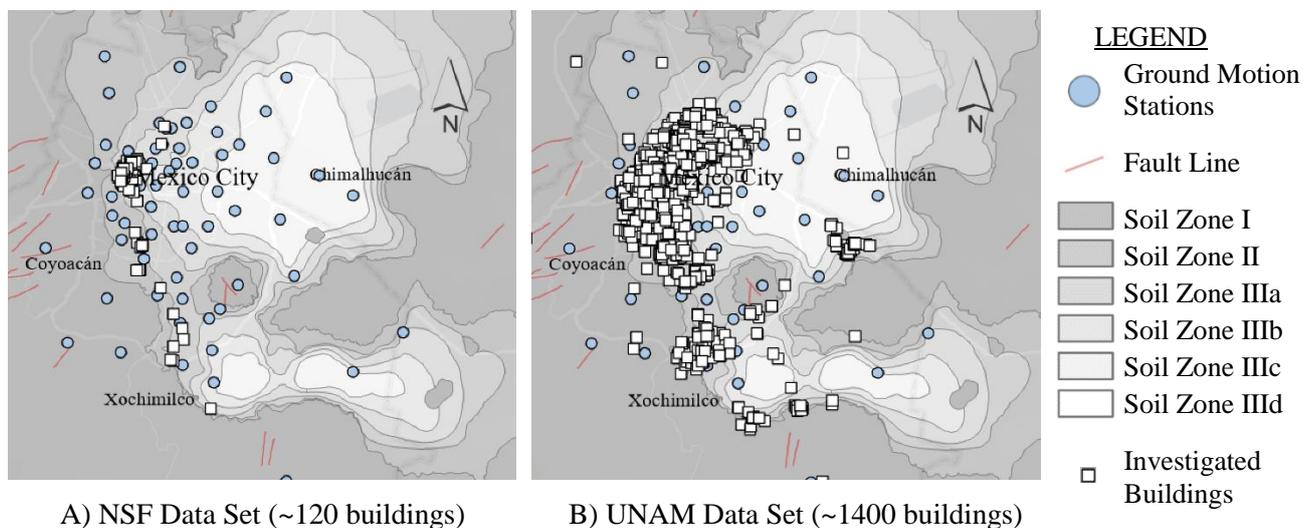
Fig. 1 – ArcGIS maps of Mexico City study area

To compare RC buildings to the general building stock in Mexico City, a data set containing a variety of structural systems and compiled by the National Autonomous University of Mexico (UNAM) was analyzed and is illustrated by the square markers in Fig. 1B. Henceforth referred to as the UNAM data set, it consists of approximately 1400 buildings with metadata including number of stories, location, and damage type for each building. Damage in the UNAM data set was classified differently from the NSF data set, and is plotted in this paper in categories of collapse and partial collapse, structural damage (includes damage to structural elements, differential settlement, and residual displacement), non-structural damage, and no damage.

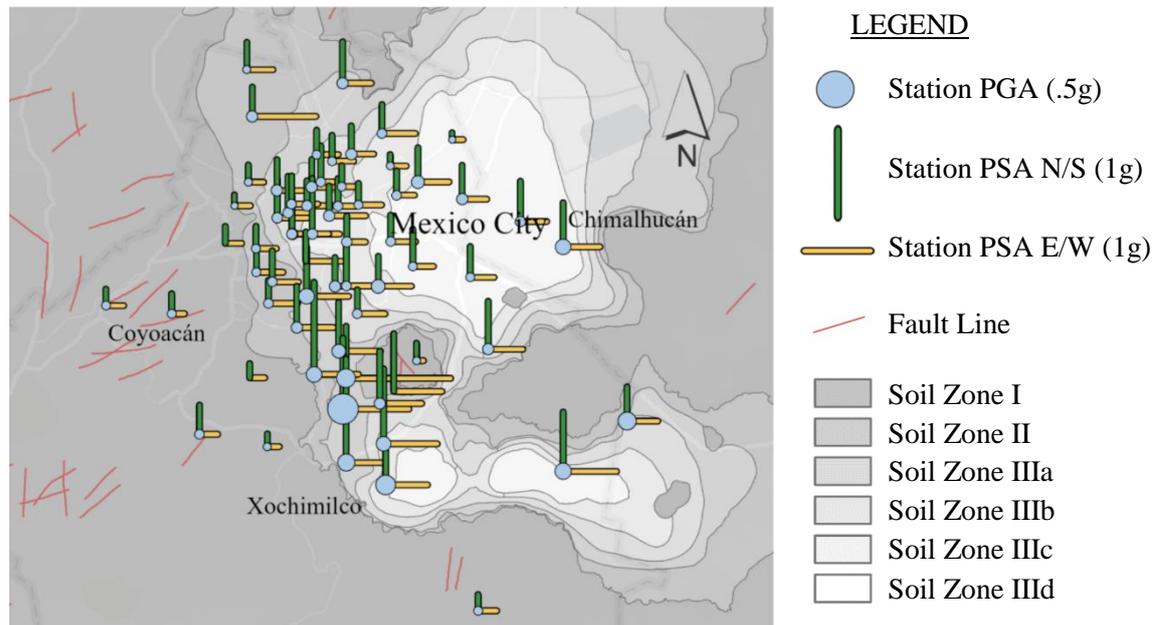
Fig. 2 – Ground motion stations with PGA and PSA values represented

In addition to relationships between damage and structural characteristics, the soil type for each building was extracted using the ArcGIS and ground motion records were collected from approximately 60 accelerometer stations located around Mexico City. A map of ground motion (GM) stations is provided in Fig. 2 and shows the peak ground acceleration (PGA) recorded at each station as well as peak spectral accelerations (PSA) in north/south and east/west directions. PGA and PSA magnitudes are denoted in Fig. 2 by the size of the blue circle markers and the length of the green and yellow bars, respectively. A calculation method was developed in MATLAB was used to determine the nearest station to each building. This enabled the authors to examine relationships between building damage, peak ground acceleration and velocity, and period ratios between a building's natural period and the dominant period associated with the ground motion. ArcGIS images display geospatial information relating damage severity to building characteristics, soil zones, and GM stations while MATLAB plots provide a quantitative way of investigating data correlations.

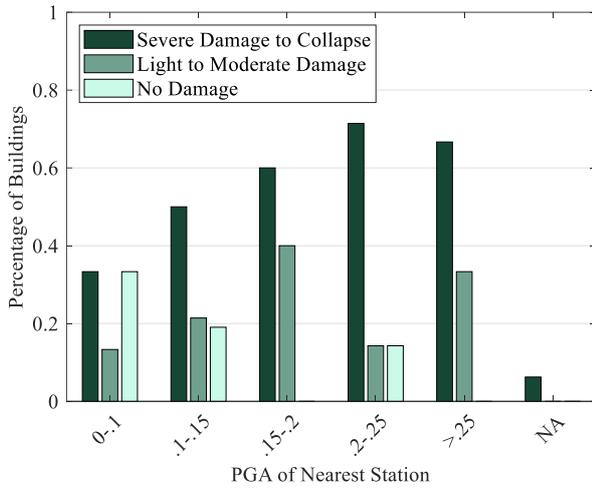
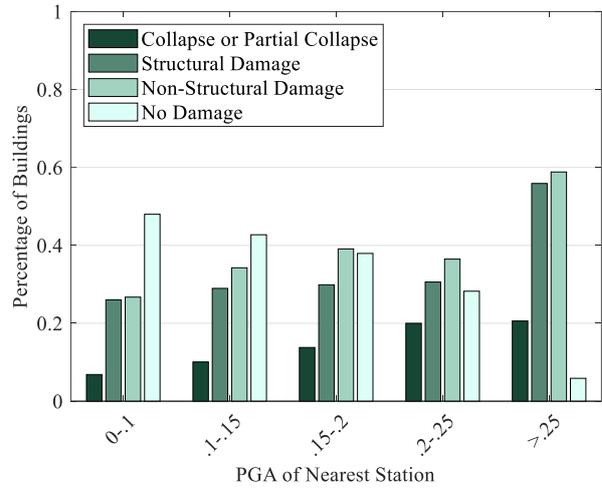
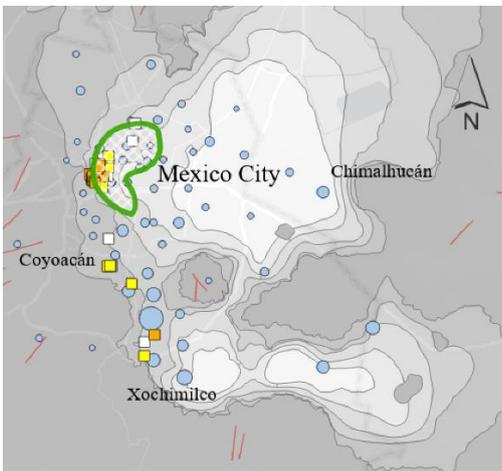
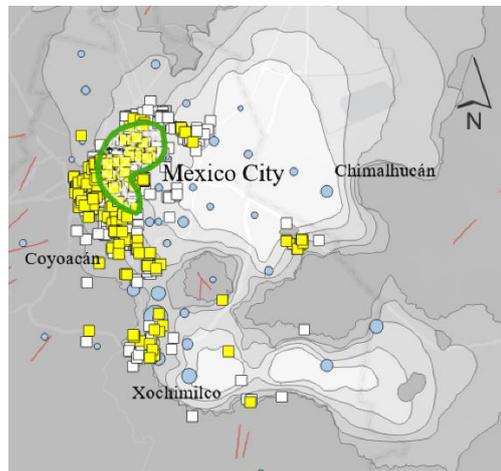
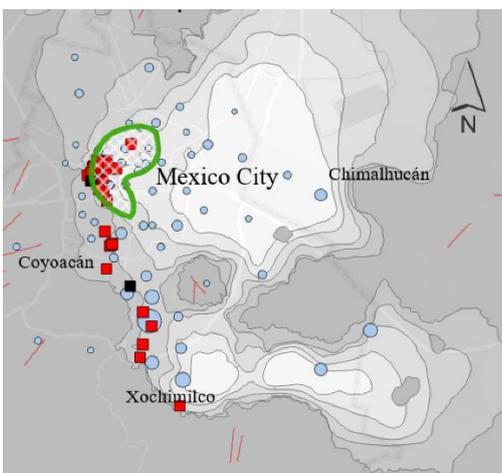
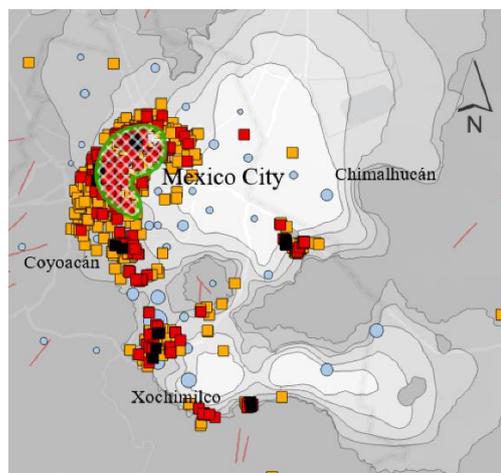
A) NSF data set: all damage categories

B) UNAM data set: all damage categories

C) NSF data set: no damage to moderate damage

D) UNAM data set: no damage and non-structural damage

E) NSF: severe damage to collapse

F) UNAM: structural damage to collapse

Fig. 3 – Quantitative and geospatial analysis of relationship between damaged buildings and PGA values

The PGA for the nearest station to each building was plotted against damage severity, as illustrated in Fig. 3A for the NSF data set and Fig. 3B for the UNAM data set. Along the y-axis, percentage of buildings is calculated as the number of buildings characterized by a specific damage category in a PGA range divided by the total number of buildings in that PGA range. Both data sets indicate that increasing PGA values correspond with increasing damage. For reinforced concrete buildings and the general building stock, if the ground motion is more intense, there is a greater quantity of severely damaged buildings and a smaller quantity of buildings in the no damage category. Data was also analyzed using ArcGIS to determine if a similar relationship could be geospatially observed between PGA values and building damage; these maps are shown in Fig. 3C-F. Examination of Fig. 3F indicates a cluster of total and partial collapses in the southwest corner of the image. The poor performance of structures in that location is an example of the trend identified via Fig. 3B as stations near this cluster measured higher PGA values, indicated by larger blue circle markers in the ArcGIS maps.

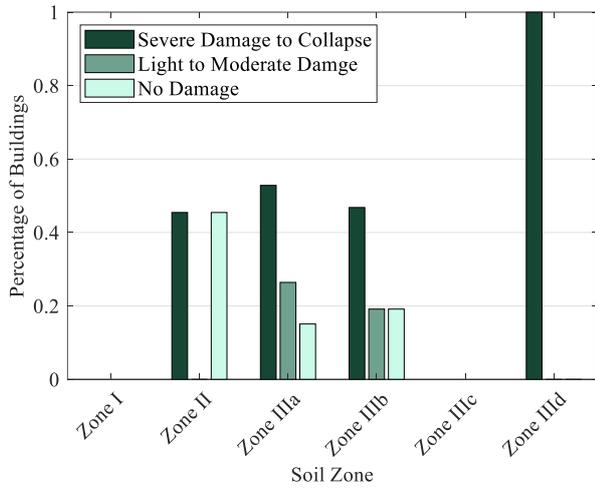
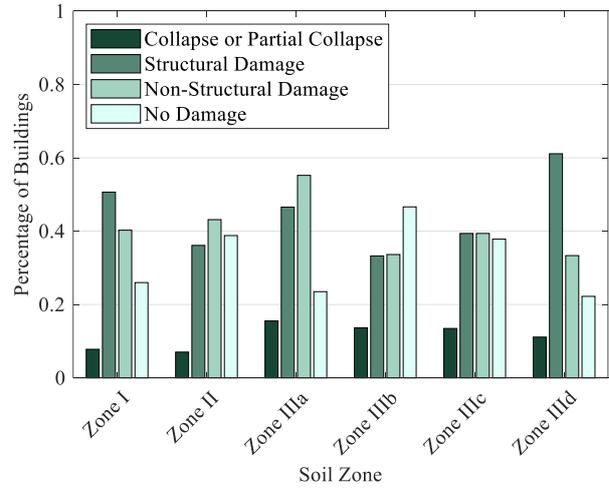
A) NSF data set\*

B) UNAM data set

Fig. 4 – Damaged buildings in each soil zone

\*Only one building was surveyed in Zone III d

As shown in Fig. 4, soil zone had a less significant impact than PGA in predicting damage severity. However, PGA values tended to be larger in Zone IIIa, which is where both NSF and UNAM data sets show a slight peak in damage severity. This finding is consistent with observations from the 1985 earthquake, where damage was concentrated in Zone III at sites with dominant ground periods longer than approximately 1.5 sec [3, 7]. Soil-structure interaction in the 2017 earthquake differed from the 1985 event because damage was located primarily in the west and southwest edge of Zone III, while damage in 1985 was clustered in the northwest area of Zone III as noted by the region enclosed with a green line in Fig. 3C-F [3, 4]. NSF reconnaissance teams focused their investigation efforts primarily in Zones IIIa and IIIb, where there appeared to be substantial reinforced concrete building damage.

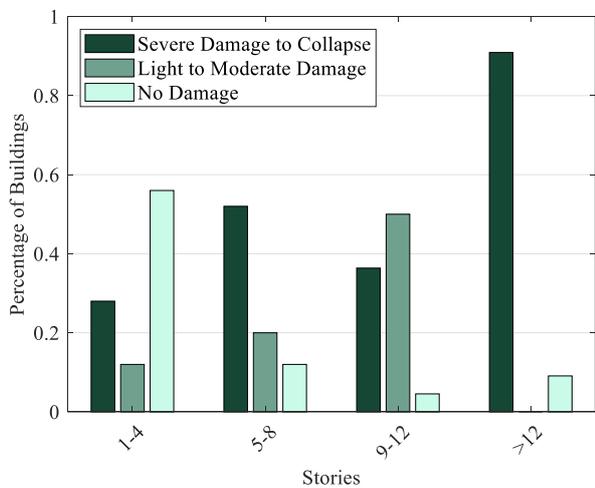
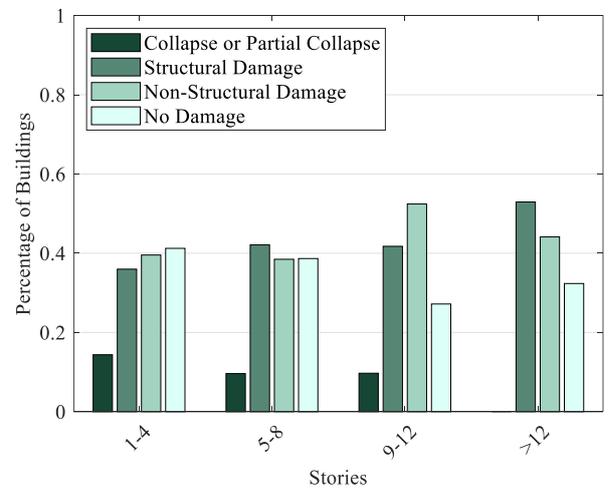
A) NSF data set

B) UNAM data set

Fig. 5 – Damaged buildings in each story range

During the 1985 earthquake, resonance compounded damage in buildings of an intermediate height with periods corresponding to the dominant motion of the soft soil zones [6]. Mid-rise buildings also experienced damage because they often lacked the inelastic capacity of tall buildings with high ductility detailing and a fundamental period exceeding 2 seconds, and the overstrength of short buildings with high wall density and a fundamental period less than 0.5 seconds [6]. A preliminary way of investigating resonance in the 2017 event was to determine if damage was concentrated in one story range more than any other. Illustrated in Fig. 5A, RC building damage was more substantial in the 5-8 story range and the >12 story range. However, the >12 story range only has eleven surveyed buildings, six of which are classified under the same address and may be wings of the same building. Therefore, the sample size of the >12 story range in the NSF data set is small and suggests inconclusive results compared to the 5-8 story range. The UNAM data set (Fig. 5B) offers no distinct indication of damage correlated with a specific story range, but a map of damage in the 5-8 story range is provided in Fig. 11C. The 5-8 story range seems to be affected more substantially for reinforced concrete buildings, but the relationship between story range and building damage is not as clear across all buildings types as was observed in the 1985 earthquake.

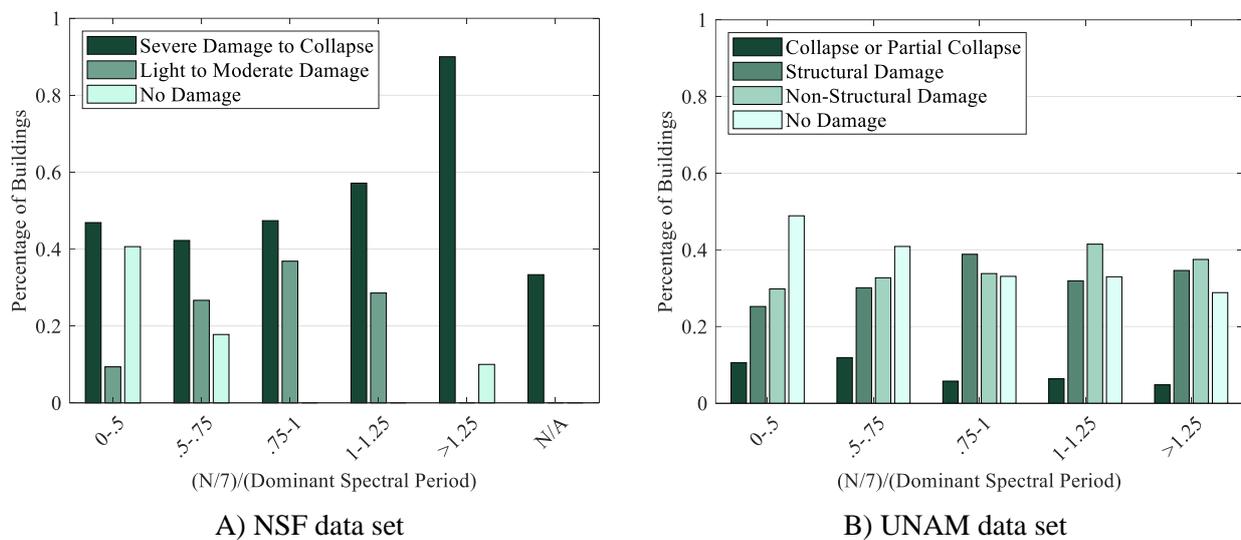
Fig. 6 – Damaged buildings in each range of period ratios

A more in-depth investigation of resonance was undertaken to determine its role in building damage during the 2017 earthquake. The dominant spectral period was obtained from each ground motion record by identifying the period associated with the peak spectral acceleration. The period of each building was estimated by dividing the number of stories by seven, a method that has been used with relative accuracy for typical buildings in Mexico City [10]. A ratio was taken of each estimated building period to the dominant spectral period of the nearest station. Fig. 6 indicates that resonance did not play a significant factor in the 2017 earthquake because damage is not concentrated near a period ratio of one ( $T_n=1$ ) in either data set. This was likely because the 2017 event was closer in proximity than the 1985 event and generated a ground motion with higher frequency content than the long period motions from 1985 [3].

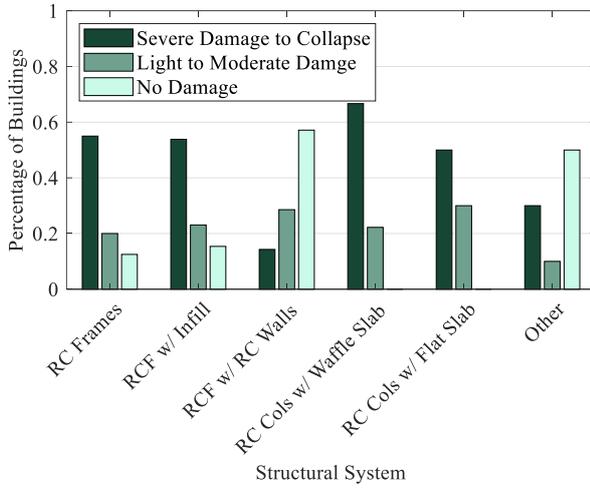
A) Damaged buildings with each structural system

Fig. 7 – NSF data set reinforced concrete structural systems

For the NSF data set, the specific reinforced concrete structural system was recorded for each building. Fig. 7A illustrates that RC frames with RC walls performed better than any other concrete structural system. Fig. 7B shows a specific collapse that occurred with a flat slab building, and is one of only two collapses that were recorded in the NSF data set. Additional reconnaissance efforts investigating collapsed buildings [11] reveal that many flat slab systems lacked column heads or drop panels, and flat slab systems were consistently problematic across Mexico City during the 2017 earthquake. 61% of collapsed buildings were flat slab systems [12]. The 1985 Mexico City earthquake also saw significant damage and several failures due to weak flat slab-column connections [4].

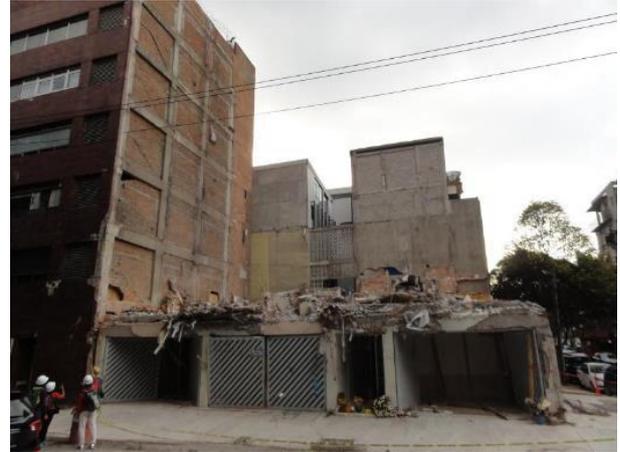
B) Flat slab collapse

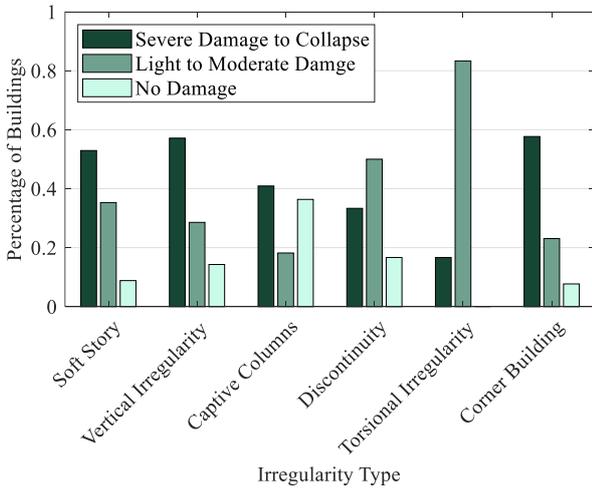
A) Damaged buildings with each irregularity

Fig. 8 – NSF data set buildings with irregularities

Fig. 8A demonstrates that soft stories, vertical irregularities, and corner buildings tended to result in more damage to reinforced concrete buildings than other structural irregularities. An example of severe soft story damage is shown in Fig. 8B and a map of buildings with soft stories is provided in Fig. 11A. Many structures in Mexico City include soft stories due to limited space for new construction, necessitating parking space to be placed below buildings thus decreasing the quantity of lateral force resisting elements on the ground floor. Corner buildings are also problematic because windows occupy two faces of the building to capitalize upon outside views at the upper floors or street access at the lower floors, resulting in decreased wall space, torsional effects, and vulnerabilities in both directions.

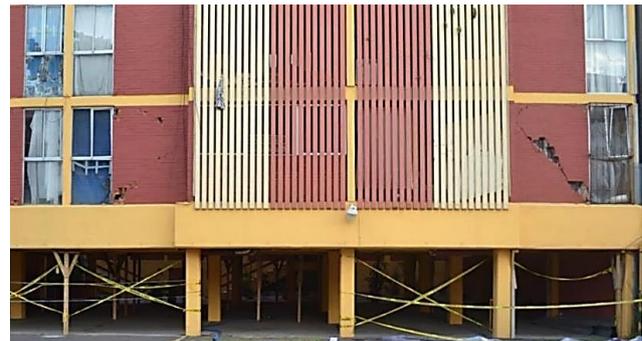
B) Soft story damage

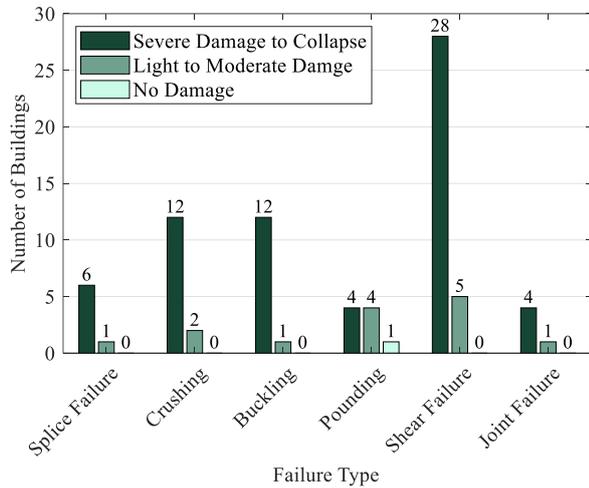
A) Damaged buildings with each type of failure

Fig. 9 – NSF data set categorization of damage/failure type

The NSF data set includes damage type for each building in addition to damage severity. Many severely damaged structures experienced multiple types of damage, while buildings that experienced no damage are generally not included in Fig. 9A. This graph illustrates that shear was the primary mode of damage, followed by crushing and buckling. Examples of shear and buckling damage are shown in Fig. 9B-9C and a map of

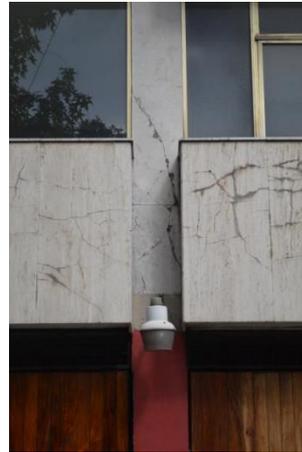
B) Shear damage

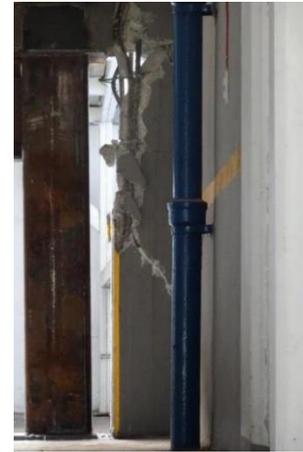
C) Buckling damage

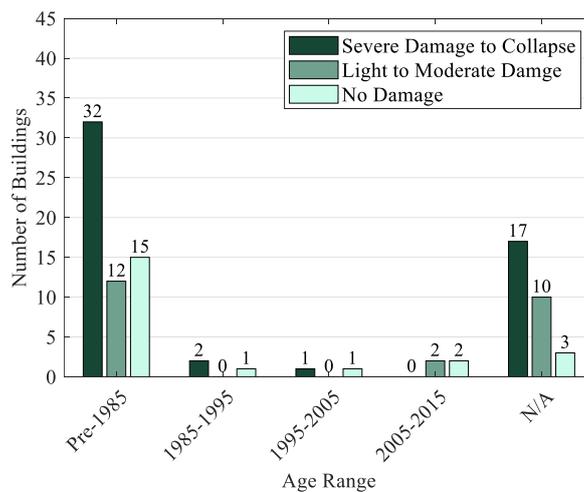
Fig. 10 – NSF data set damaged buildings in each age range

The large majority of buildings surveyed by the NSF RAPID reconnaissance teams were constructed before the 1985 earthquake. Fig. 10 shows the number of buildings in each age range and damage category, with insignificant sample sizes in the years following 1985. The lack of data indicates that damage was likely concentrated in pre-1985 buildings because the reconnaissance teams surveyed damaged structures more often than undamaged structures. It is therefore reasonable to assume that newer buildings performed better than older buildings because of updates in code requirements and improvements in design and construction techniques following the 1985 earthquake.

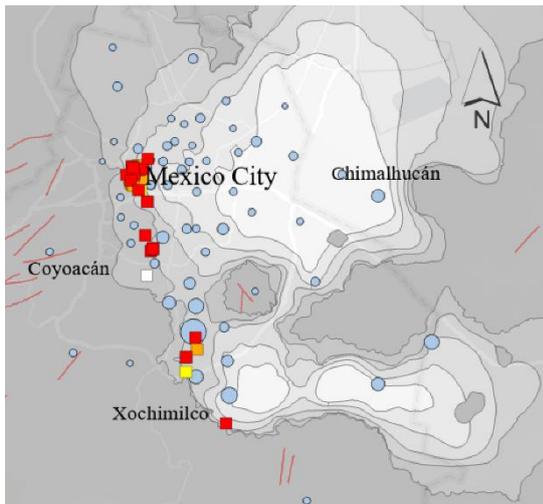
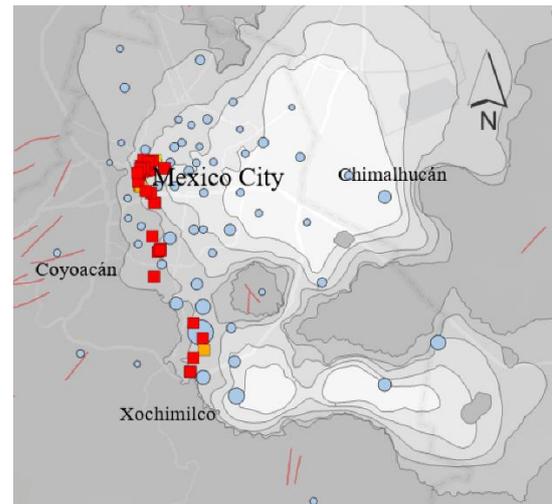
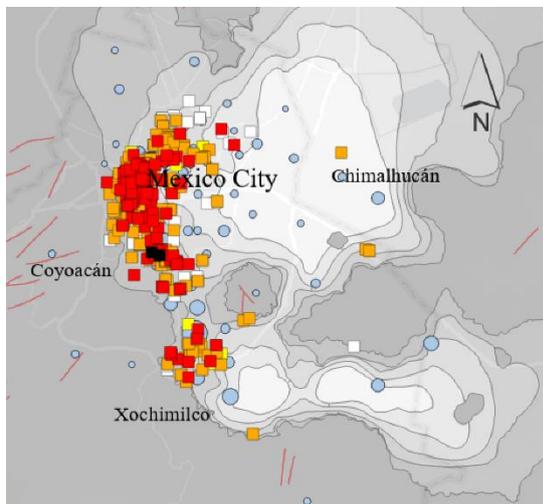
A) NSF data set: buildings with soft stories

B) NSF data set: buildings with shear damage

C) UNAM data set: buildings with 5 to 8 stories

Fig. 11 – ArcGIS maps focused on specific building and damage characteristics

buildings that experienced shear damage is provided in Fig. 11B. Although ratios of total column area to floor area can be a predictor of damage [13], the authors' investigation of this metric in the NSF data set suggests that column ratio did not show a clear correlation with building damage for RC buildings in Mexico City.

MATLAB and ArcGIS can both be used to partition data sets based on specific parameters. Throughout this paper, MATLAB plots describe relationships between damage and various building or site characteristics. Maps showing damage severity for isolated characteristics are presented in Fig. 11.

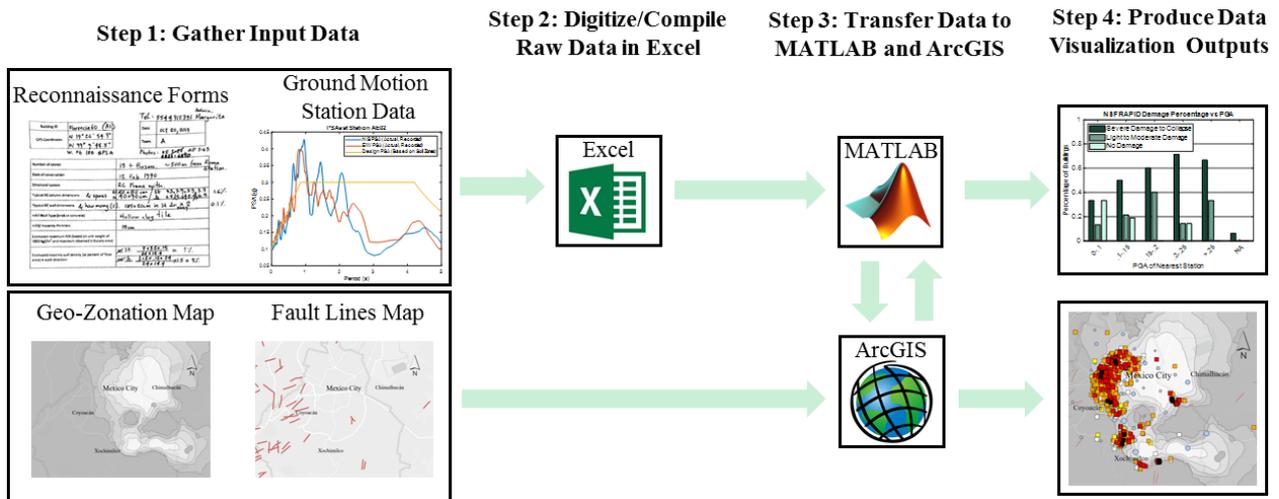
Fig. 12 – Data analysis and visualization process

The workflow for developing ArcGIS images and MATLAB plots with multiple (or isolated) parameters is illustrated in Fig. 12 and a description of the steps are as follows:

1. Gather raw data inputs:
  - Building reconnaissance forms, drawings, and photographs describing structural characteristics and damage

- Ground motion data retrieved from accelerometer stations
  - Maps containing fault lines and geotechnical zones
  - Relevant data about building damage from prior earthquakes in the region to provide a point of comparison to the current seismic event being studied

2. Digitize and compile raw data in Excel spreadsheets
  3. Transfer data to MATLAB and ArcGIS
    - MATLAB:
      - Organize building and ground motion station data into data structures

- Calculate estimated building periods and dominant spectral periods
      - Determine the nearest GM station to each building
    - ArcGIS:
      - Receive and associate building markers with as-built and damage metadata

- Receive and associate ground motion station markers with values such as PGA and PSA as well as plots of design spectra
      - Extract the soil zone for each building to add to the MATLAB data structure

4. Produce data visualization outputs
    - MATLAB: generate plots to examine the correlation between damage, building characteristics, site and ground motion attributes

- ArcGIS: develop maps to examine geospatial variance of data
