## PROTECTION OF EARTHQUAKE DAMAGED “JAPANESE” ROOFS BY BLUE TARPS (SHEETS) ~ A CASE STUDY ON SETTING CONDITIONS ~

In this study, we investigated the characteristics of the blue tarps setting condition in Takatsuki City, Osaka, Japan, where an earthquake attacked in 2018. The roofs of 65 houses were investigated. The results showed the wide variety of the methods of covering damaged roofs. For example, the difference of soil bag to stabilize the tarps (black bags and white bags) were observed, and the black bags which have higher durability were used in only about 30% of damaged houses.

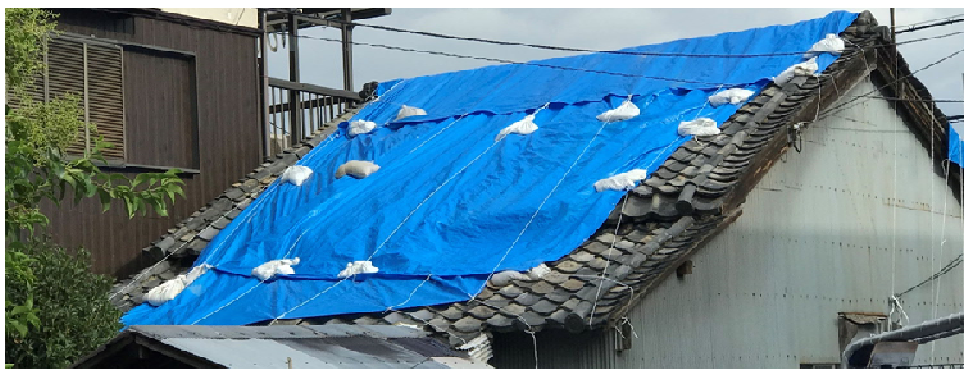
Fig. 1 An example of earthquake damaged roof covered by blue tarps (sheets)

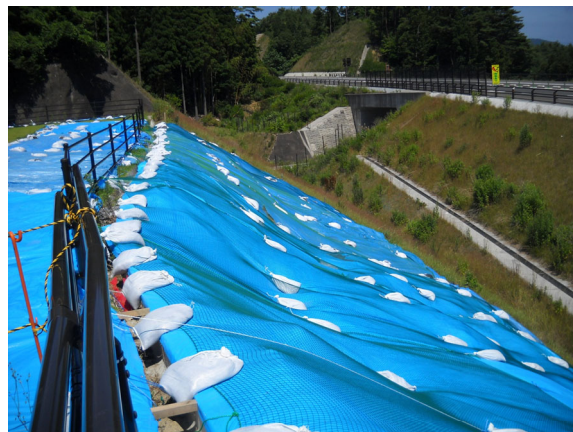
Blue tarps (sheets) were often observed as the material for temporary restoration after an earthquake. For example, blue tarps covering damaged slopes are often observed as shown in Fig. 1. It was used to prevent successive failure of slope by stopping infiltration of rainfalls. In many cases, these blue tarps are stabilized by soil bags.

Fig. 1 An example of blue tarps (sheets) application to prevent successive failure of slopes

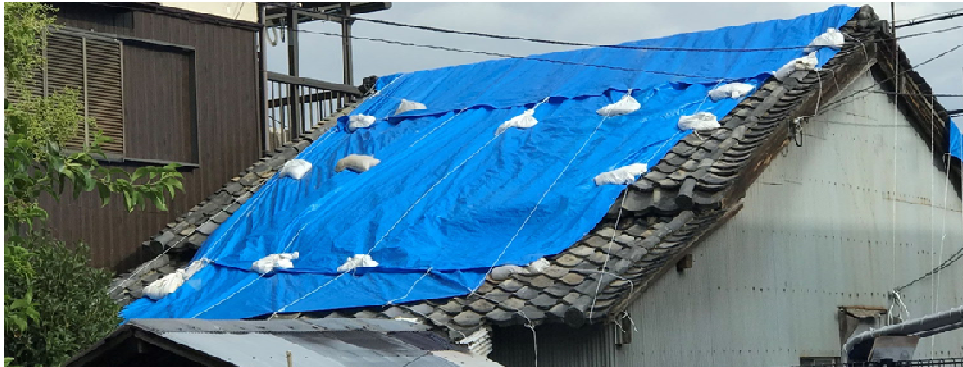
Application of blue tarps is not limited for slope stability issues. Roofs of damaged houses were also covered by blue tarps as shown in Fig. 2. As same as the usage of blue tarps on slopes, the blue tarps on roofs were often fixed by using the weight of soil bags. However, the stability of blue tarps on roofs is more critical issue than that of blue tarps on slopes. This is because the blue tarps on roofs may need more careful stabilization than that on slopes, considering strong winds on roofs and possible traffic under the roofs. Fig. 3 is an example of damaged blue tarps found on a street. This damage may be induced by inappropriate way of blue tarp stabilization.

Fig. 2 An example of earthquake damaged roof covered by blue tarps (sheets)

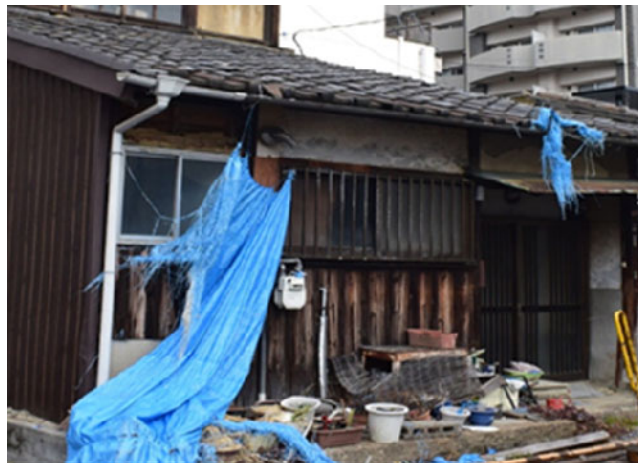
Fig. 3 An example of blue tarps (sheets) inappropriately used on a damaged house

It suggests that the reality of the usage of blue tarps on roofs is not well organized. The techniques on the works are experience based. And both experienced engineer and non-experienced engineer work on the temporarily restoration at the affected area. And this situation make some houses inappropriately restored as shown in Fig. 3. It is necessary to establish a standard appropriate method of using blue tarps for damaged roofs.

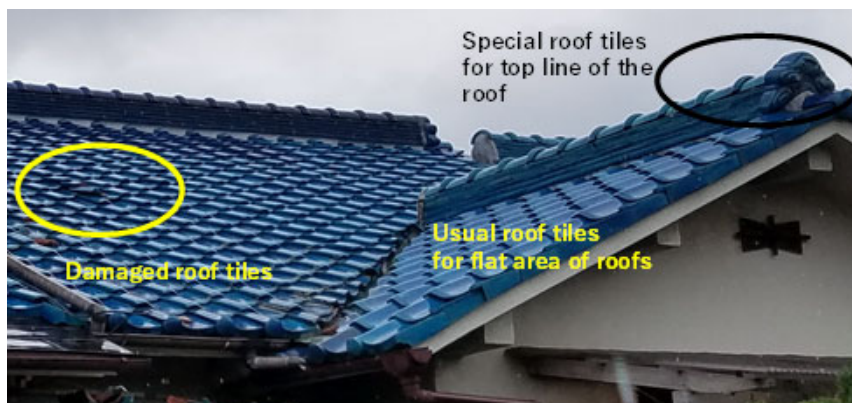
However, it is not easy to stabilize the blue tarps on roof appropriately. Fig. 4 is an example of damaged roofs of a Japanese house. Japanese roofs are covered by roofing tiles, but the shape of roof is not simple. Roofing tiles of different shapes and sizes are used on top horizontal line of roofs and sloped flat roofs. Technically, there is no standard way of the application of blue tarps on roofs.

Fig. 4 An example of damaged roof and difference of roof tiles

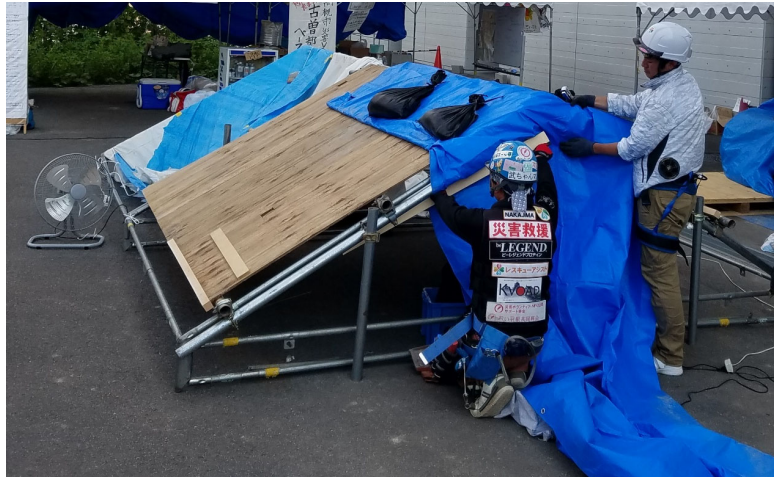
Fig.5 An example of workshop on how to install blue tarps for temporary restoration

Some volunteer groups have much experiences of the application of blue tarps on damaged houses. However, usual peoples including local carpenters never experienced the work of blue tarps on roofs. This is because the temporary restoration of earthquake damaged roof is not a usual work. Due to the luck of experiences in local carpenters, there were some workshops on how to use blue tarps on damaged roofs, at the time of 2018 earthquake disaster in northern Osaka prefecture. These workshops were organized by volunteer groups, and participants of the workshop could share some techniques of using blue tarps appropriately, as shown in Fig. 5.

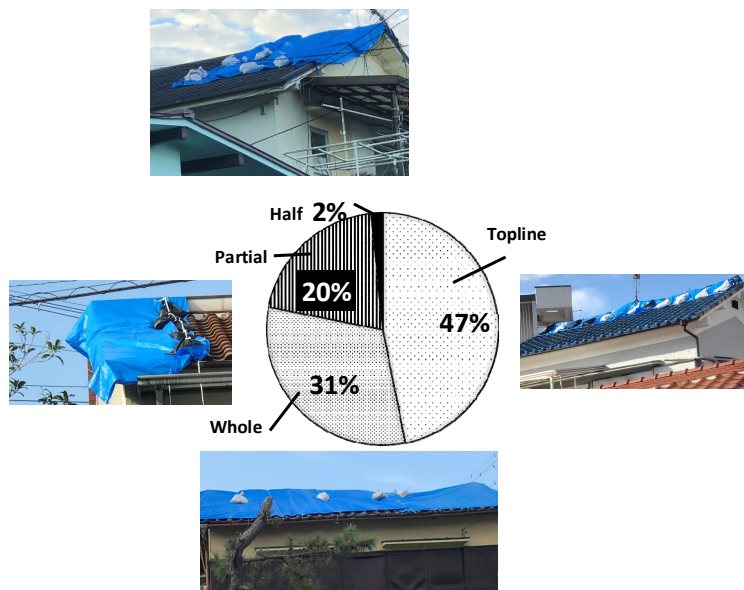
Fig. 8 The location of tarps on the roof

Fig. 8 is the summary of the location of tarps. More than half of the tarps were used for top line of the roofs. The damage characteristics of the roof tile may depend on the structure of roofs. In this 2018 northern Osaka prefecture earthquake disaster, many roofs of Japanese classic style houses were damaged. In Japanese style roofs, a roof tile in flat slope area is partially covered by another roof tile. Thus, the roof tile in flat slope area is stabilized. However, the roof tile at the top line is made as special shape, and it is not covered by other tiles. This is why there were many damage at the top line of the roofs. If the shaking was more strong, more roof tiles at the flat slope area may be damaged and the ratio of full covered tarps may be increased. Note the thickness of tarps were not checked in this field survey. Since the resistance of the tarp depends on the thickness of the tarps, it is preferable to develop a method to check the thickness of the tarp in future study.

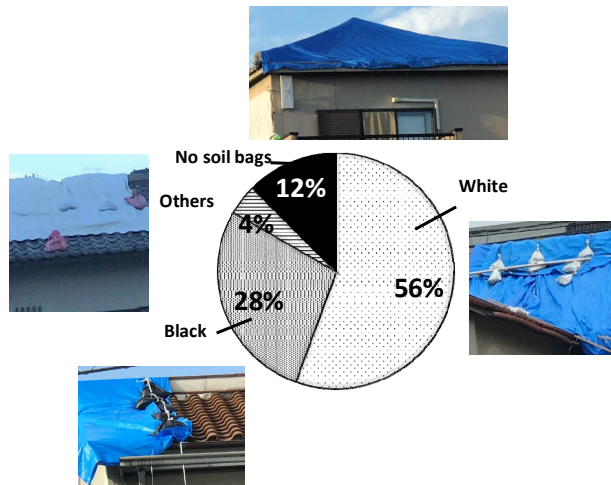
Fig. 9 is the summary on the usage of soil bags. Soil bags were used in more than 80 % of cases. White soil bags were used in 46 % of all the cases. The UV resistant black soil bags were used in only about 30 % cases. The main usage of white soil bag in usual is gathering of garbage in gardening activity, and construction of small embankment to prevent water inundation. In other words, application of white soil bag on damaged roofs is not designated purpose. Thus, it is important to promote UV resistant black soil bags more.

Fig. 9 The color of soil bags

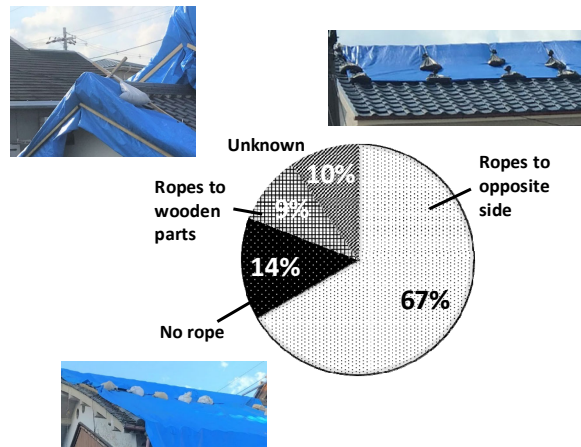
Fig. 10 The connection of ropes

Fig. 10 show how the ropes were used. In most cases, the rope of soil bags was connected to something in the opposite side. Although the opposite side of roof is not visually checked, it may be connected to a counter weight soil bag. In around 10 % of cases, the ropes were connected to wooden structure.

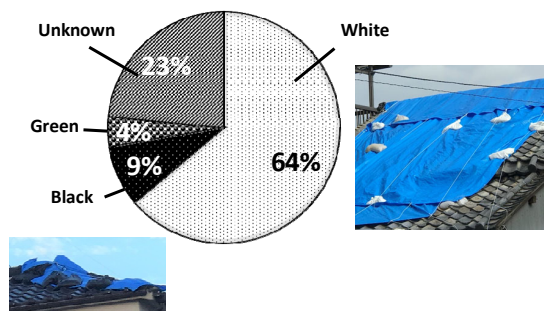
Fig. 11 The color of ropes

Fig. 11 is the summary of colors of ropes. In about a half of cases, white rope was used. As same as soil bags, black ropes are UV resistant and preferable. The major use of the white rope in usual is to tie garbage such as cardboard/newspapers. Again, application of white ropes on damaged roofs is not designated purpose. Thus, it is important to promote UV resistant black ropes more.

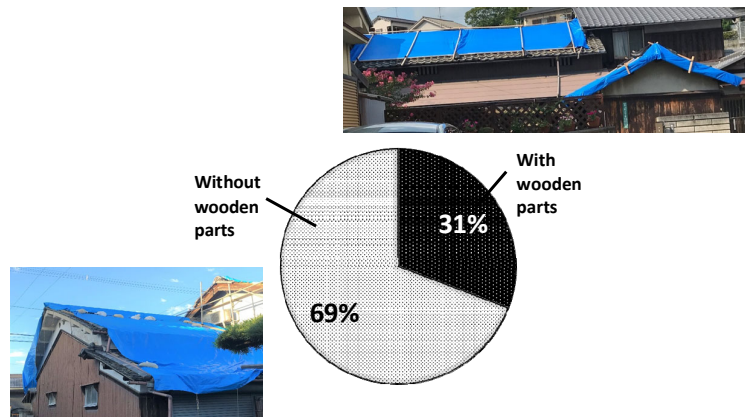
Fig. 12 The application of wooden plates/bars

Fig. 12 is the summary of the usage of wooden plates/bars. In about a half cases, wooden plates/bars were used. Since the shape of Japanese roof is complicated, it is not easy to construct a wooden structure on roofs. Skilled engineer is necessary to install wooden plates/bars appropriately.

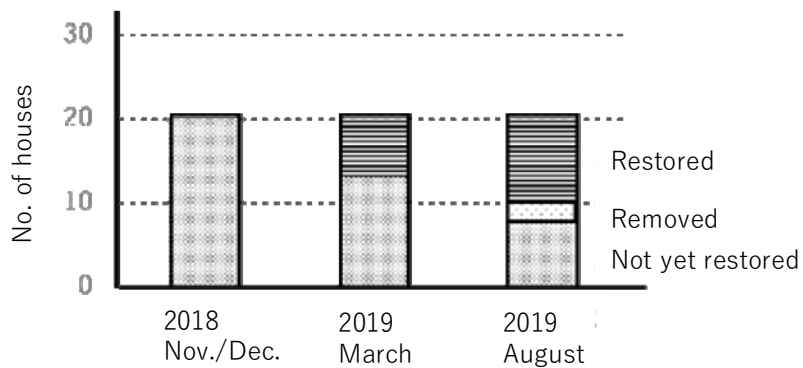
The summary of the progress in restoration is shown in Fig.14. Only a half of houses were restored. There are 2 houses (10%) removed after disaster. Thus, 40 % of all houses were not restored even after one year from the disaster. The delay of restoration come from many reasons. Settsu City did a questionnaire survey on the progress of restoration [1]. In the survey conducted at July, 2019, about the 40 % of not-yet-recovered case is due to the difficulty in the scheduling of the carpenters. But in about 30 % of cases, they did not decide whether the house shall be restored or not. It implied that the many damaged house, which are often old aged, are vacant or planned to be vacant soon. The management of these unused houses is a critical issue for the safety of local society in Japan.

Fig.14 Progress of restoration in monitored houses

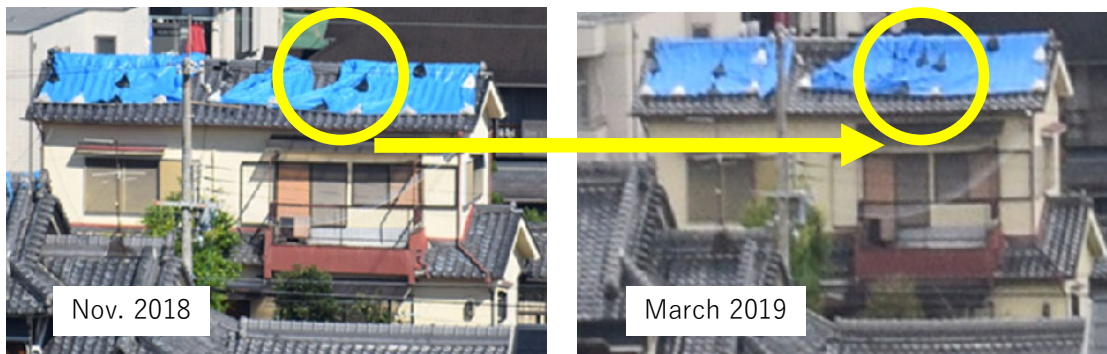
The owner of houses may not imagine that the restoration takes such a long time. Since it took more than one year in many houses for restoration, some maintenance works were necessary for tarps in some houses. Fig. 15 shows an evidence of maintenance work for tarps on a roof.

Fig.15 An example of maintenance work for tarps on a roof
