AN UNEXPECTED BEAM SIDE SWAY MECHANISM OF A REINFORCED CONCRETE BUILDING IN 2016 KUMAMOTO EARTHQUAKE

Toshikazu Kabeyasawa⁽¹⁾

Abstract

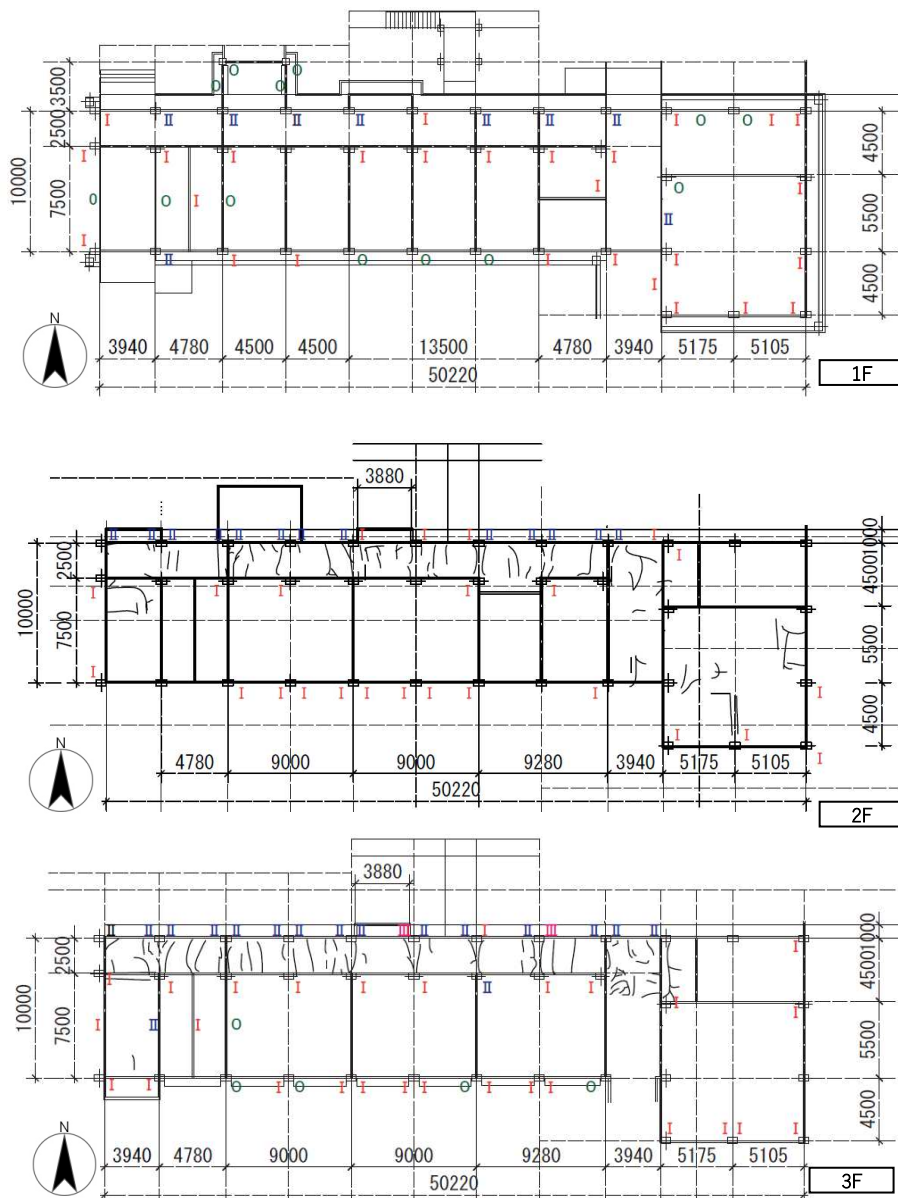
Figure.3 Post-earthquake damage evaluation for the beams and floor slabs

Figure 3 shows the result of the post-earthquake damage evaluation for the beams and floor slabs on the 1st floor to 3rd floors. Photo 1 shows residual cracks on the longitudinal beams and floor slabs in the north frame. The beams on the north side has 1050 mm height standing walls and 750 mm hanging walls in the cross section and large residual cracks was observed at the end of the standing walls and hanging walls. The maximum crack width is 1mm on those beams. A number of large residual cracks are observed in the 2nd and 3rd floor. The maximum crack width is 2 mm on those beams. The ceiling materials dropped off in the classroom and music preparation room at the end of the 3rd floor. There is one short column on the 1st story due to the existence of the huge height of the standing walls, and the shear cracks occurred in this short column locally.

The beam side sway mechanism was observed in the school building, and the 2nd and 3rd story of the building are heavily damaged. The residual seismic capacity of the building was investigated based on the residual cracks on the beams and columns in the post-earthquake damage observation. The seismic index R of the capacity was 89% in the longitudinal direction of the 2nd story, and it indicates the degree of the building damage is minor. In determining the degree of damage, almost all of the beams are covered by the ceilings except for the beams in the north frame, so that the damage on the beams could not be identified. The cracking damage of the beams was regarded as the damage of the attached columns base on 2001 version of "Post Earthquake Damage Evaluation and Restoration Technology Guidance for Seismic Damaged Buildings "[2].

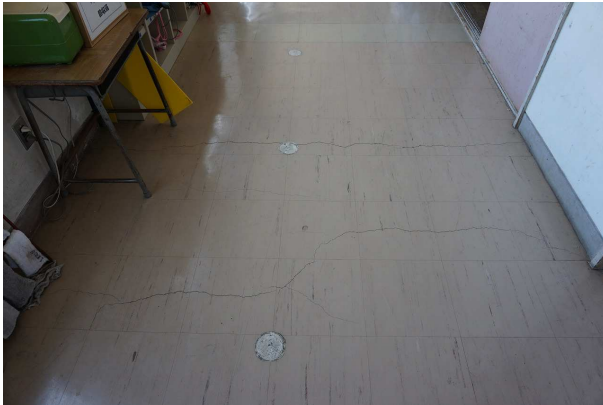
(a) Cracks on floor slabs

Photo.1 Residual cracks on the longitudinal beams and floor slabs
