## TEST FACILITY TO STUDY TRADITIONAL COMPOSITE MASONRY STRUCTURES IN BHUTAN – AN OUTCOME OF SATREPS

### Abstract

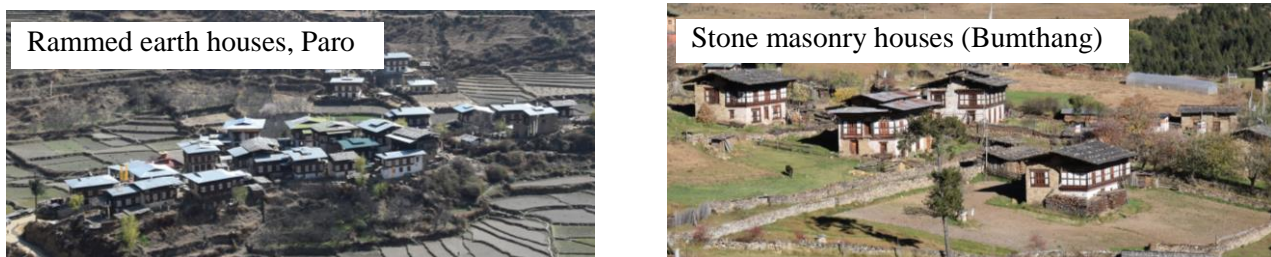
Fig. 1 – Cluster of rammed earth houses (left) in Esuna village, Paro and stone masonry houses (right) in Shingkhar village, Bumthang

There is a rich repository of traditional knowledge systems in the field of Bhutanese indigenous construction materials, techniques, and practices, i.e., rammed earth and stone masonry (with mud mortar) houses. These rich traditions have been passed down from generation to generation through oral transmission and hands-on practices. However, there are rare documentation of such practices in written format, and if found, are only limited to religious works of literature. Statistically, most houses in Bhutan are build using indigenous materials and techniques, such as rammed earth and random stone masonry in mud mortar with an integrated timber system. Rammed earth construction is one of the most dominant traditional construction practices and popular in the western part of Bhutan (Fig.1). A massive rammed earth wall combined with timber components are the main features of such construction typology. The basic technique involves the selection and placing of suitable soil in layers inside a formwork, made of wooden boards, and then hardened by ramming. Stone masonry with mud mortar construction is popular in the eastern region of Bhutan.

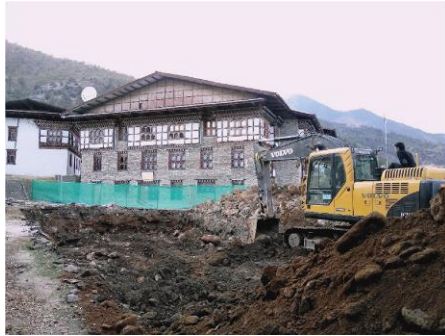
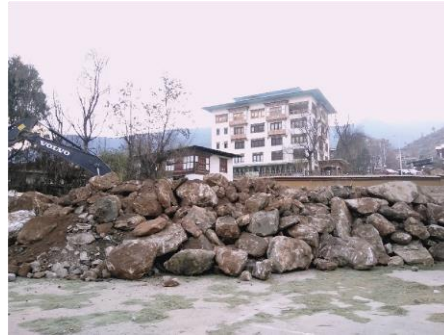
Fig. 5 – Excavation works (Task 2)

**Task 2.** The excavation works were delayed by two weeks. The work was expected to be completed by the first week of January 2018, but the work extended up to the third week of January. As per the contract documents, the excavation work was supposed to involve medium to hard soil. However, big boulders were found as shown in Fig. 5, which needed heavy-duty excavation works, including rock breaker equipped to excavators and employing heating and thawing techniques. Further, the use of excavators could not be done during the weekdays and the office hours since it caused vibrations to the adjacent office buildings. The change in specification of excavation was subsequently made. The subsequent tasks following excavation work were delayed by two weeks. [Delayed by two weeks].

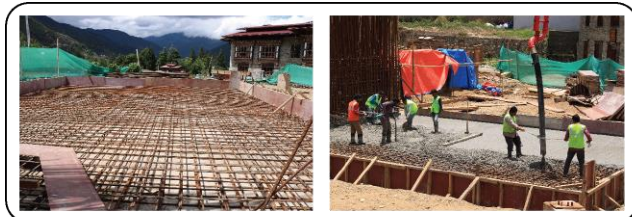
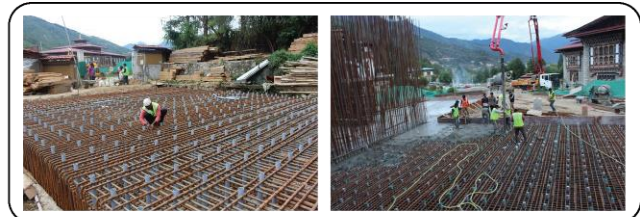
Fig. 7 – Tasks 09 to 15: (a) Reinforcement and concreting works for floor-3, (b) Reinforcement and concreting works for floor-2

Tasks 9-11. Tasks 9-11 for floor-3 (Fig. 7a) were completed within three weeks instead of four weeks as per the initial plan of action. The tasks were supposed to start at the end of February but could only begin at the start of April due to extra effort required for completion of Task 7 and 8. [Delayed by five weeks]

Tasks 12-15. These tasks on Strong floor-2 (Fig. 7b) started after the end of Task 10. The reason for the delay was similar to the reason stated for the preceding set of tasks. [Delayed by five weeks]

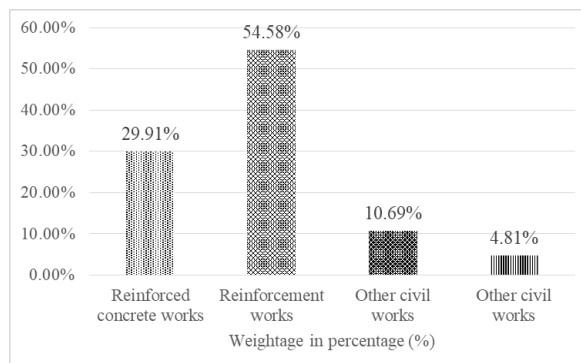
Fig. 9 –Weightage for different activities in percentage (%)

The significant weightage compared to all the activities was seen in the reinforcement and reinforced concrete works, as shown in Fig. 9. The consumption of reinforcement was approximately about 200MT in total, out of which the utilization of 28mm diameter reinforcement contributes to approximately about 100MT. Other civil works were limited to excavation, stone soiling, plain cement concrete, plastering, shuttering, and roofing works. Thus, this projection may be non-applicable to the construction of residential and commercial buildings where other civil works may attribute to a significant increase in the cost of the work.

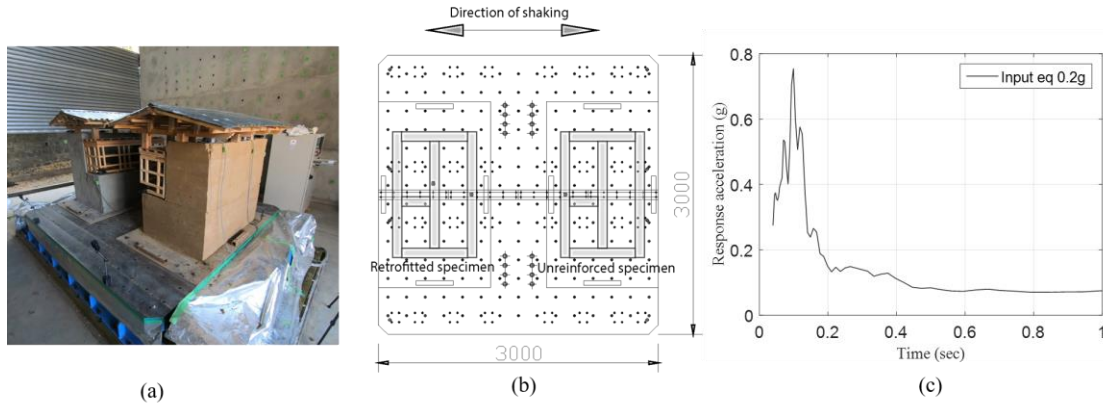
Fig. 11 – (a) Picture of test specimens on shaking table, (b) Test set-up, (c) Response acceleration spectra for the input ground motion PGA 0.2g (damping coefficient = 5%).

The input ground motions are applied in 8 sequential runs with increasing amplitudes of the target PGAs – 0.2g, 0.4g, 0.6g, 0.8g, 1.0g, 1.2g, 1.4g, and 1.6g. Fig.11(c) shows the response acceleration spectra for the input ground motion with PGA 0.2g. It should be noted that before the actual earthquake loading, the specimens are subjected to white noise with PGA 0.03g and frequency from 1Hz to 25Hz. The natural period of vibration for both unreinforced RE and reinforced RE was 0.0625 sec.

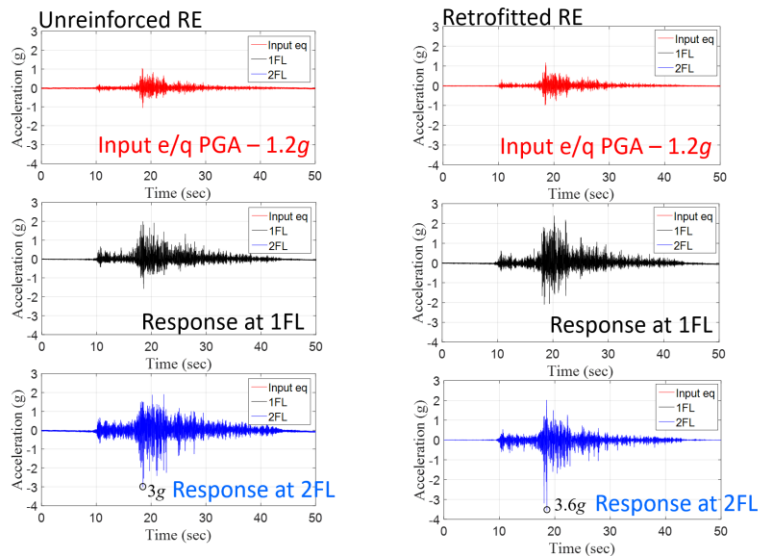
Fig. 12 – Acceleration time-history for unreinforced and retrofitted specimens at PGA 1.0g.

Fig.12 shows the acceleration time history records for the two specimens tested at PGA of 1g. The acceleration records are presented for the input  $e/q$ , response at the first-floor level (1FL), and second-floor level (2FL). The unreinforced RE specimen showed a response acceleration 3 (three) times the ground excitation, and the retrofitted counterpart showed stiffer response with 3.6 times the ground acceleration. The unreinforced RE showed multiple cracks with clear vertical and horizontal cracks at the back wall and was near collapse state (Fig.13). The retrofitted counterpart showed comparatively stable response with limited cracks within the walls, with some plaster spalling near the openings at 1FL and no visible cracks at the back wall.

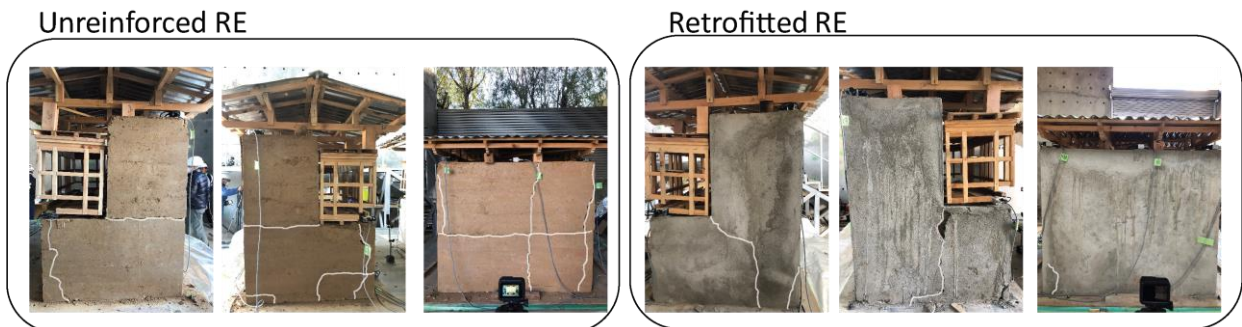
Fig. 13 – Damage for unreinforced and retrofitted specimens at PGA 1.0g.
