Tests and analysis of small radius curve continuous beam bridges during the Wenchuan Earthquake

D.Z. SUN⁽¹⁾, Y. HUANG⁽²⁾

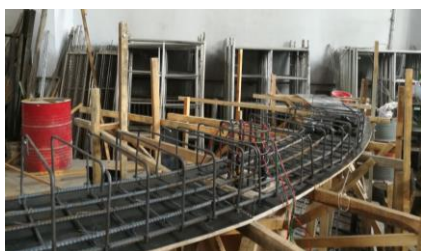
Fig.3- Model construction

The model was mainly composed of three parts: bridge deck, column and base. The three parts were bounded with steel bars, respectively, and then cast-in-place concrete, as Fig.3 shown. After the column reinforcement bounded, the strain patches were pasted on both ends of the column to collect the strain changes of the reinforcement.

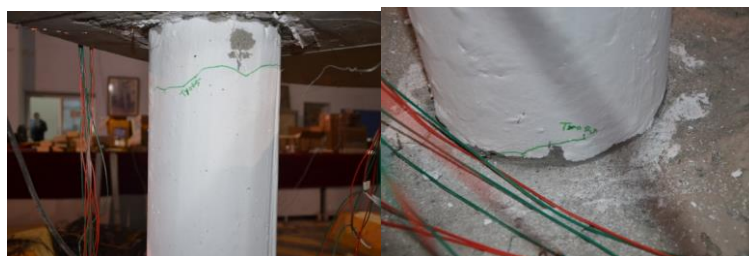
Fig.5 - circumferential fine cracks under taft wave with Y direction 0.45g

Under basic seismic inputs, the cracks began to happen. Under Taft wave with Y direction 0.45g, circumferential fine cracks appeared at the top of the middle column, with a length of about 20cm, and circumferential cracks to the top of the syncline at the bottom of the column, with a length of about 6cm, shown as Fig.5.

From 0.45g input, circumferential cracks appeared at both ends of the column, which mainly were caused by the clockwise torque. With the increase of PGA inputs, the torque gradually increased, and the crack length also widened and lengthened. When PGA reached 0.8g, diagonal cracks began to appear. The diagonal cracks were the result of multiple actions of compression, bending and torsion. When PGA reached 1.45g, the concrete crushed. According to the location of the final crack and the concrete compression phenomenon, it was in good agreement with the actual earthquake damage. The basic frequency changes of model were shown in Table 4.

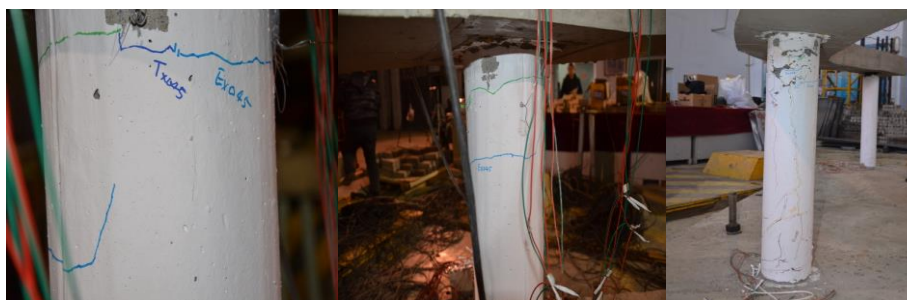
Fig.6 -Circumferential and diagonal cracks

Then the cracks continued to develop and new circumferential cracks appeared at the bottom of the column, with a length of about 5cm. At the height of 1 / 5 from the top of the column, there were circumferential and diagonal cracks, the length of which was about 25cm, shown as Fig.6. The circumferential cracks were mainly caused by torsion, while the diagonal parts were caused by shear force. At the same time, the sliding amount of the top support of the two ends of the column was about 5mm, and the trend of increasing the sliding was not obvious.
