THE RESTORATION OF A COLLAPSED HISTORIC MONUMENT - ARCHITECTURAL AND STRUCTURAL DILLEMA

Abstract

3. General overview of the structure

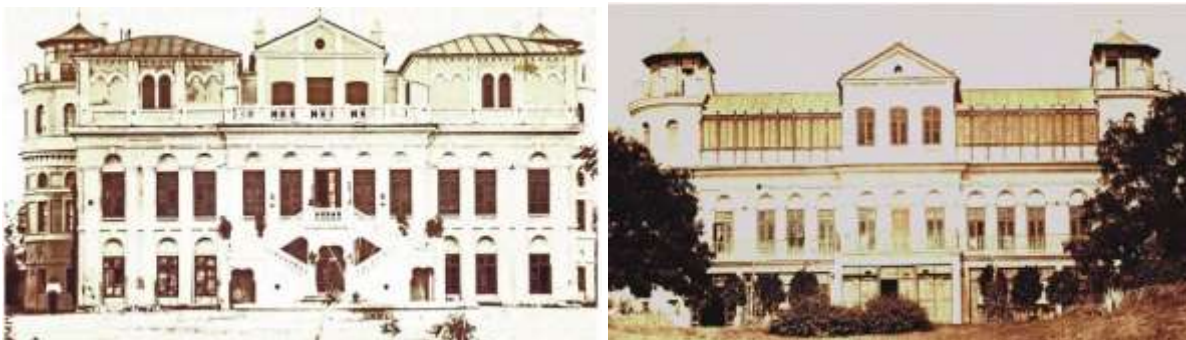
Fig. 2 –Images by Franz Duschek the father (1863 - 1868) main façade and the façade to the lake [10]

In the period 1863-1876 he remodeled the manor house in the style of holiday chalets in the Italian-Austrian alpine area or the spa resorts of Karlovy Vary, Herculane, adding the great honor staircase on the facade N with two allegorical statues Venus and Apollo, adding the side towers on east and west, floor 2 extension and “glazing” configuration, adding the existing terrace to the park on the 1st floor on the south façade. The photographs of the mansion made by Franz Duschek - the father (1863-1868), shows the romantic and sumptuous character of the building that became a palace [10]. In 1876 Ion Oteteleşanu dies, leaving the will of the Romanian Academy for the founding of an Institute of Poor.

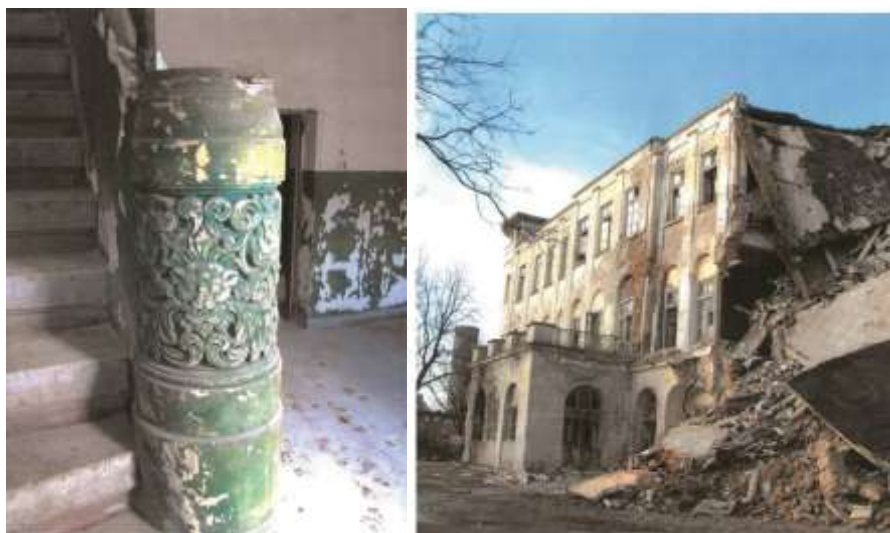
Fig. 4 – Left - Railing detail; Right - The posterior existence facade [12]

Stage VI. IFTM Period - INCDFM (1977-2019). In 1979 it becomes the Institute of Physics of Materials (IFTM-INCDFM), who used very difficult the uncertain space affected by the 1986 and 1990 earthquakes. In 2011 the east tower crash. The existing situation required either demolition or consolidation of the building.

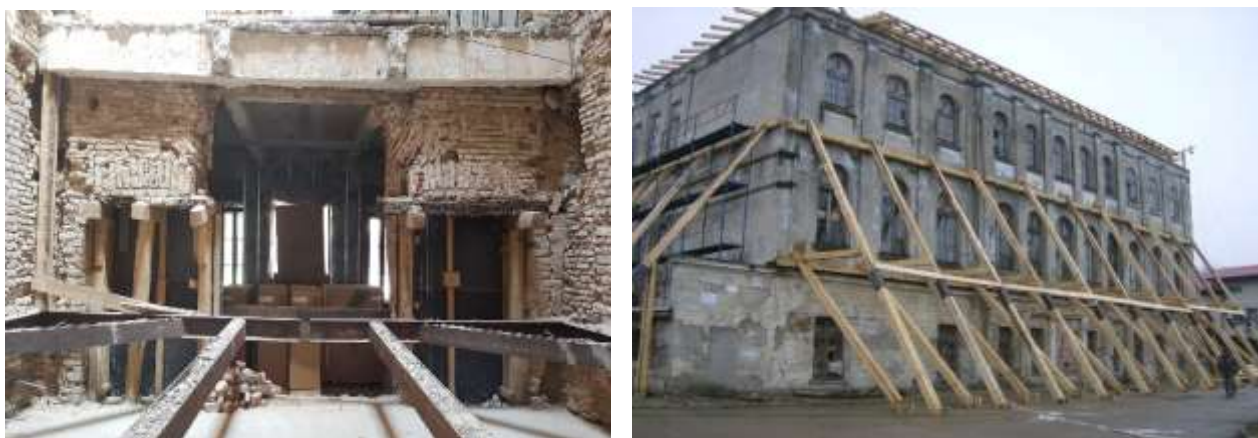
As noted in the previous chapter, the analysed structure was build, extended and rehabilitated with a complete absence of the minimum measures of seismic design, taking into account only the behaviour of the structure under gravitational loads. The extensive assessment of the building highlighted a series of degradations and structural defects.

Fig. 8 — Left - Central core (ground floor); Right - North façade [14]

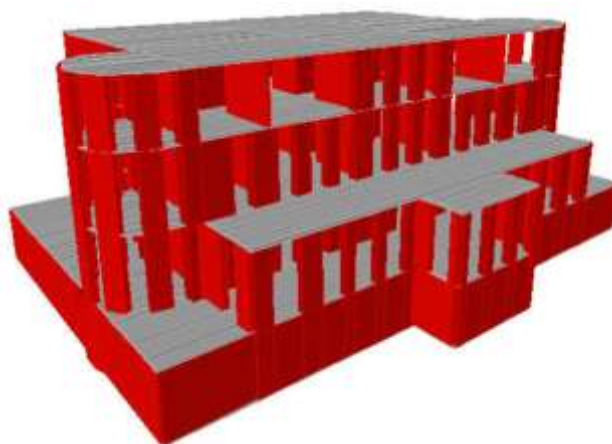
Fig. 9 – 3D design model of the structure [15]

The calculations involved in the assessment of the seismic risk class and the design of the strengthening elements were compliant to principles and criteria from Romanian technical norms and standards (considered to be more restrictive than the European codes regarding seismic design calculation). [16]

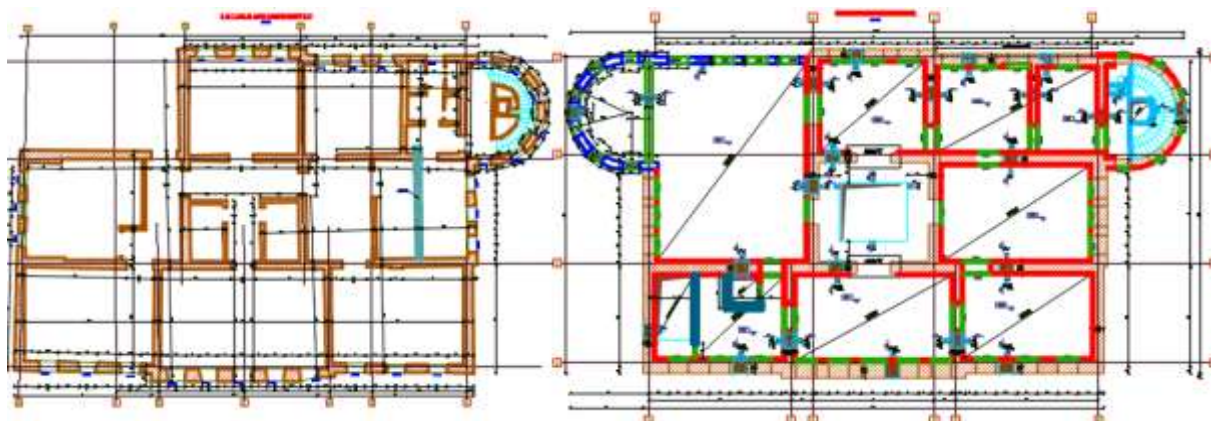
Fig. 10 – Comparison between the slabs over the 2nd floor, existing situation and consolidation measurements [15]

- Full restoration of the East tower and ensuring of a correct connection between the new reinforced concrete elements with the existing masonry and the interior coatings applied on the masonry walls;
- Execution of the reinforced concrete coatings with the rebalancing of the structural overall behaviour;
- Concrete slabs demolition (total or partial) with the execution of new reinforced concrete floors and ensuring their horizontal connection with the vertical structural elements (new or existing); [15]

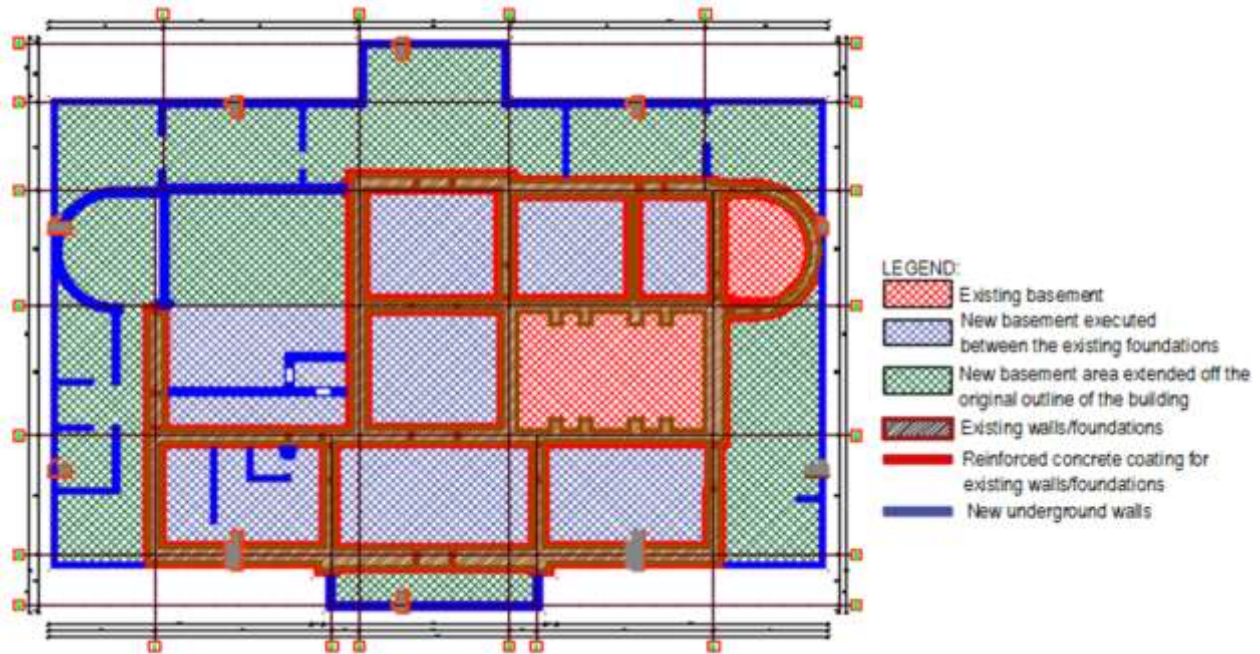
Fig. 11 – Extension areas of the existing basement [15]

The execution of the extended basement area was a very difficult and long-lasting operation that required the following operations to be performed:

- The underpinning of the existing foundations on a height of about 2.00m in order to the foundation level of the newly created basement to not exceed the foundation quota of the existing basement (-4.30m);
- Execution of the general raft in thickness of 50 cm with the incorporation, in its mass, of the existing foundations in the central area (so-called Nucleus area) and of the new foundations resulting from the underpinning operations;

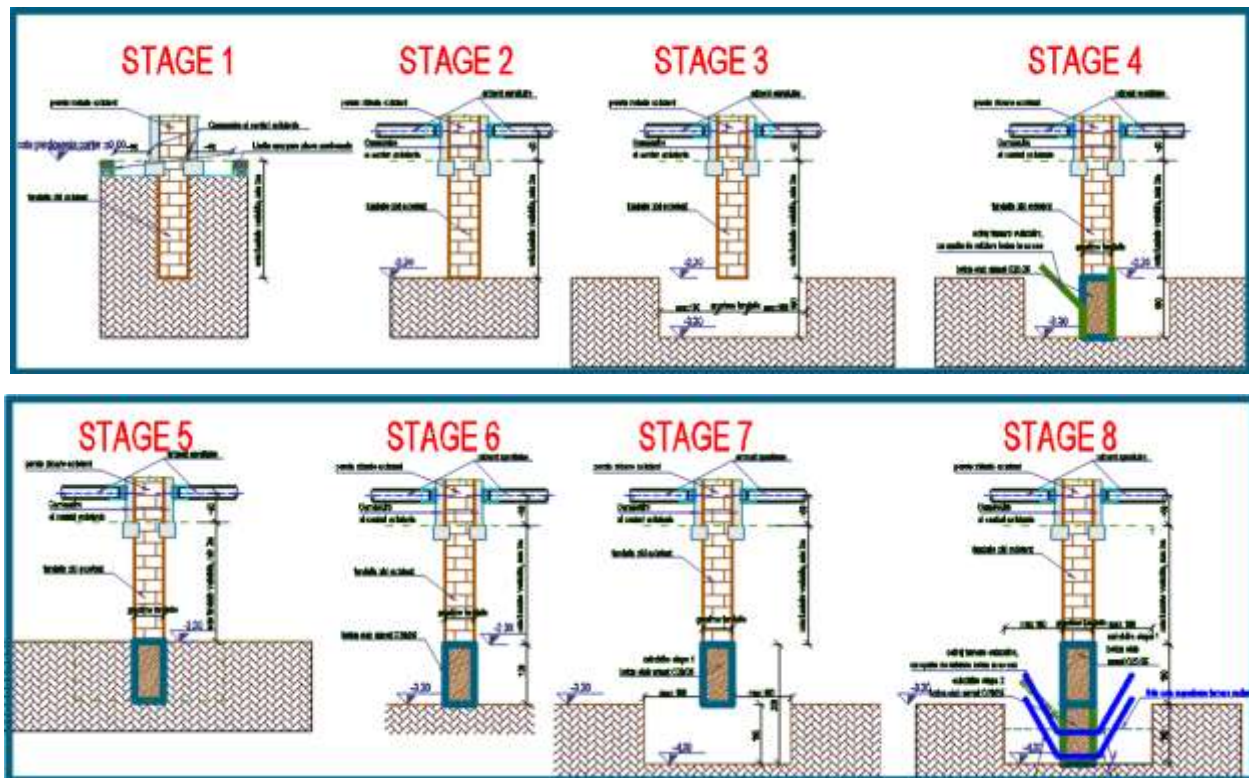
Fig. 12 – Execution stages of the basement level under the existing foundations [15]

- Consolidation of existing foundations (including the underpinnings) by double reinforced concrete coating in thickness of 30 cm, starting from the level of the raft to the slab positioned on +/- 0.00m building level (see the stages presented below);
- Execution of the new walls in underground level following the architectural design;
- Execution of the slab on +/-0.00m level and the connections between the reinforcement mounted in the underground concrete coatings with the reinforcements from the ground floor structural elements (the walls areas remain not casted);
- The removal of the horizontal bracings;
- Execution, by cutting, of the doors and windows holes in the new underground walls.

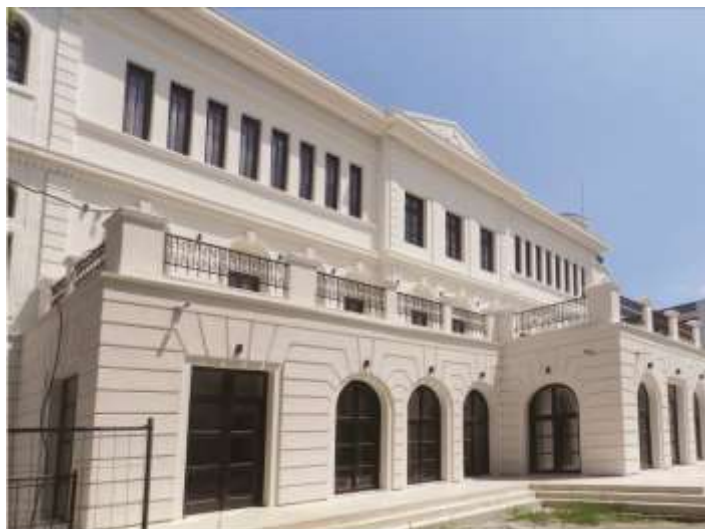
Fig. 13 – North façade of Oteteleşanu Castle after restauration [10]

After performing these operations, the rest of the interventions (including the execution of the eastern tower) continued as in the case of a classic consolidation, the only more difficult operations remaining the repairs to the exterior facades of the building.
