SEISMIC PERFORMANCE EVALUATION OF JAPANESE TRADITIONAL L-SHAPED THATCHED WOODEN STRUCTURES, *CHUMON-ZUKURI*

N. Takiyama⁽¹⁾, K. Kawashima⁽²⁾ and X. Chen⁽³⁾

Abstract

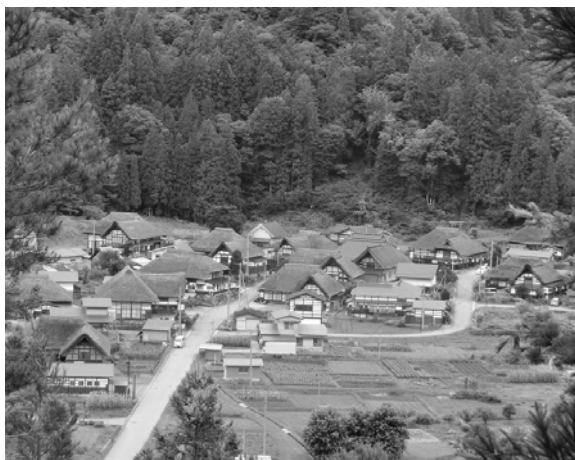
(a) Maesawa preservation district.

The Maesawa district is a mountain village and was registered as an IPDGHB in 2011 [5]. Many households have a thatched roof and are built on land surrounded by mountains, as shown in Fig. 1(a). The thatched houses have a large building pitch. This district has approximately 14 thatched houses: 10 L-shaped houses called *Chumon-Zukuri* and 4 rectangular-shaped houses called *Sugoya*. The Maesawa preservation district is a tourist location.

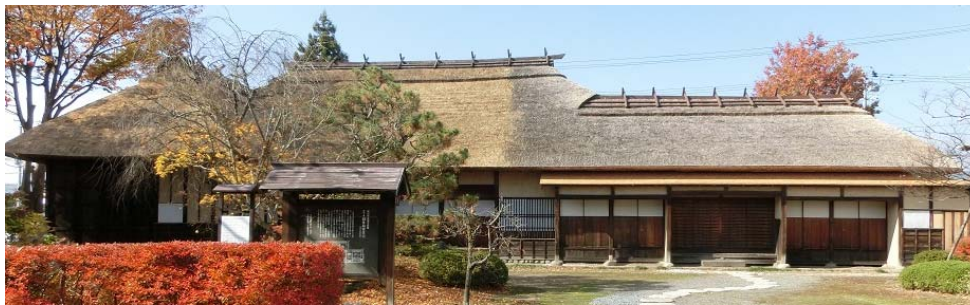
Fig. 3 – Appearance of House D

This chapter concerns House D in Kitakata city. House D was built in 1771 and was relocated 29 years ago.

The front facade of the House D is shown in Fig. 3, and the structure of the house is shown in Fig. 4. The plan is shown in Fig. 4(a). This is a one-storied house. The cross section along the span, S1 and S4, is shown in Figs 4(e) and (c), respectively, and the ridge cross section, S2 and S3, is shown in Figs 4(b) and (d), respectively. The columns are set on the ground sill.

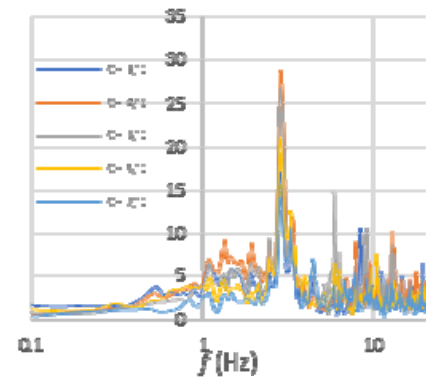
Fig. 5 – Microtremor measurements of House D

The microtremor measurement results for House D are shown in Figs 5 and 6. The measurement points are indicated in Fig. 5(a). One velocimeter was installed on the ground, while others were installed in the attic. The first natural frequencies, f_1 , are provided in Table 2. The first natural frequency in the ridge direction is 2.9 Hz, as shown in the Fourier spectrum ratio in Fig. 5(b); that in the span direction is also 2.9 Hz. The vibration modes are shown in Fig. 6. Unlike House A, it was found that House D had not become separated at the joint between the *Omoya* and *Umayaya*.

Microtremor measurements were conducted. Several overdamping velocimeters were used, and simultaneous measurements were conducted for 500 s (approximately 8 min).

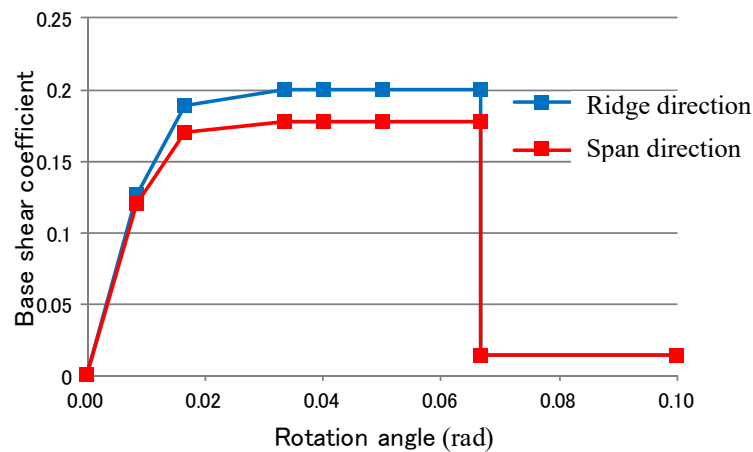
Fig. 7 – Base shear coefficients of House D

The base shear coefficient of House D is shown in Fig. 7. The yield base shear coefficient was 0.36 at 1/30 rad in the ridge direction and 0.32 at 1/30 rad in the span direction.

The yield base shear coefficient of House D was calculated by simply combining the restoring forces using the limit-strength calculation [7, 8]. In the conventional method, the base shear coefficient at 1/30 rad is used as the yield base shear coefficient, C_y . Using C_y as an indicator, the seismic resistance was evaluated.

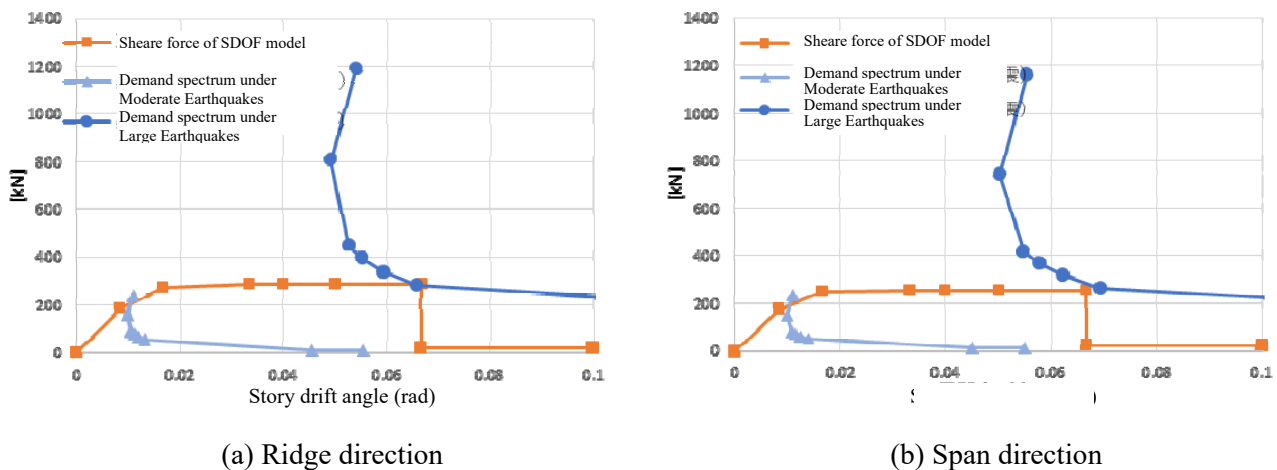
Fig. 8 – Earthquake response values of House D

The earthquake response value of House D was calculated via the conventional limit-strength calculation, as shown in Fig. 8. The response deformation angle of House D is shown in Table 3 with the corresponding values for House A. In the conventional method, the response deformation angle of House A is 0.011 rad for a moderate earthquake and 0.066 rad for a large earthquake. Likewise, the response deformation angle of House D is 0.010 rad for a moderate earthquake and 0.066 rad for a large earthquake.

(a) Ridge direction

(b) Span direction

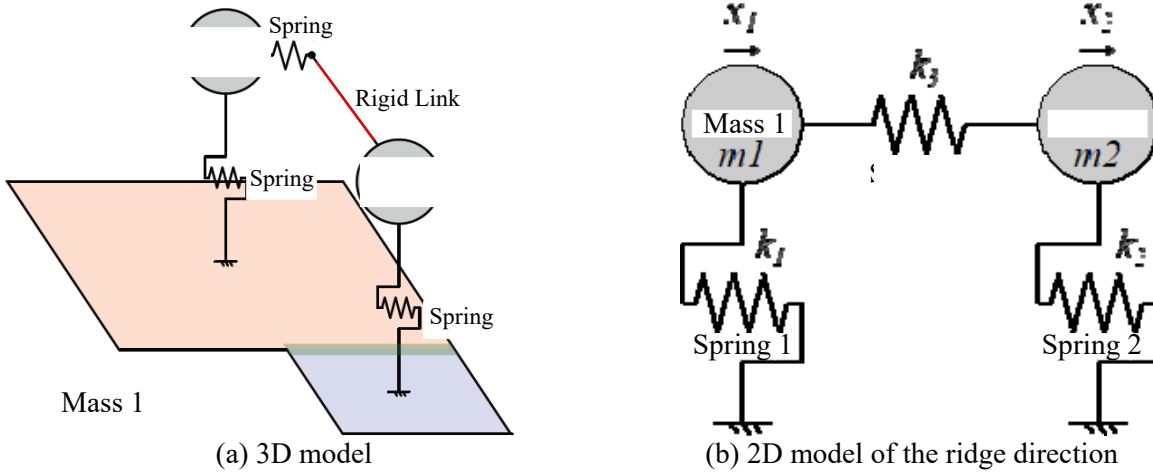
Fig. 9 – Model of the ridge direction of House D

- 1) Calculate the weight of each mass point and restoring force of spring each displacement step based on Fig. 9(a).
- 2) Calculate the stiffness matrix and mass matrix. Make a balanced expression of each mass point, as shown in Fig. 9(b).

$$\begin{bmatrix} m_1 & 0 \\ 0 & m_2 \end{bmatrix} \begin{pmatrix} \ddot{x}_1 \\ \ddot{x}_2 \end{pmatrix} + \begin{bmatrix} k_1 + k_3 & -k_3 \\ -k_3 & k_2 + k_3 \end{bmatrix} \begin{pmatrix} x_1 \\ x_2 \end{pmatrix} = \begin{pmatrix} 0 \\ 0 \end{pmatrix} \quad (1)$$

In the conventional calculation method, single mass points are reduced for each layer. Because of the L-shaped structures of these houses, earthquake-resistant factors may not function within one body. We therefore propose a new reducing method for equivalent single degree of freedom (SDOF) systems in the ridge direction.

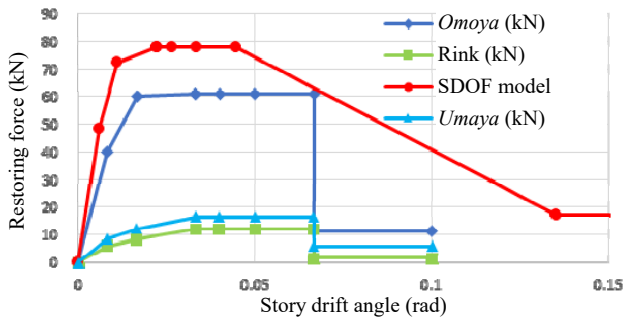
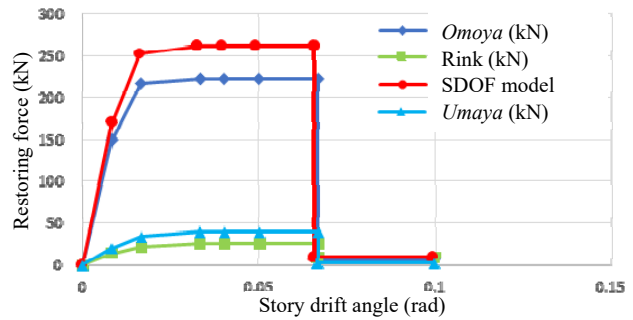
Fig. 10 – Earthquake response values of the ridge directions of Houses A and D

The earthquake response values of Houses A and D were re-calculated using the proposed method, as shown in Fig. 10. The obtained response deformation angles are shown in Table 3. In proposed method, the response deformation angle of House A is 0.009 rad for a moderate earthquake, but House A was judged to collapse for a large earthquake. Likewise, the response deformation angle of House D is 0.011 rad for a moderate earthquake, but House D was judged to collapse for a large earthquake.

(a) Restoring forces of House A

(b) Restoring forces of House D

(c) Response values of House A

(d) Response values of House D
