EVALUATING STATE-OF-THE-ART METHODOLOGIES FOR POST-EARTHQUAKE STRUCTURAL RECONNAISSANCE

Keywords: Post-earthquake reconnaissance; 3D damage documentation; Laser scanning; Structure from motion

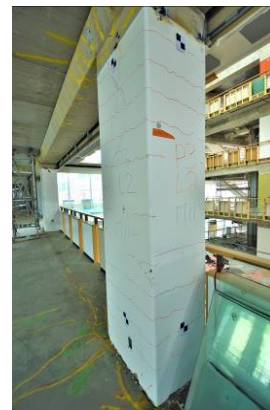
Fig. 2- Targets locations on top and bottom of each face of columns

Next, scanning target locations were selected and scanning targets were applied so that data collected from multiple scans (either for a single scanner or for combining the TLS and SFM/MVS 3D scan data) could be registered and combined into a cohesive model. The 90 mm x 120 mm targets were placed at the top and bottom of each column face and consisted of black and white boxes pattern as shown in Fig. 2.

Finally, damage in the structure was highlighted in select locations. Specifically, cracks were mapped on the diaphragm, soffit of the floor above and columns and beams in Piers 2 and 3 as shown in Fig. 2. The cracks on the diaphragm were measured manually for comparison with the crack width identified using the different scanning methods. Cracks in Pier 1 were not marked to determine the ability of the damage detection techniques to identify cracking without pre-mapping.

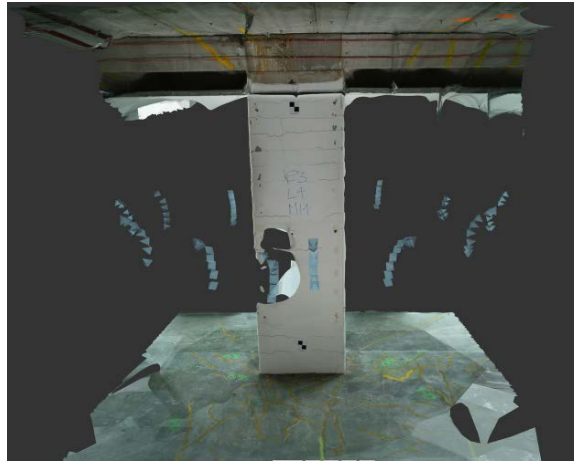
Fig. 6- Showing the poor quality of the model generated with varying light intensities using SFM/MVS

One of the challenges when collecting images for the SFM/MVS was the different lighting conditions on columns in the exterior frames. Prior work has shown that different light exposure across a single element can affect the quality of the 3D model generated from SFM/MVS [11]. Here, two distinct exposures were noted on the external columns, namely a bright exposure on the external face from sun light and a dark exposure on the internal face due to a lack of natural lighting. An attempt to balance the light exposure using portable lights in different locations around column regions was explored part of this case study.

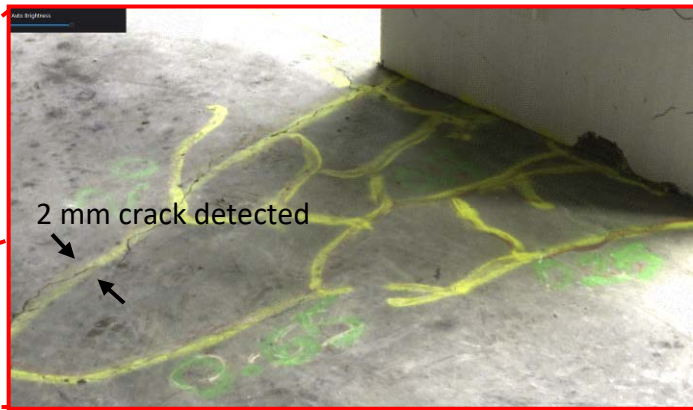
(c) Scanned column using RTC360 scanner

(d) Damage data collected using RTC360 scanner

Fig. 7- shows an example of the difference in the level of detail in techniques used

The relative performance of both reconnaissance techniques was evaluated based on their ability to capture damage in the case-study building as well as the efficiency with which the data was collected and post-processed. Time consumed in post-processing was determined based on a machine with an Intel® Core™ i7-7700 CPU processor, 16GB RAM and Intel® HD Graphics 630 video card. A summary of the differences found regarding data collection, transfer, and post-processing while utilizing different equipment for both techniques is found in Table 2, where the table mainly compares the required resources (e.g. personnel, equipment and time-on-site) that were required to successfully document the structural damage for the case study building using the different techniques. To compare the ability to capture damage and the level of details captured using each technique, a single column from Pier 3 (in which the cracks were measured and mapped prior to scanning) was used for the comparison as shown in Fig. 7. Note that the point clouds generated using the TLS's have been coupled with panoramic images as shown in Fig. 7 to enhance the visualization of cracking. Results from both TLS's showed that TLS's could detect 2 mm crack widths as shown in Fig. 7b and Fig.7d. Even though one scanner had almost half the capabilities of the other, both were able to detect cracks with widths about 2 mm. Both scanners were able to capture this crack width because the distance from the damaged regions to the scanners was relatively short (approximately 2 m). The highest level of detail achieved was using close-range SFM, where cracks with widths down to 0.65 mm were detected as shown in Fig. 7f.

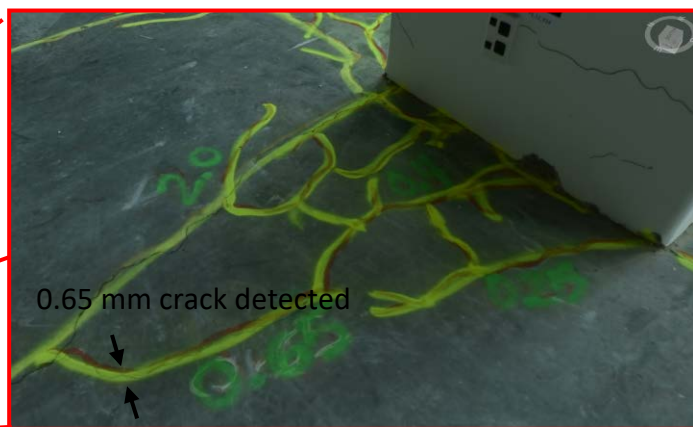
(e) Scanned column using SFM

(f) Damage data collected using SFM
