SHAKE TABLE TEST OF A FULL-SCALE LOW-DAMAGE CONCRETE WALL BUILDING

Keywords: Shake table test; reinforced concrete; low-damage; post-tensioning wall; slotted beam.

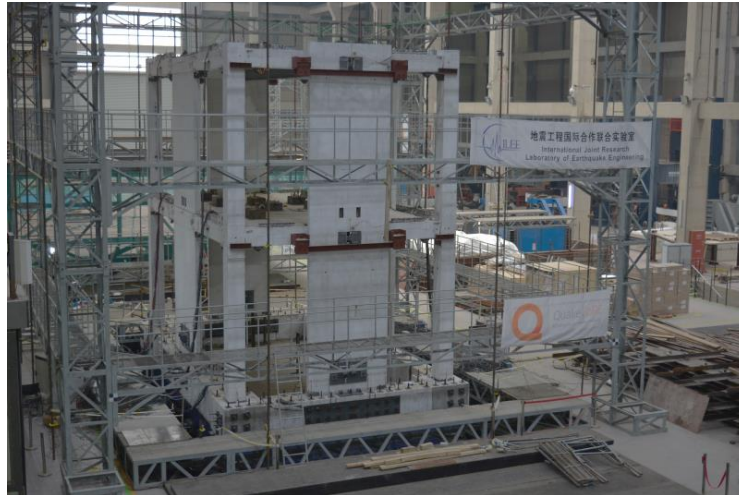
Fig. 1 - The test building on the shake-table array at Tongji University's Jiading campus

The building was designed using the Direct Displacement-Based Design method [11], assuming the building is to be used for general office purposes and located in Wellington, New Zealand. The two-storey test building had plan dimensions of 5.4×8.95 m. The total height of the building from foundation surface was 8 m with each storey 4 m high. The building weighed roughly 1350 kN, close of the payload capacity of the shake table. The building structural system consisted of a perimeter frame and two exterior PT walls in both directions. The four PT walls were designed to primarily resist seismic loads in both directions. The perimeter frame was designed to primarily carry gravity loads and used a slotted beam detail [12]. The Level 1 floor system consisted of a long-span precast concrete double tee and a steel tray composite floor was used for level 2 in a short span configuration with a secondary steel beam aligned through the longitudinal center of the floor. The constructed building and the floor plan of the building are shown in Fig. 1 and Fig. 2, respectively. The building used detailing consistent with that implemented in buildings in New Zealand. The building design is described in detail by Lu et al. [13]. Key features included:

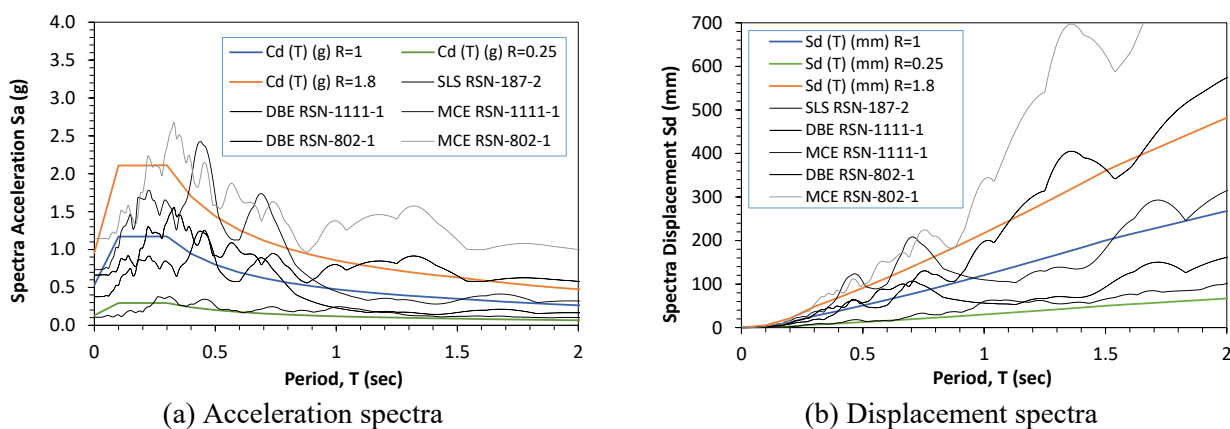
Fig. 3 - Response spectra comparison

All the input ground motions included scaled components in two horizontal axes (X and Y). The input ground motion to simulate Serviceability Limit State (SLS) level earthquakes was from the Parachute Test Site station recorded during the 1979 Imperial Valley earthquake (RSN-187). The ground motions recorded from the Nishi-Akashi station during the 1995 Kobe earthquake (RSN-1111) and Saratoga – Aloha Ave station during the 1989 Loma Prieta earthquake (RSN-802) were selected to simulate design level Far-Fault (FF) and Near-Fault (NF) earthquakes, respectively. The Maximum Considered Earthquake (MCE) used same ground motions that simulated Design-Based Earthquakes (DBE) but with a larger scale factor. Finally, a long-duration ground motion that was recorded at the Sanfernando station during 1985 Chile earthquake (Chile) was selected to investigate the behaviour of the building subjected to a long-duration MCE event. The elastic 5% damped acceleration and displacement response spectra of the three input motions and the target response spectra for NZS 1170.5 SLS (25%), DBE and MCE in the location of Soil C in Wellington are compared in Fig. 3.

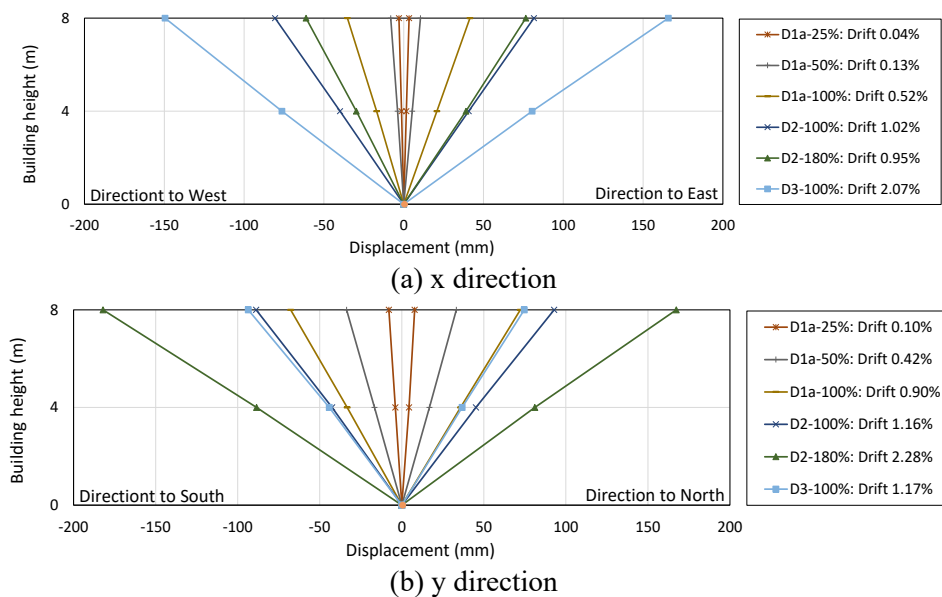
Fig. 4 – Displacement profile of the test building at peak drift

Fig. 4 shows the lateral displacement profiles over the height of the building at peak drifts for Design 1a, Design 2 and Design 3 during bi-directional ground motions at different intensities. The displacements plotted in Fig. 4 is the center displacements at two orthogonal directions calculated as the average of the measurements of four corners, as shown in Fig. 5.

As shown in Fig. 4, the lateral displacement profiles are almost linear, confirming that the building response was controlled by near-rigid body rotation of PT walls. For all the cases, the peak drifts were smaller than the design drifts. For example, the peak drift to the North for Design 1a at 100% intensity was only 0.52%, approximately half of the design drift of 1.0%. The small drift was attributed to the overstrength of the building due to a combination of the safety factors induced in the DDBD design and the influence of wall-to-floor interactions. For most cases, the peak drift in the y direction was larger than in the the x direction as an isolated wall-to-floor connection was used in the y direction and so the overstrength due to wall-to-floor interaction was less significant. It should be noted that the peak drift in the y direction was smaller than x direction for Design 3. This larger drift in the x direction was attributed to the larger damage to the corners of wall 1 and 3 due to the minimal armoring and larger number of tests in the x direction. The building was significantly more flexible in the x direction during the ground motions for Design 3.

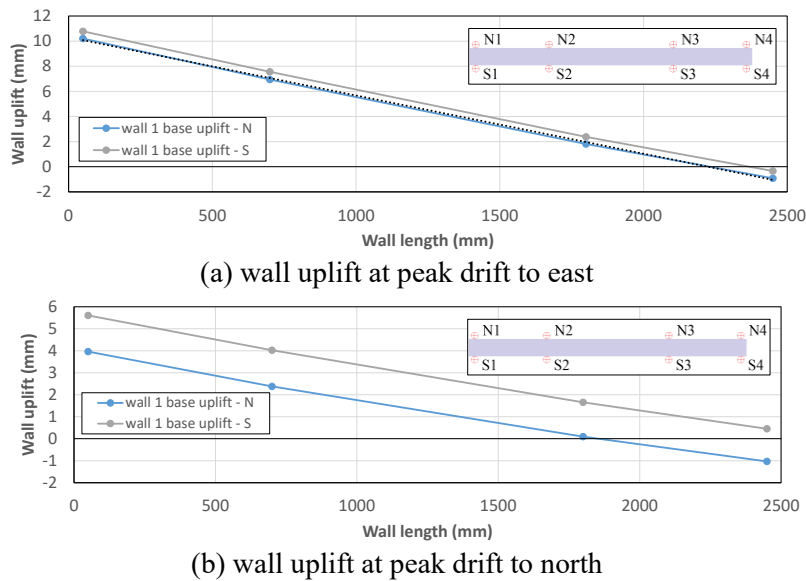
Fig. 7 - Uplift of wall 1 base at peak drift for Design 1a at 100% design intensity

Two rows of linear-pot displacement gauges installed on each side of the wall base, respectively, allowed the gap-opening profiles and wall base rotations to be monitored. An example of uplifts along the length of wall 1 at peak drifts for Design 1a at 100% intensity are plotted in Fig. 7. The uplifts along the wall length were linear from both the northern and southern measurements. At the peak in-plane drift (to east), differences between the measurements on the north and south faces were negligible as the out-of-plane wall rotation was modest. However, the north and south face measurements at peak out-of-plane drifts for wall 1 were offset by around 2 mm, with a combination of in-plane and out-of-plane rotations resulted in a higher compressive strains in the corner of the wall.

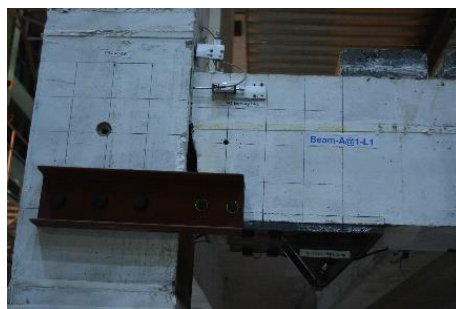
(a) Beam A@1-L1

(b) Beam 1@Bc-L2

Fig. 14 - Slotted beam joint condition after different intensity earthquakes

The slotted-beam connections performed well, minimising beam-elongation (frame dilation) demands on the floors and limiting residual crack widths. Fig. 14 shows examples of the final condition for the slotted beam joints. Only 1-2 diagonal cracks extended from the top of slot to the floor surface with maximum residual crack widths less than 1 mm.

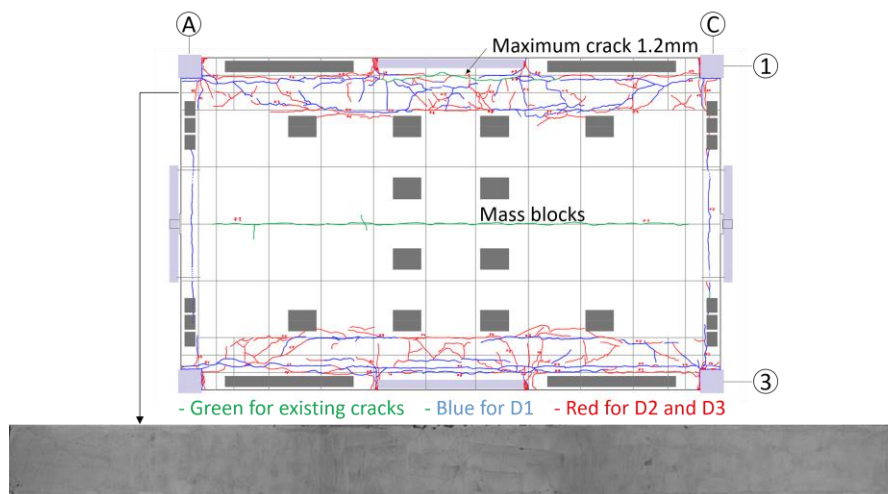
Fig. 16 – Crack map of link slab at end of test

Out-of-plane floor deflections at different locations were measured by string-pot displacement gauges extending vertically from the shake-table to the bottom of the Level 1 floor and from the top of the Level 1 floor to the bottom of the Level 2 floor. The floor out-of-plane deformations were used to investigate the wall-to-floor interaction when different connections were implemented. An example, the level 1 floor deflections at peak drifts for Design 1a at 100% intensity are plotted in Fig. 15. The resulting floor deformations show how the wall picked up the edge of the floor and how this deformation was concentrated within the flexible link slab section. At the peak drift to the east, the vertical floor deformation near the West end of the wall was 7.4 mm larger than the floor deformation at the edge of the link slab near the double tees, and 10.3 mm larger than the floor deformation at column A. However, the flexible wall-to-floor connections used in the test building accommodated the wall deformations as intended, resulting in only minor cracks in the floors. Fig. 16 shows the crack maps of the entire Level 1 floor and an example of crack map photo of the link slab. As shown in Fig. 16, floor cracks were mainly concentrated within the two link slabs. The cracks were evenly distributed along the length of the link slab with a maximum residual crack width of approximately 1 mm.
